Technical Service Information

GM 6T70/75 & 6L50/80/90

NUMEROUS SOLENOID & TCC PERFORMANCE CODES

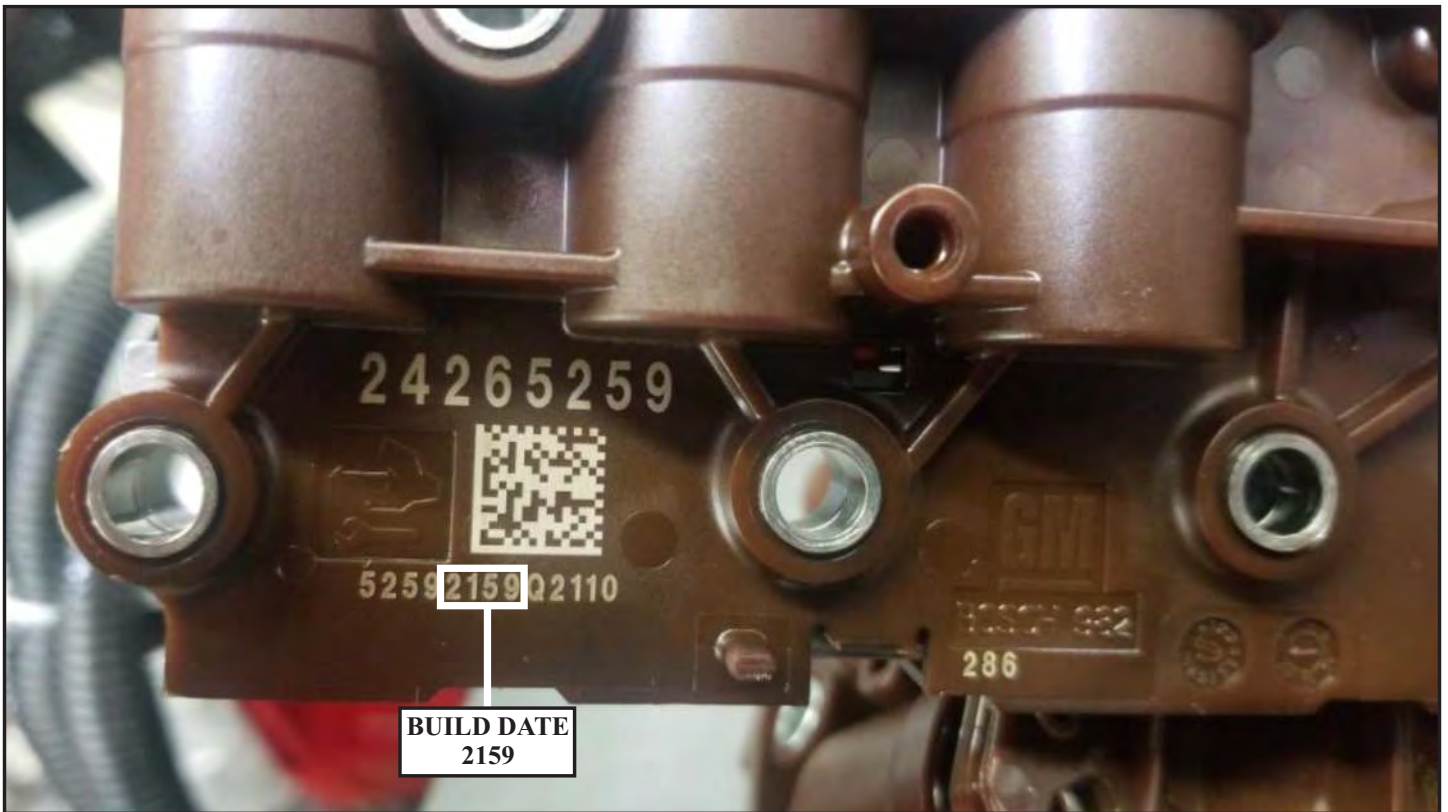
Figure 1

CAUSE: These complaints may be caused by a defective capacitor located inside the TEHCM requiring TEHCM replacement. However, diagnostics for all above mentioned codes must result in the TEHCM being at fault before actual replacement.

CORRECTION: To determine if the TEHCM in your vehicle is a defective one, check the build date on the TEHCM, refer to figures 1 and 2.
If the build date is 7209 through 7262 which covers dates July 28, 2017 to September 19, 2017, the TEHCM should be replaced.
If your TEHCM does not fall into these build dates, then this is not a defective one and code diagnostics should be performed.
