Technical Service Information

GM 6T40 SERIES TRANSMISSIONS LOSS OF OSS SIGNAL

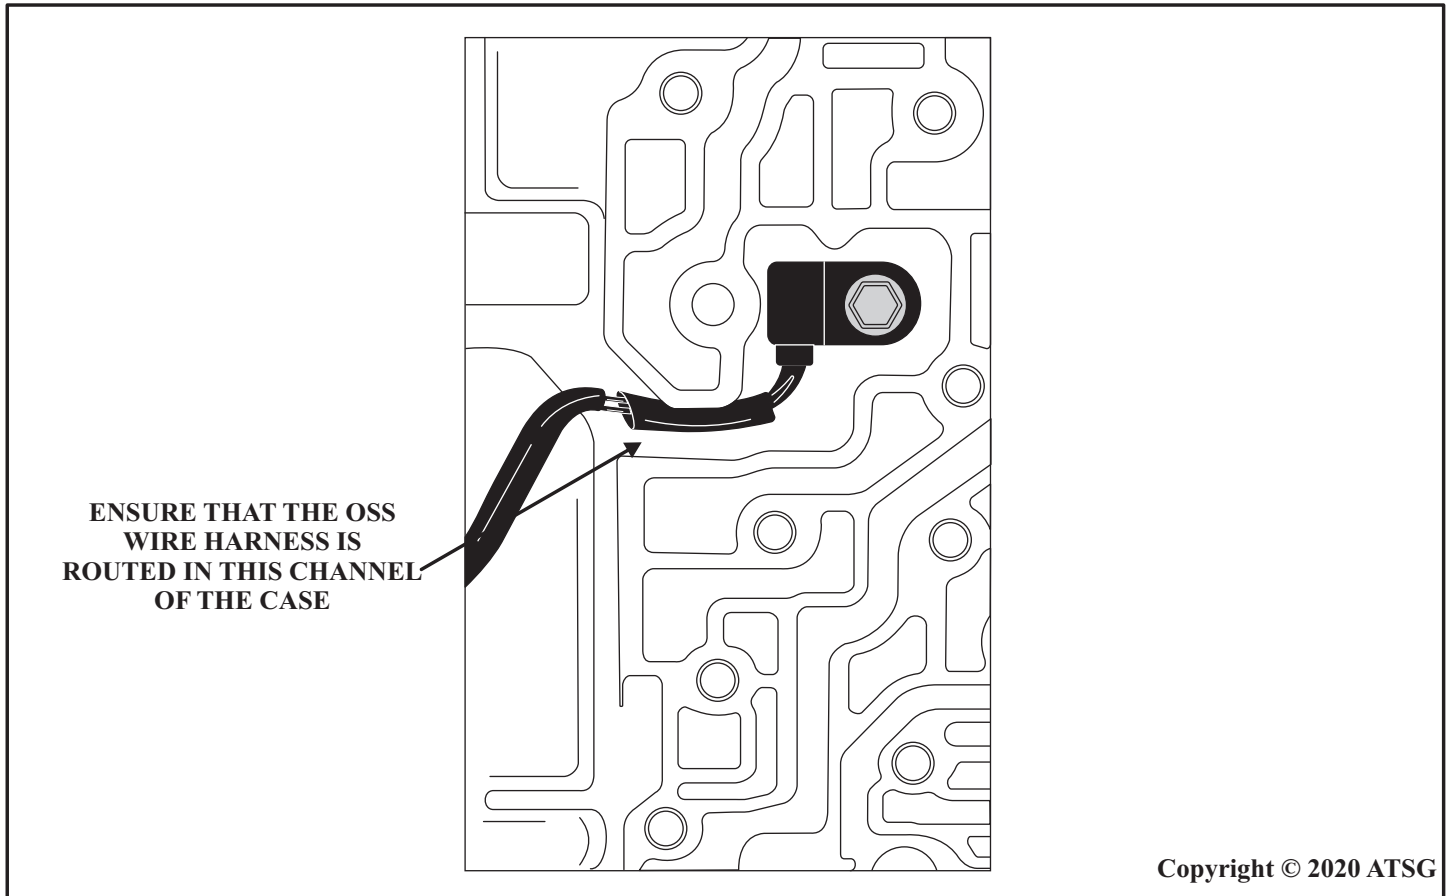
Figure 1

COMPLAINT: After overhauling a GM vehicle equipped with a 6T40 Series Transmission, diagnostic trouble code P077C for the Output Speed Sensor Circuit Voltage Low sets.

CAUSE: During the overhaul process, the rebuild technician caught the output speed sensor wires under the valve body, this is very easy to do if you are not watching.

CORRECTION: Carefully route the OSS wire harness into the channel in the case as seen in figure 1. Ensure that when the valve body is placed onto the transmission case that the OSS wire harness remains free as seen in figure 2.
