Technical Service Information

GM 6T70/75

NO REVERSE, 3RD OR 5TH GEARS

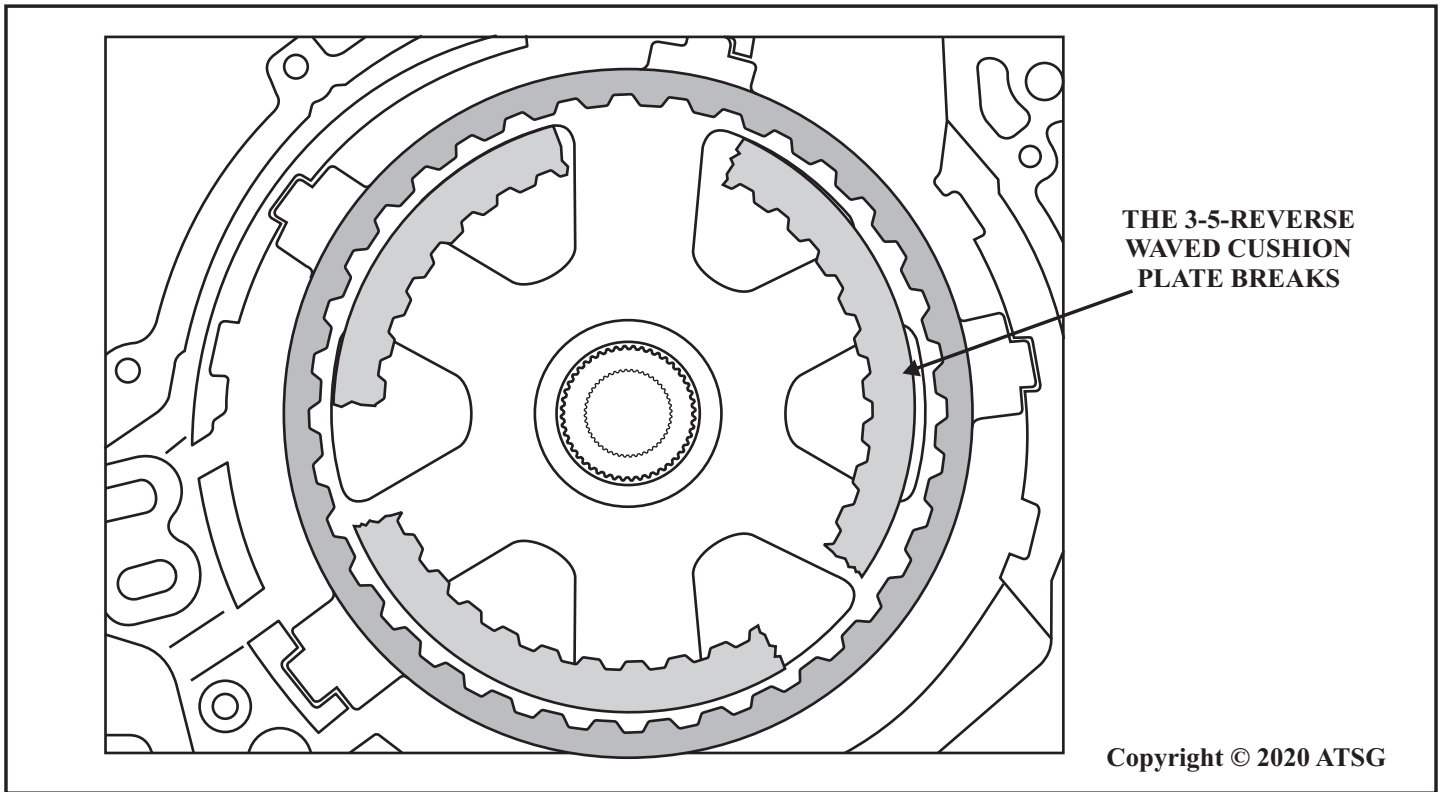
Figure 1

Upon disassembly of the transmission a number of damaged parts are found, but not limited to, including the 3-5-Reverse drum and piston return spring assembly and the transmission end cover shown in Figures 1, 2, and 3.

CAUSE: The 3-5-Reverse wave plate has broken allowing the piston to over stroke.

CORRECTION: Replace the damaged parts using the part numbers found under “Service Information”.

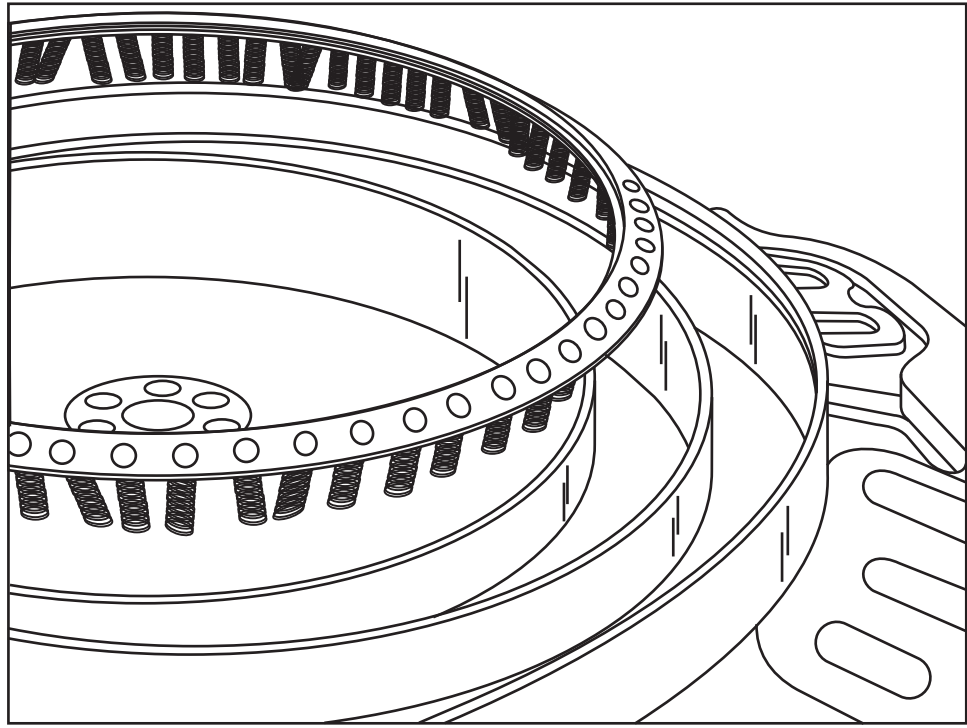
Figure 3

**THE 3-5-REVERSE
PISTON RETURN
SPRING ASSEMBLY
& THE TRANSMISSION
END COVER ARE
ALSO DAMAGED**
