# Technical Service Information

## GENERAL MOTORS

### NEUTRAL IDLE CONTROL

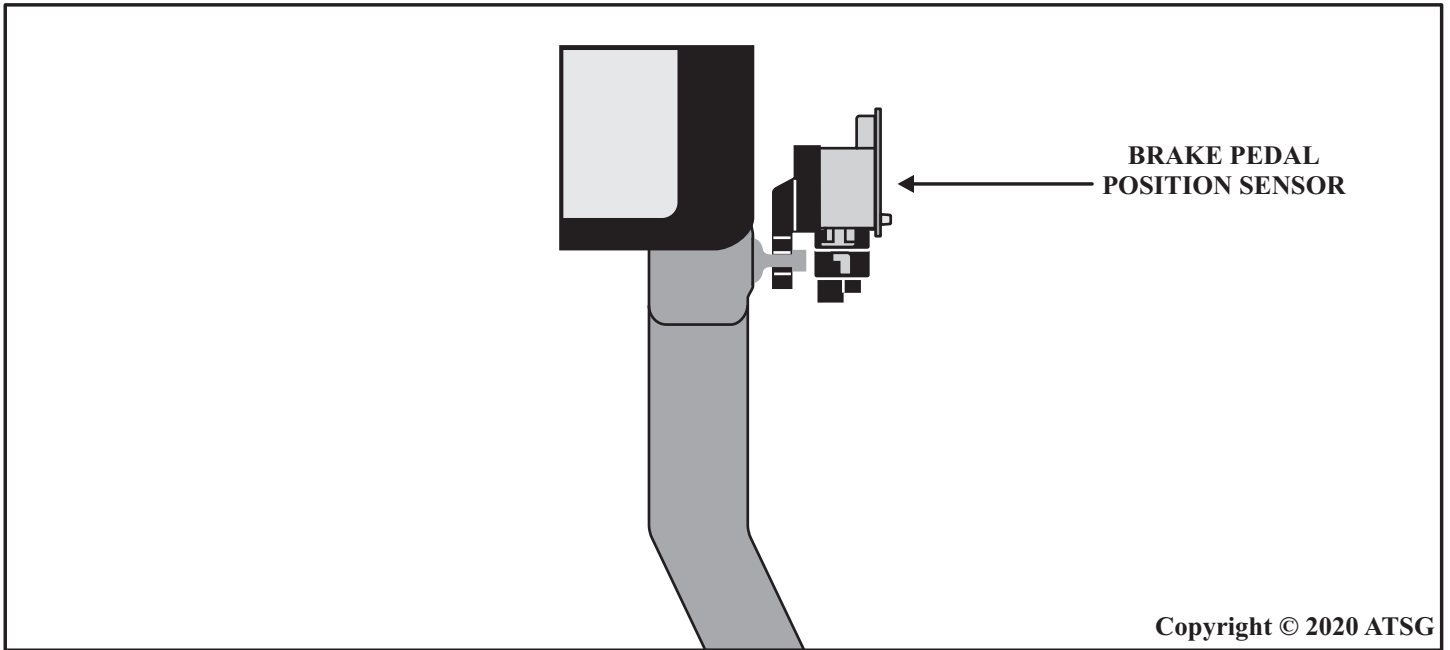
Figure 1

**CAUSE:** Starting in the 2012 model year, the GM Neutral Idle Control feature was introduced which allows the transmission to be put into a neutral state when at a stop with the foot brake applied. This was done as a fuel saving feature. Due to the malfunction of the Brake Pedal Position Sensor (see figure 1 for sensor location), the TCM would react to the voltage variation of the BPPS causing the Neutral Idle Control to engage and release which resulted in the dropping in and out of gear condition.

**CORRECTION:** Replacing the Brake Pedal Position Sensor and performing the BPPS relearn procedure corrected the complaint.

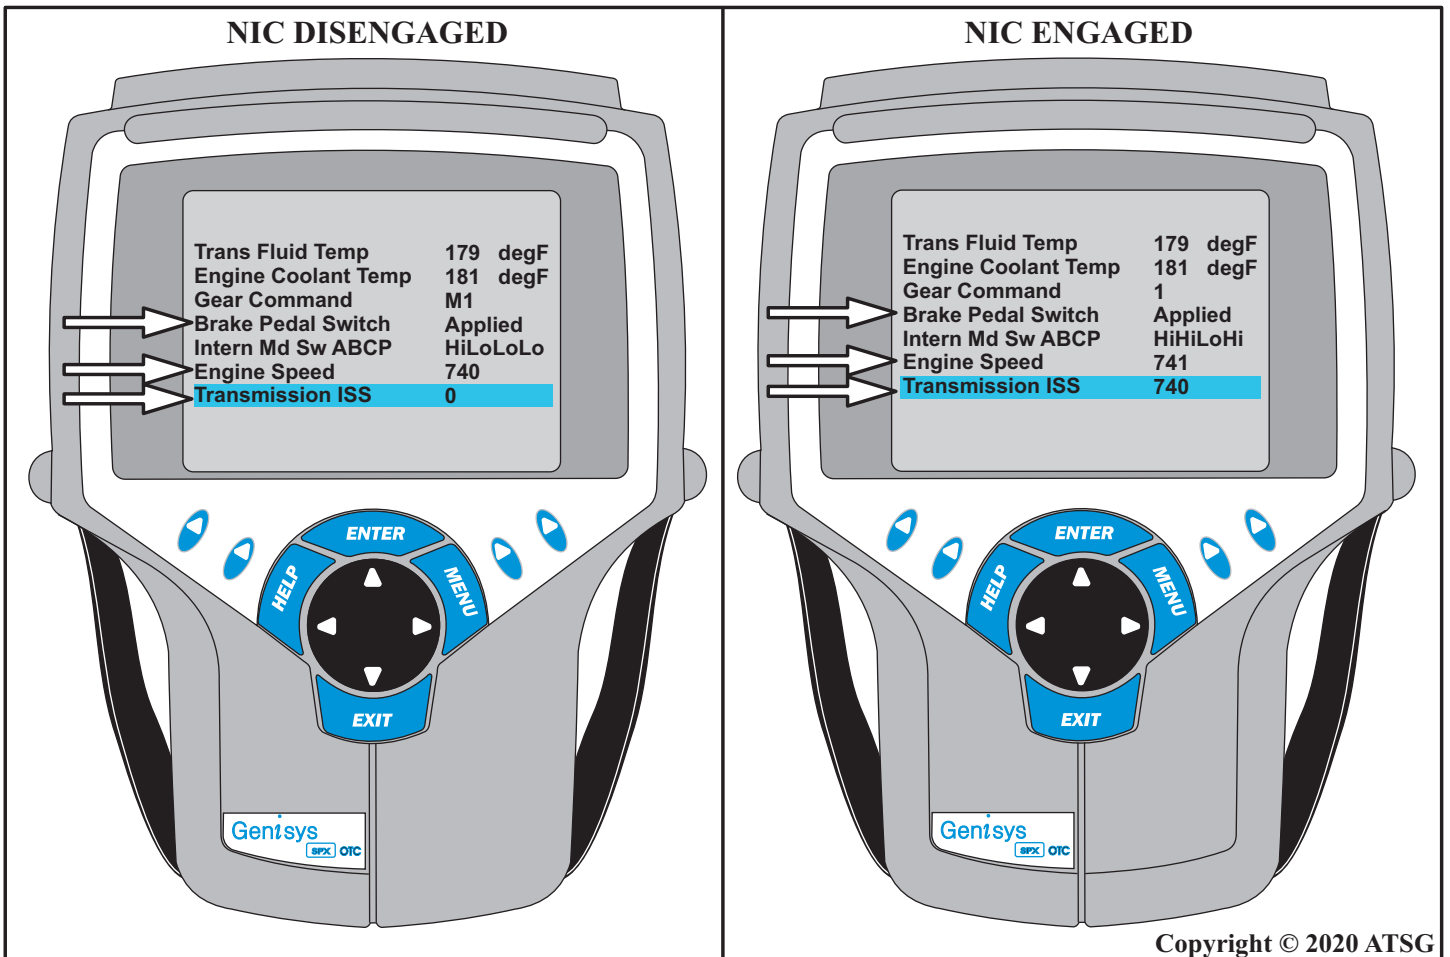
Figure 2

Neutral Idle Control can only be commanded ON when the transmission is operating in the drive range, first gear. When the foot brake is applied and vehicle speed, throttle position and transmission temperature meet the necessary requirements for Neutral Idle Control, it will then disengage. The low/reverse clutch will remain applied while the TCM will command Pressure Control Solenoid 5 to exhaust 1-2-3-4 clutch pressure putting the transmission into a neutral state. This is why PCS 5 was cycling along with the BPPS varying voltage which caused the 1-2-3-4 clutch to apply and release resulting in the dropping in and out of gear condition. This can also be seen when using the scan tool to view input speed versus engine speed. When Neutral Idle Control is not active input rpm will be zero as seen in figure 2. When Neutral Idle Control is active, input speed will nearly match engine and input speed as seen in figure 3.
