Technical Service Information

GM 6T40 GENERATION III GENERATION III CHANGES

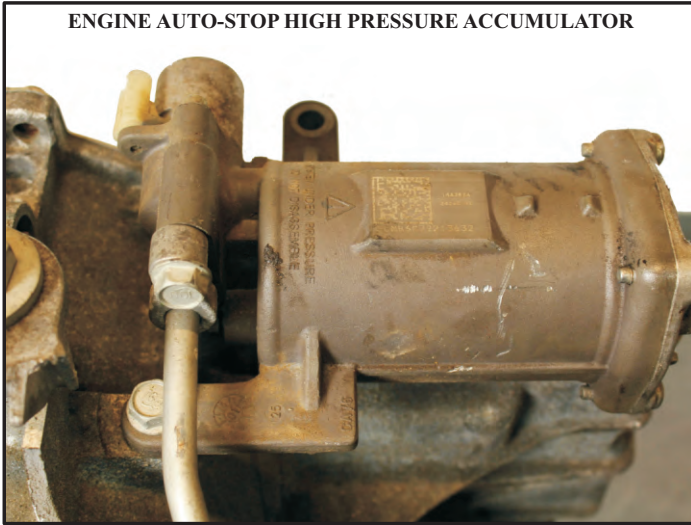
Figure 1

- (1) The addition of an externally mounted solenoid operated high pressure accumulator to provide clutch operating pressure for vehicles equipped with the Engine Auto-Stop feature (figure 1).

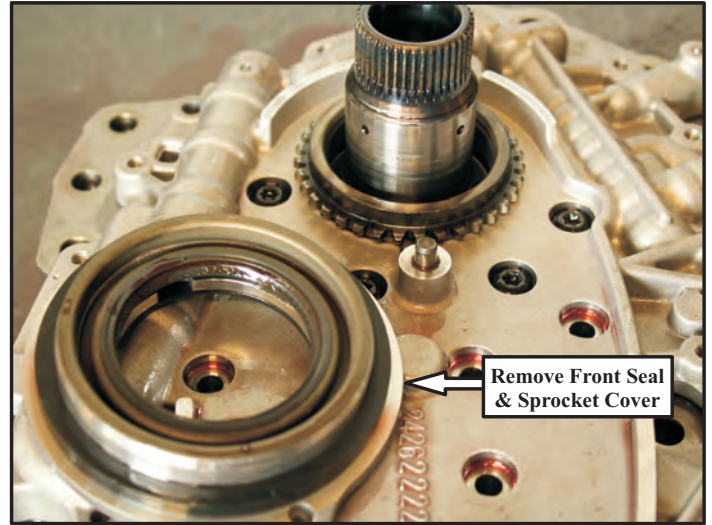
Figure 4

- (3) The sump filter changed dimensionally to 5½ inches wide and 7¾ inches long (figure 2).
- (4) The pump assembly now consists of a variable vane type pump, fluid pump cover, a fluid pump plate, a fluid pump body which contains TCC and pressure regulation valves, a drive chain, and a drive and driven sprocket, see figures 3, 4, 5, 6 and 7.

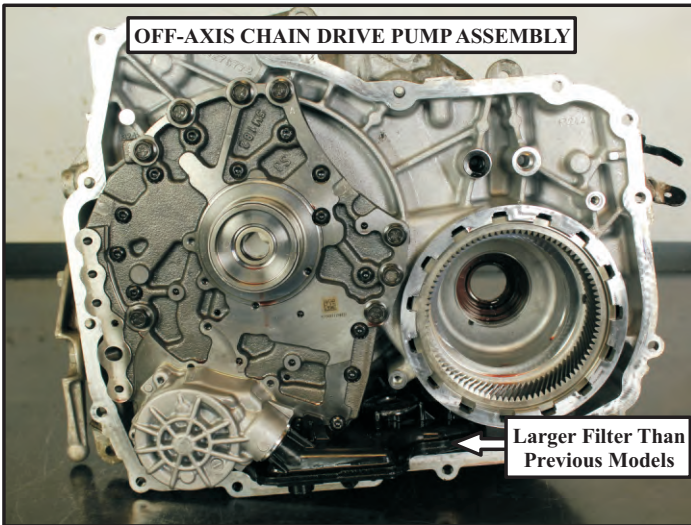
Figure 2

- (2) The torque converter housing was changed to accommodate the off axis chain driven pump assembly that is now mounted to it and to provide oil passages for the new pump design (figure 2).

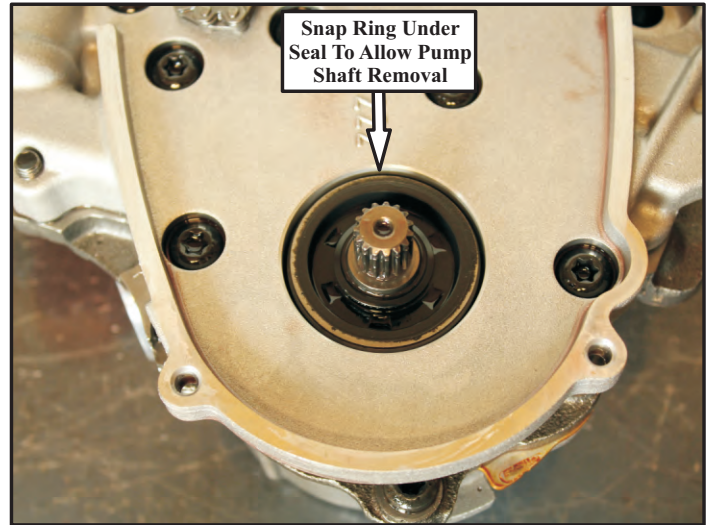
Figure 10

- (5) Transmission Pump Assembly torque specs and tightening sequences are provided in figures 8 and 9.
- (6) The pump assembly has a front seal that must be removed to gain access to the fluid pump shaft snap ring (figure 10).

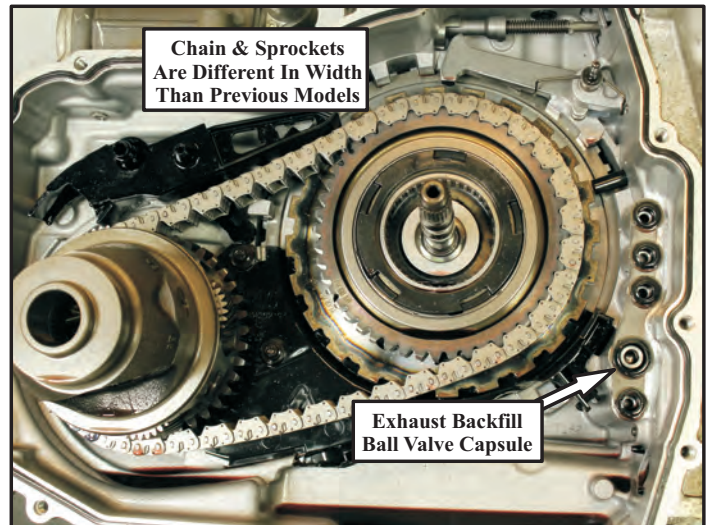
Figure 11

- (7) The transmission drive chain is now 1.106 inches wide and drive and driven sprockets that accommodate the chain width (figures 11 and 12).
- (8) The transmission case is deeper to accommodate wider parts (figure 11).

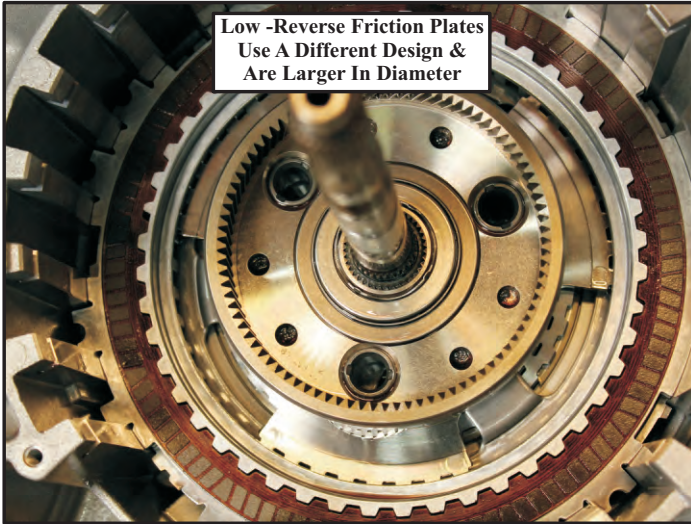
Figure 13

- (9) The low reverse friction plates have the outside diameter increased from the previous 8.43 inches to 8.57 inches to reduce drag. The friction material also changed to what is called a DOT type (figures 13 and 14).

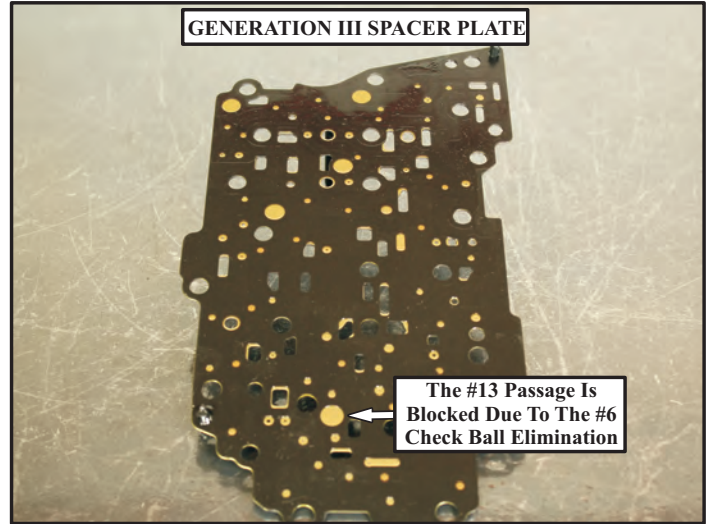
Figure 16

- (10) The main control valve body has the #6 check ball eliminated which is used in the hybrid application only (figure 15).
- (11) The Main control valve body to transfer spacer plate has eliminated the #13 passage (figures 16 and 17).

None of the above parts will back service any previous models with the exception of the valve body assembly. Install the #6 check ball if the application requires it and make certain the #13 passage in the spacer plate is open.

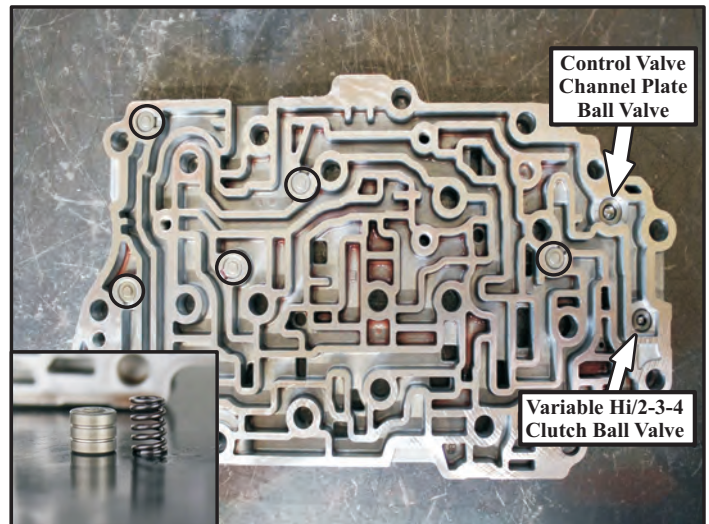
Figure 18

- (12) The valve body transfer plate is shown in figure 18. Small parts are identified and have not changed from the Generation II design level.
- (13) The Generation III TEHCM has new identification letters as compared to the Generation II (figures 19 and 20).
