# Technical Service Information

## CHRYSLER 41TE DELAYED ENGAGEMENT

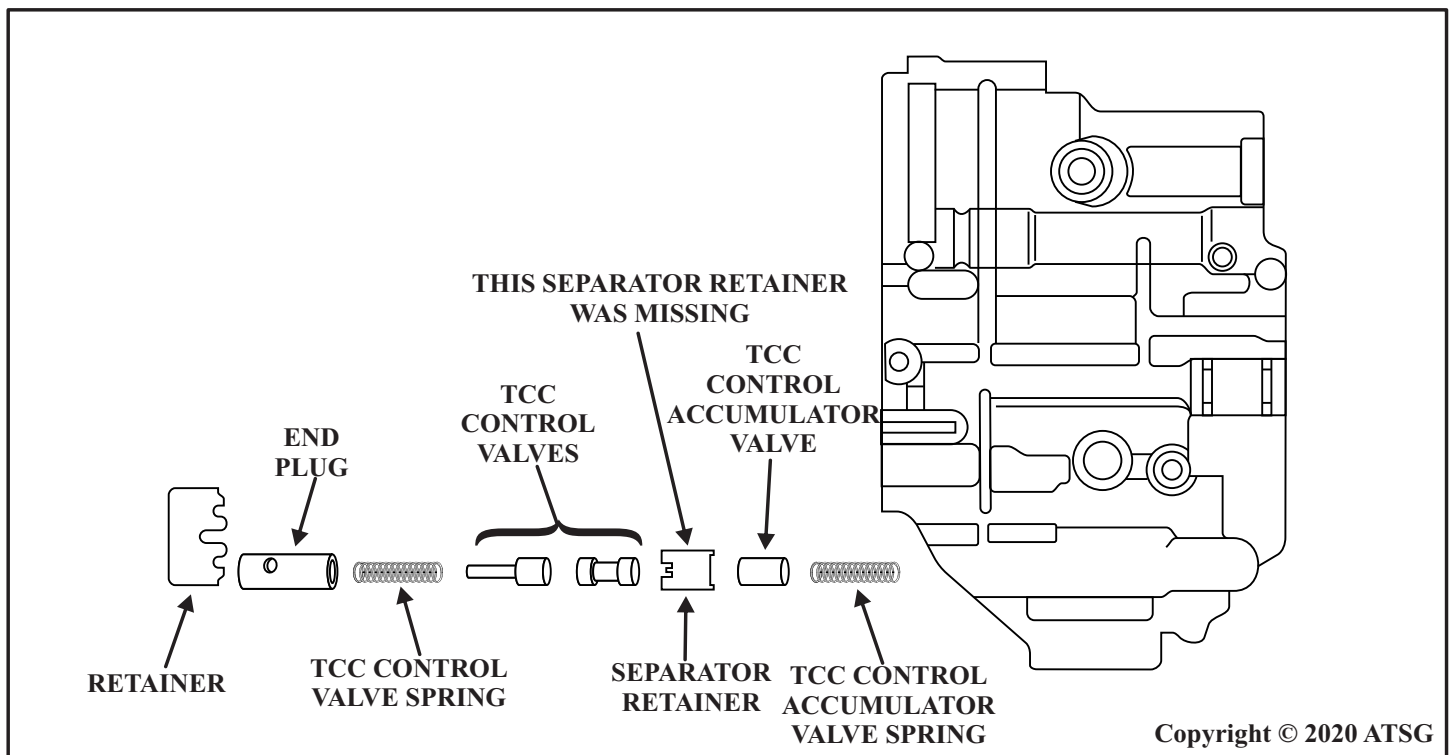
Figure 1

**CAUSE:** The retainer that separates the Lockup Control Valve and the TCC Accumulator Valve was missing, refer to figure 1.

**CORRECTION:** Install the separator retainer between the Lockup Control Valve and the TCC Accumulator Valve.

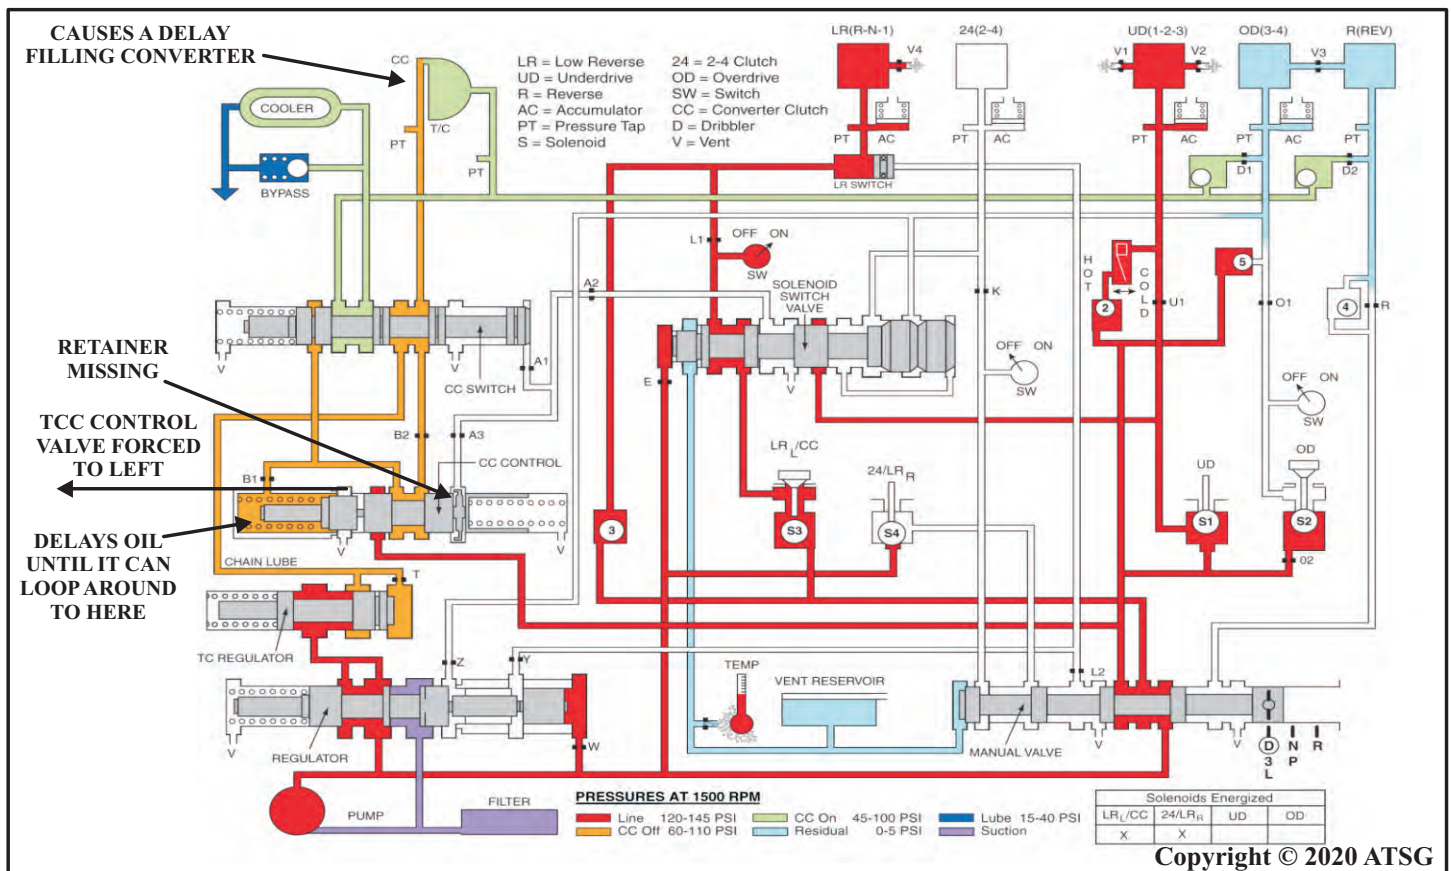
Figure 2

The first gear hydraulic seen in figure 2 will show that without the retainer in place, the Lockup Control Valve will be forced to the left by the TCC Accumulator Valve Spring. This will block TCC charge oil until it can loop around to the spring side of the Lockup Control Valve resulting in a delayed fill of the torque converter.
