GM 6T70/75

ENGAGEMENT ISSUES

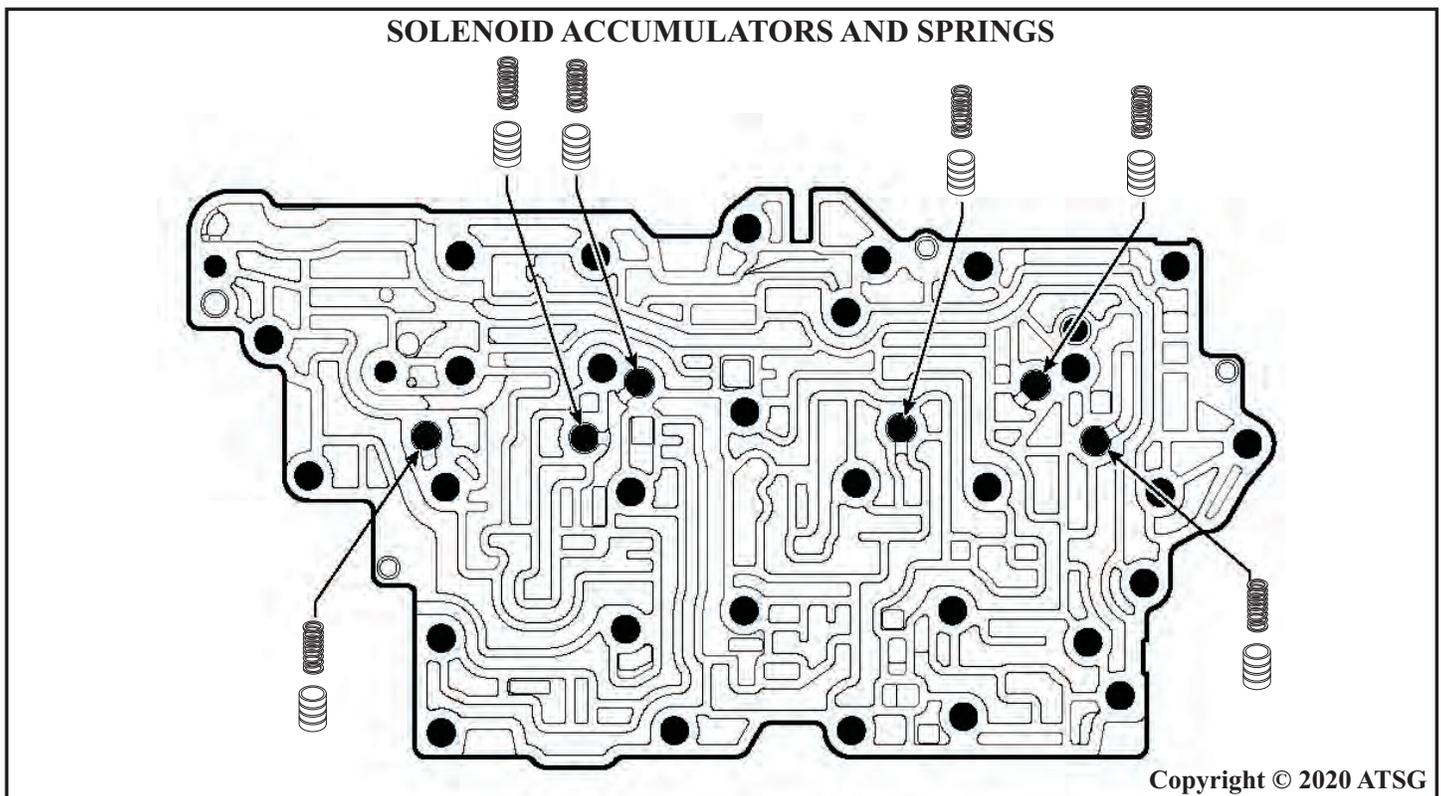
Figure 1

CAUSE: The accumulator piston bores in the valve body channel plate have worn, refer to figures 1 and 2, creating a leak in the clutch circuit that each accumulator piston is responsible for causing these complaints. The wear in the accumulator piston bores have allowed the spring end of the pistons to rotate cutting a chamfer into the spacer plate as seen in figure 3.

CORRECTION: Replace the channel plate, spacer plate and accumulator pistons.
