## ALLISON 1000/2000 SERIES SLIPPING ON INITIAL FORWARD TAKE-OFF

# Technical Service Information

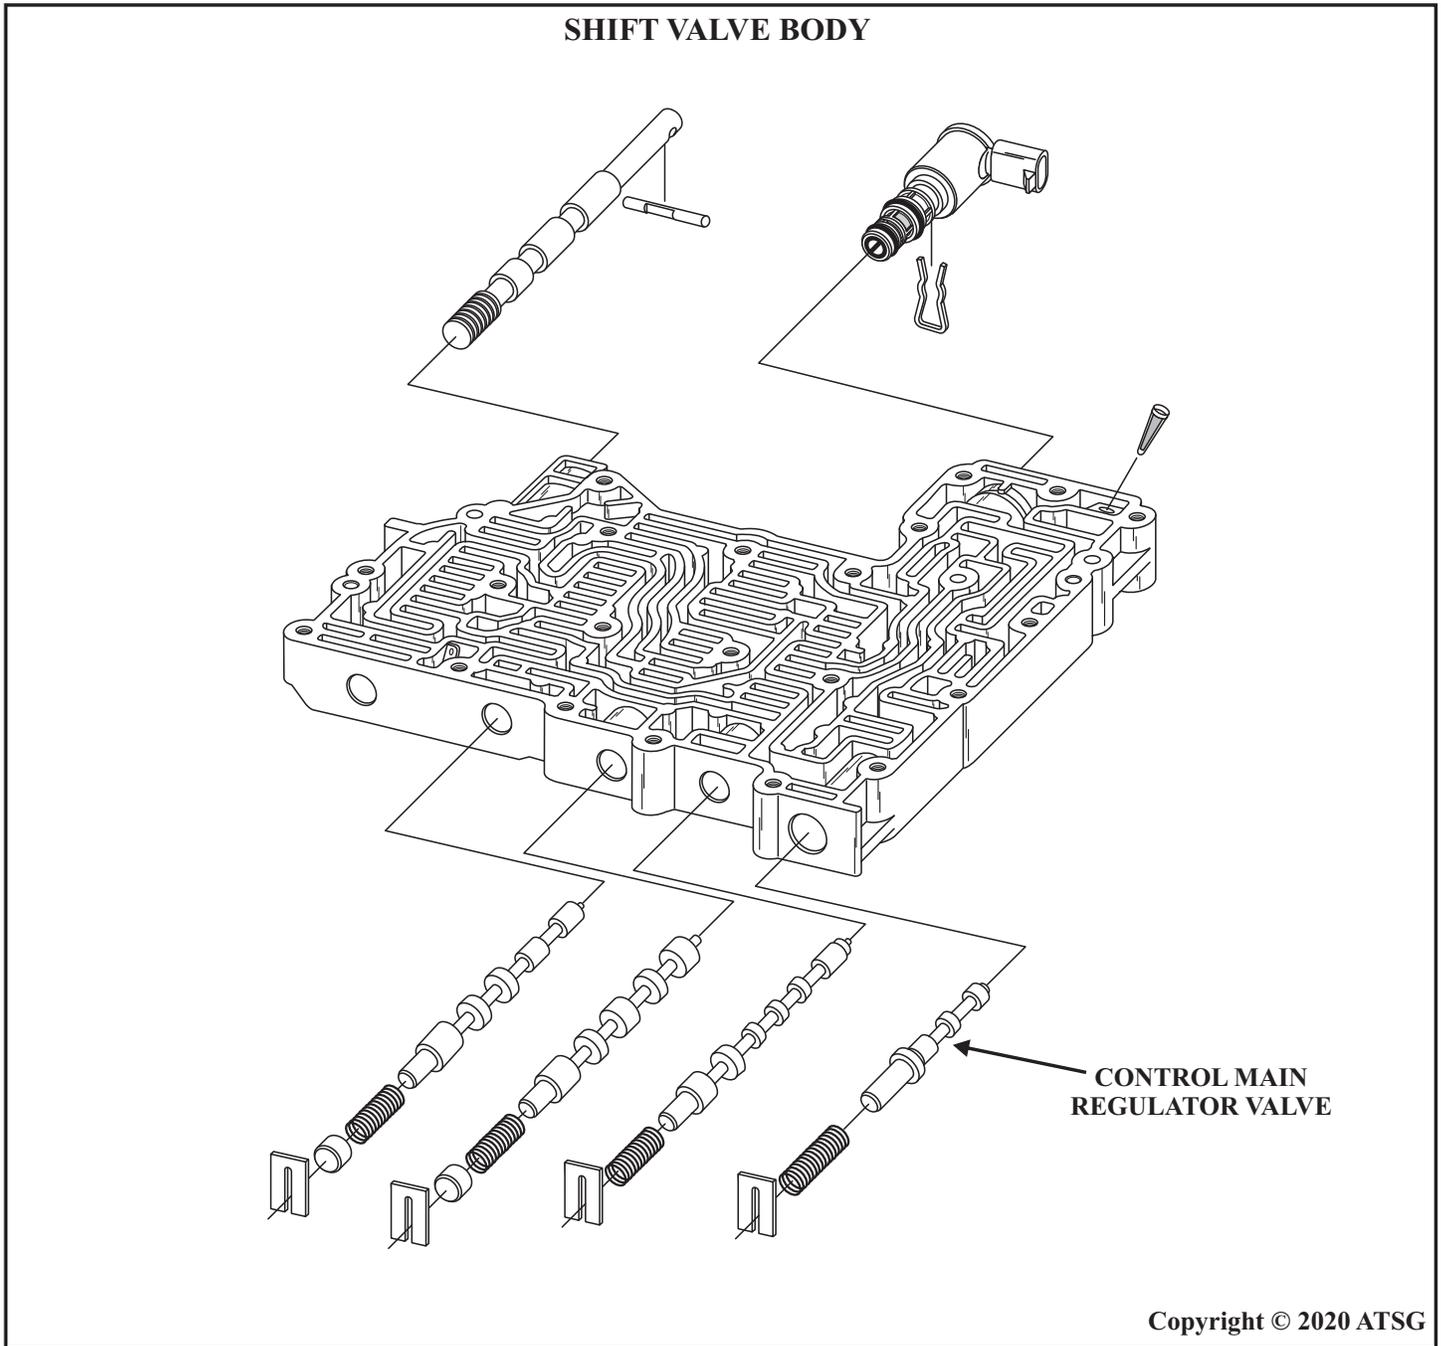
Figure 1

**CAUSE:** With nothing found in the transmission that could be blamed for the slip complaint, the valve body was disassembled for inspection. The Control Main Regulator Valve located in the shift valve body was stuck closed, refer to figure 1.

With the control main regulator valve stuck closed, the solenoids are starved of oil pressure used for clutch application. In this scenario not enough apply oil was sent to the C1 and C5 clutch to allow normal take-off in first range.

**CORRECTION:** The control main regulator valve and bore were cleaned up so the valve was now free. Once the transmission was reassembled and installed back into the vehicle, the truck returned to normal forward take-off.

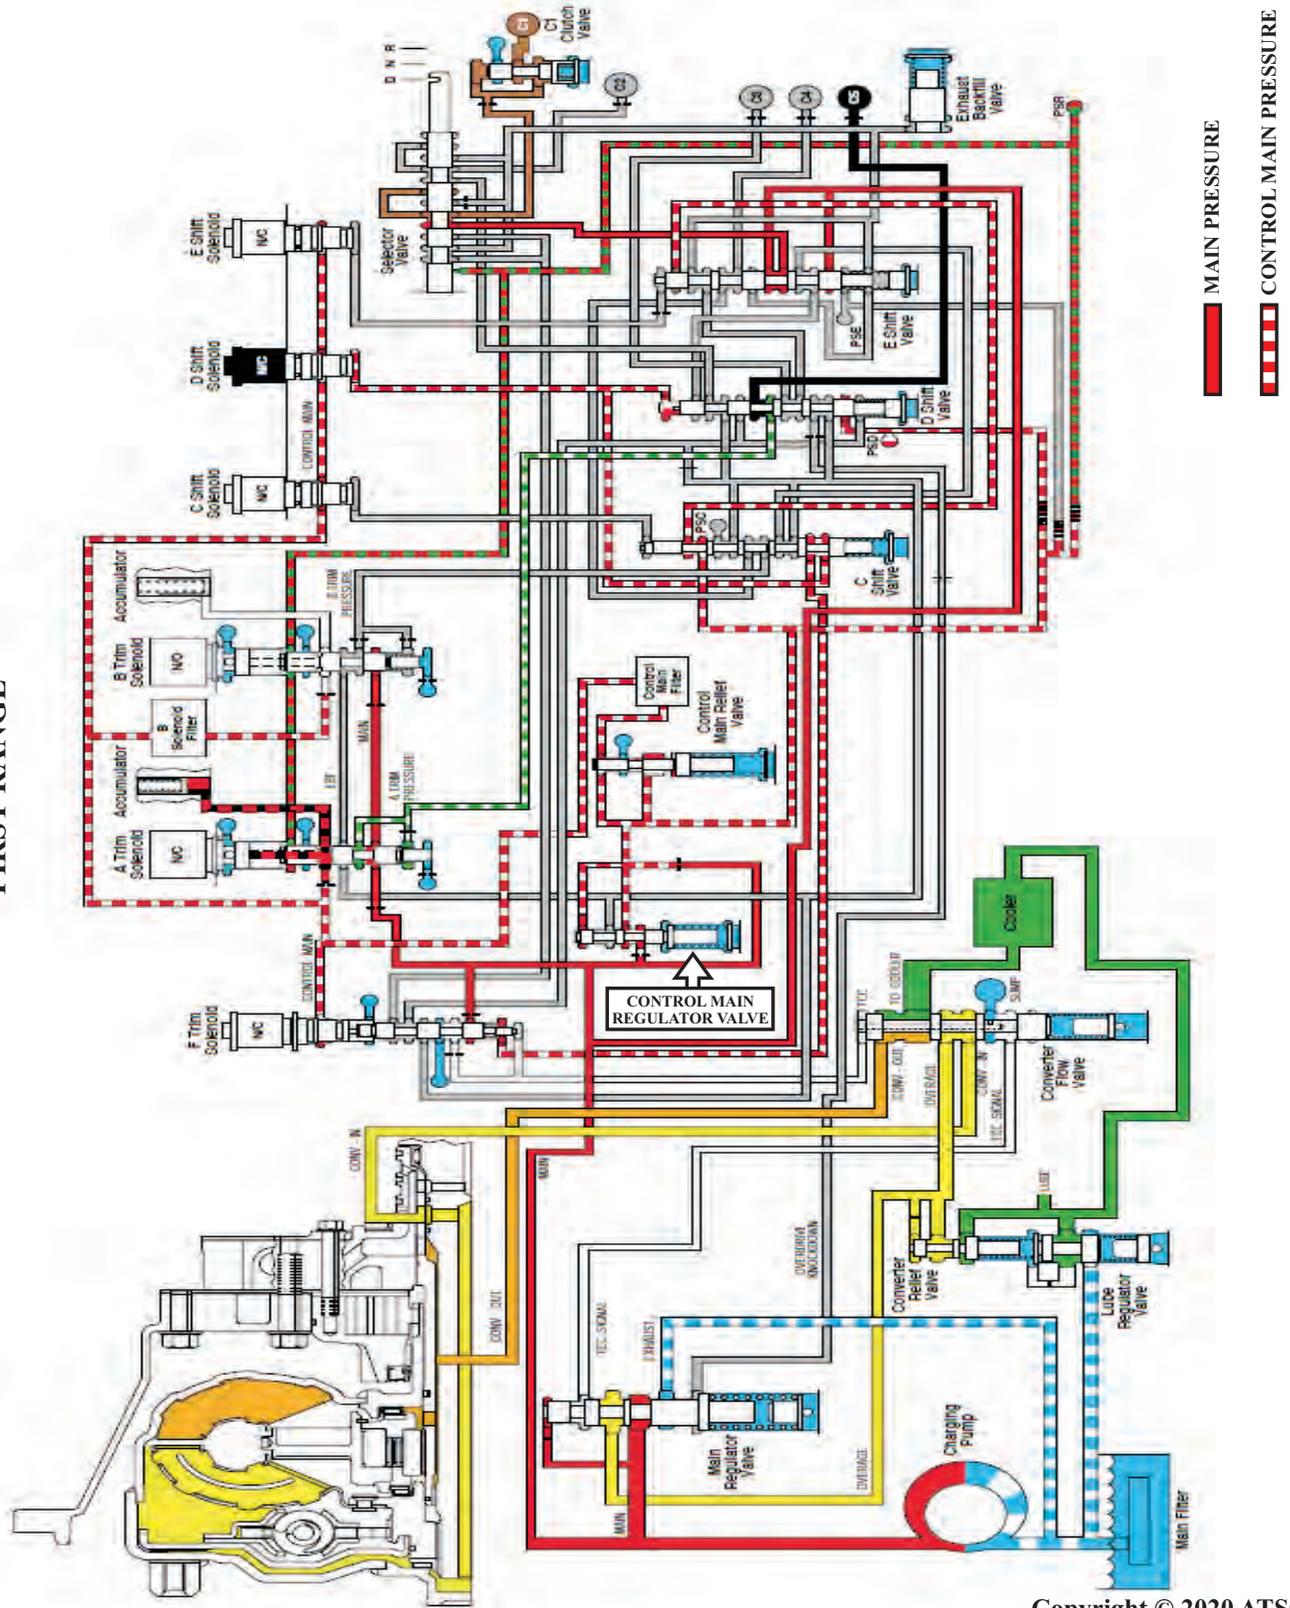
Figure 2

The control main regulator valve provides a consistent pressure for shift solenoid operation which then allows control pressure to move through the valve passage into the various clutch apply circuits to apply a clutch. The hydraulic circuit diagram seen in figure 2 shows main control pressure as red and white. This circuit travels to all shift solenoid and shift valves that then can supply normal clutch apply pressure.
