Technical Service Information

CHEVROLET 6L90 HILL START ASSIST INOPERABLE

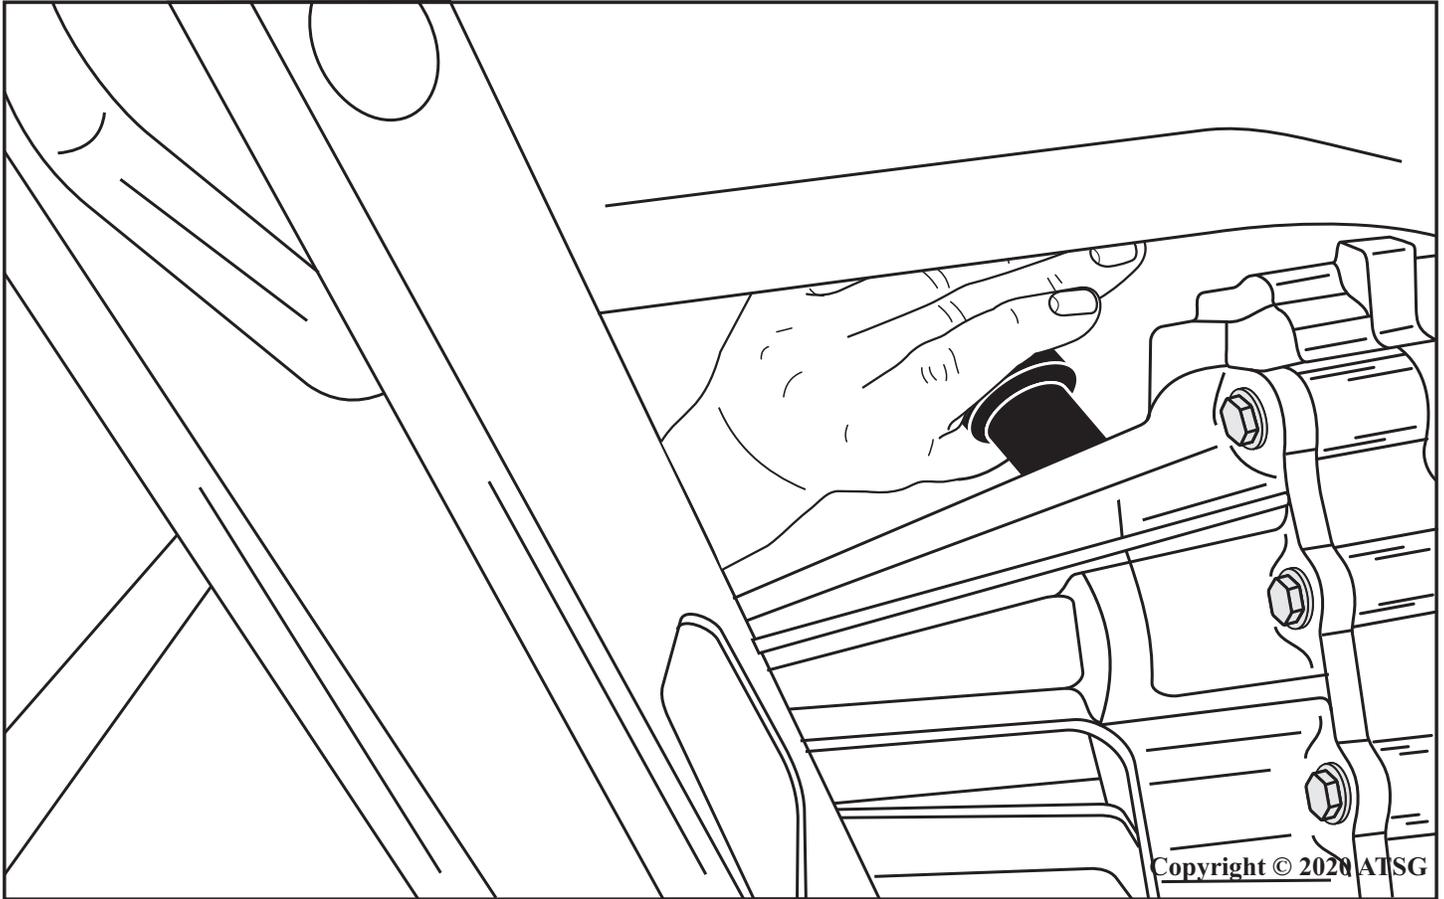
Figure 1

CAUSE: The vehicle was raised into the air for inspection. What was found was the vehicle speed sensor located in the transfer case extension housing, refer to figure 1, was not plugged all the way into the sensor.

CORRECTION: After the VSS connector was connected properly, the hill hold assist feature returned to proper working condition.
