Technical Service Information

FORD 6R60/6R80

ERRATIC TRANSMISSION TEMPERATURE

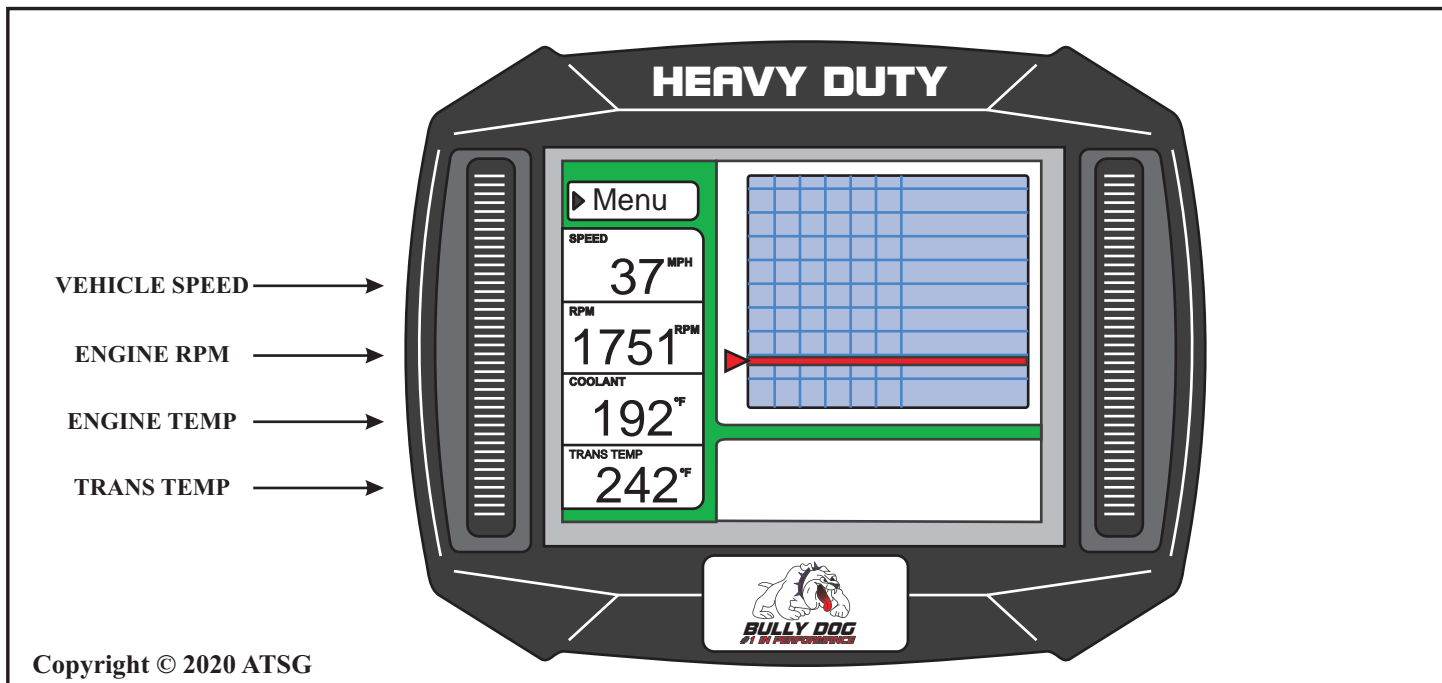
Figure 1

COMPLAINT: A 2013 Ford F150 equipped with the 6R80 Transmission was overhauled and reinstalled back into the vehicle. On the initial road test the “trans temp” lamp came on. The truck was equipped with a dash mounted monitor which was set to engine rpm, vehicle speed, engine coolant temperature and transmission temperature. While driving the technician could see erratic behavior of transmission temperature, in fact the rise and fall of the temperature reading was in cadence with vehicle speed, refer to figure 1. The technician used an infra red temperature gun to read the transmission sump temperature which was 190°F.

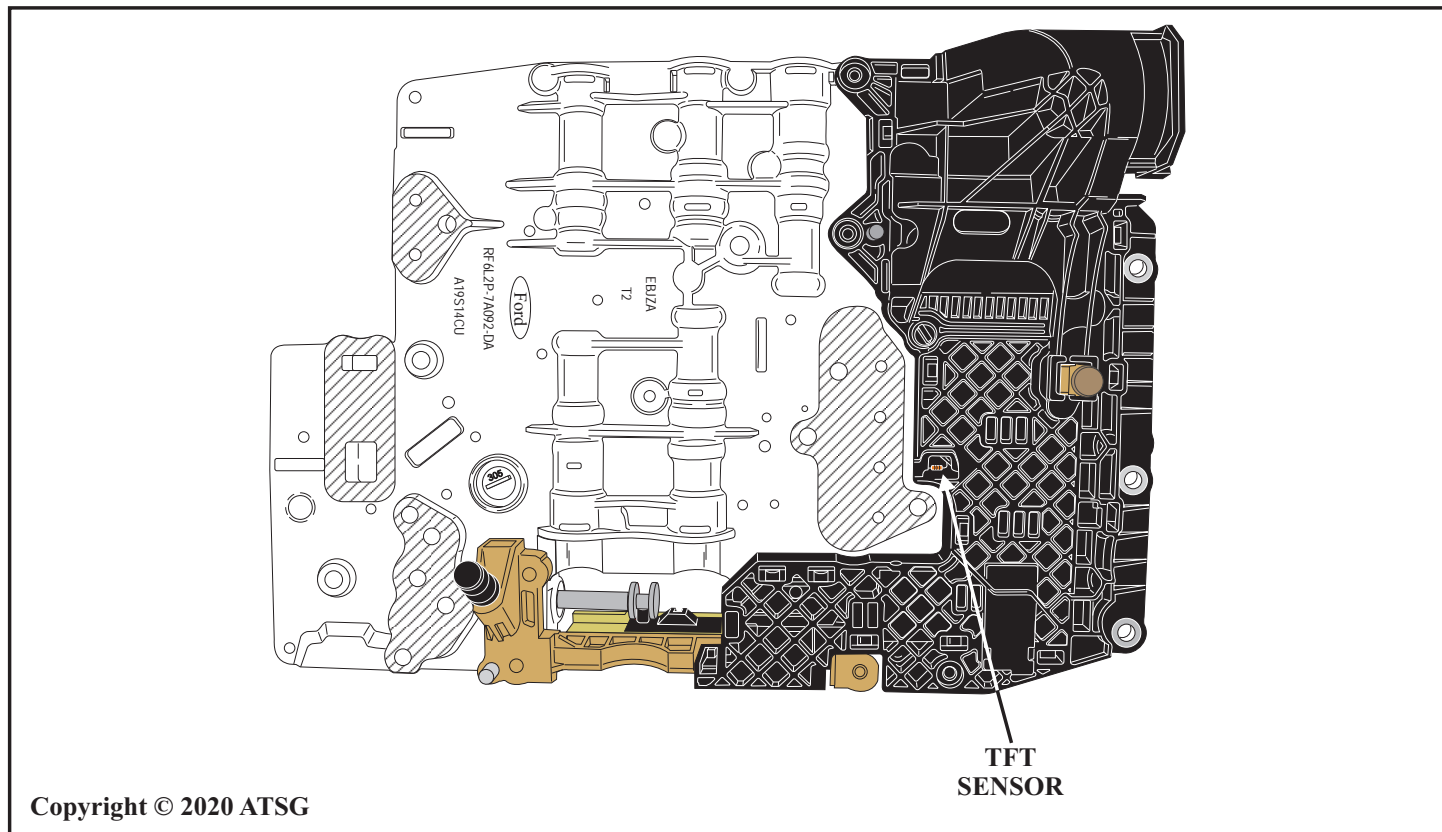
Figure 2

CAUSE: The rebuild technician used .083” steel plates to stack the low/reverse clutch, this created a clutch pack that was too tight. As a result of this, the low reverse frictions were burning and creating a great deal of heat. The ATF temperature sensor is mounted on the lead frame as seen in figure 2. The Temperature sensor is mounted directly below the low/reverse clutch pack as seen in the cutaway in figure 3.

The temperature sensors proximity to the overheated low/reverse clutch pack is what caused the transmission temperature to be so erratic.

CORRECTION: The low/reverse clutch pack was rebuilt using four .070” steel plates and one .083” steel plate which would result in a correct clutch clearance of .039” to .062”. After the transmission was reinstalled back into the vehicle, the road test results were normal transmission temperature readings and no other complaints.
