Technical Service Information

GM 6T40 SERIES TRANSMISSIONS

FRONT PUMP SEAL USAGE

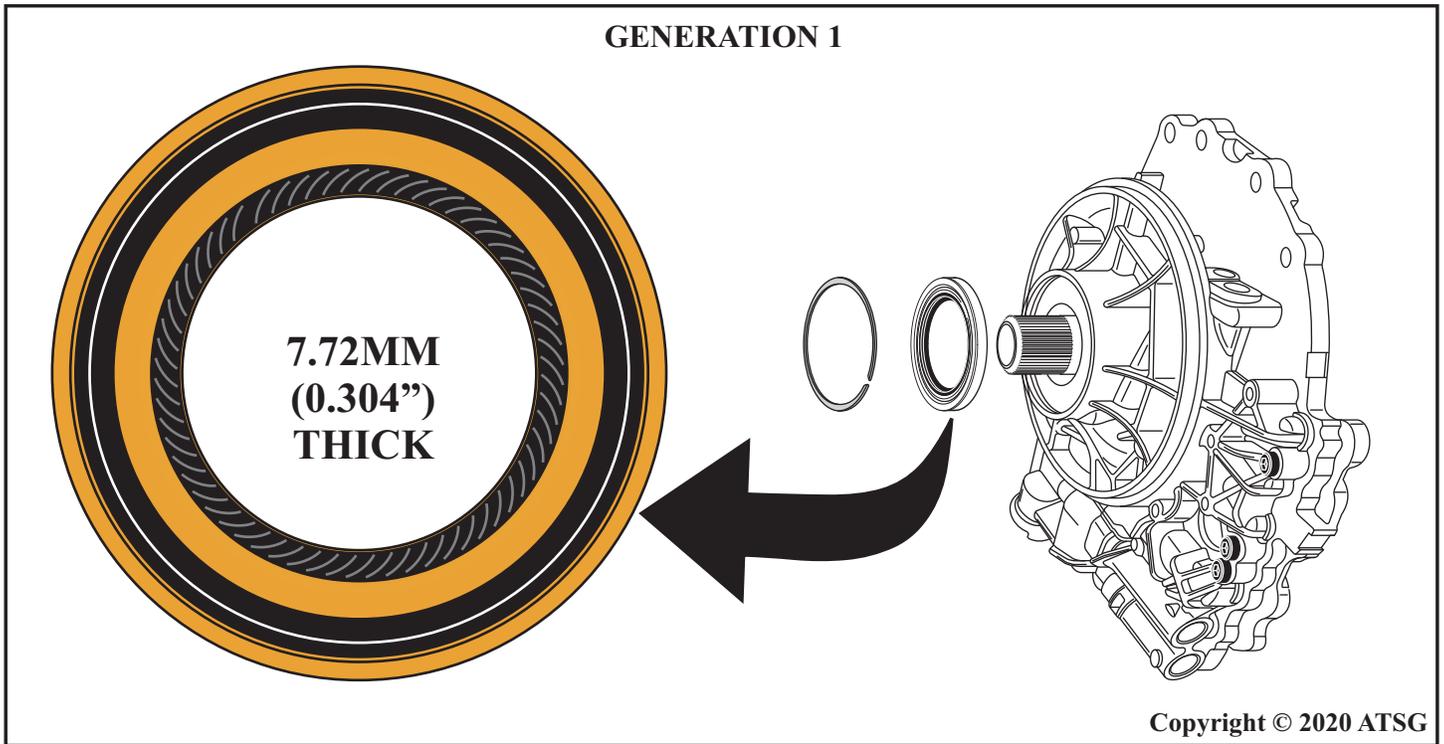
Figure 1

CORRECTION: The Generation 1 front seal is shown in figure 1, it is 7.72mm (0.304") thick.

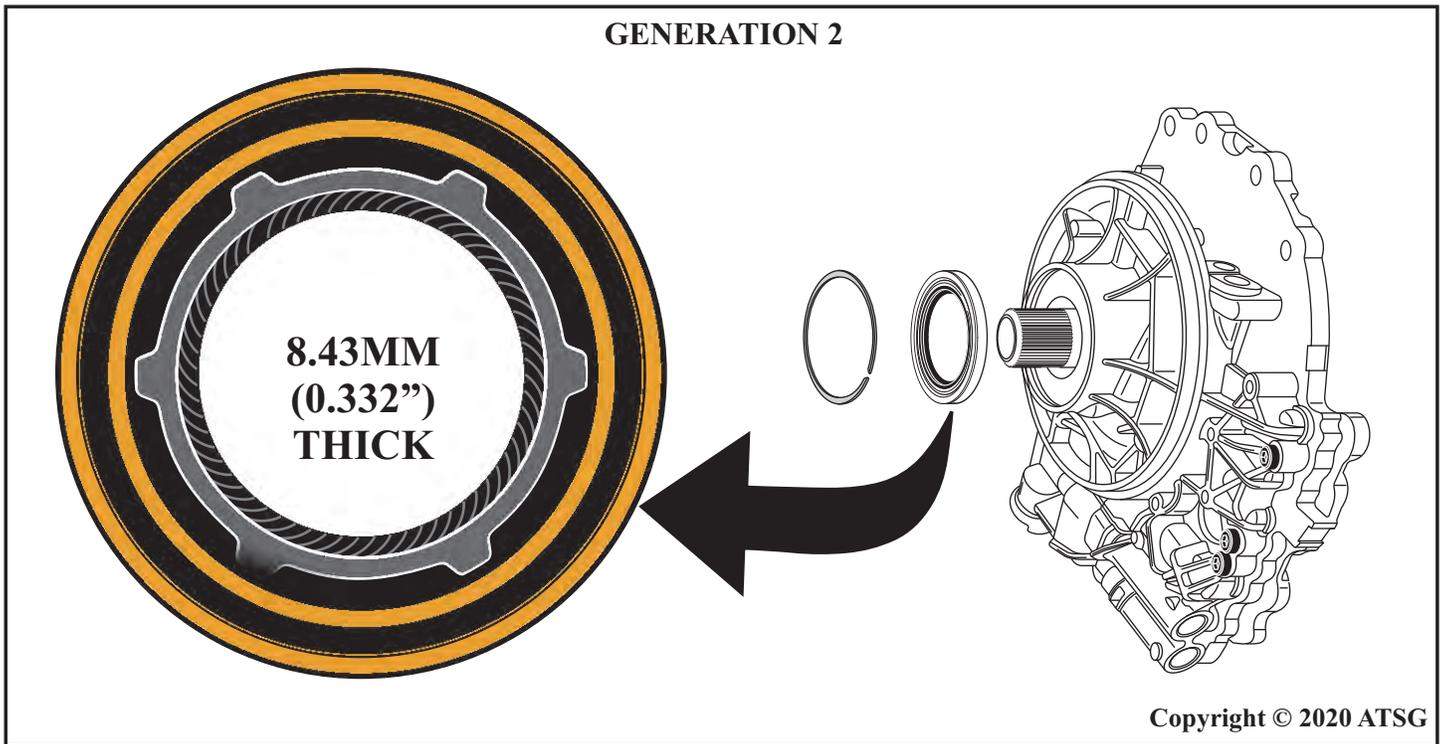
Figure 2

The Generation 2 front seal is shown in figure 2, it is 8.43mm (0.332") thick.

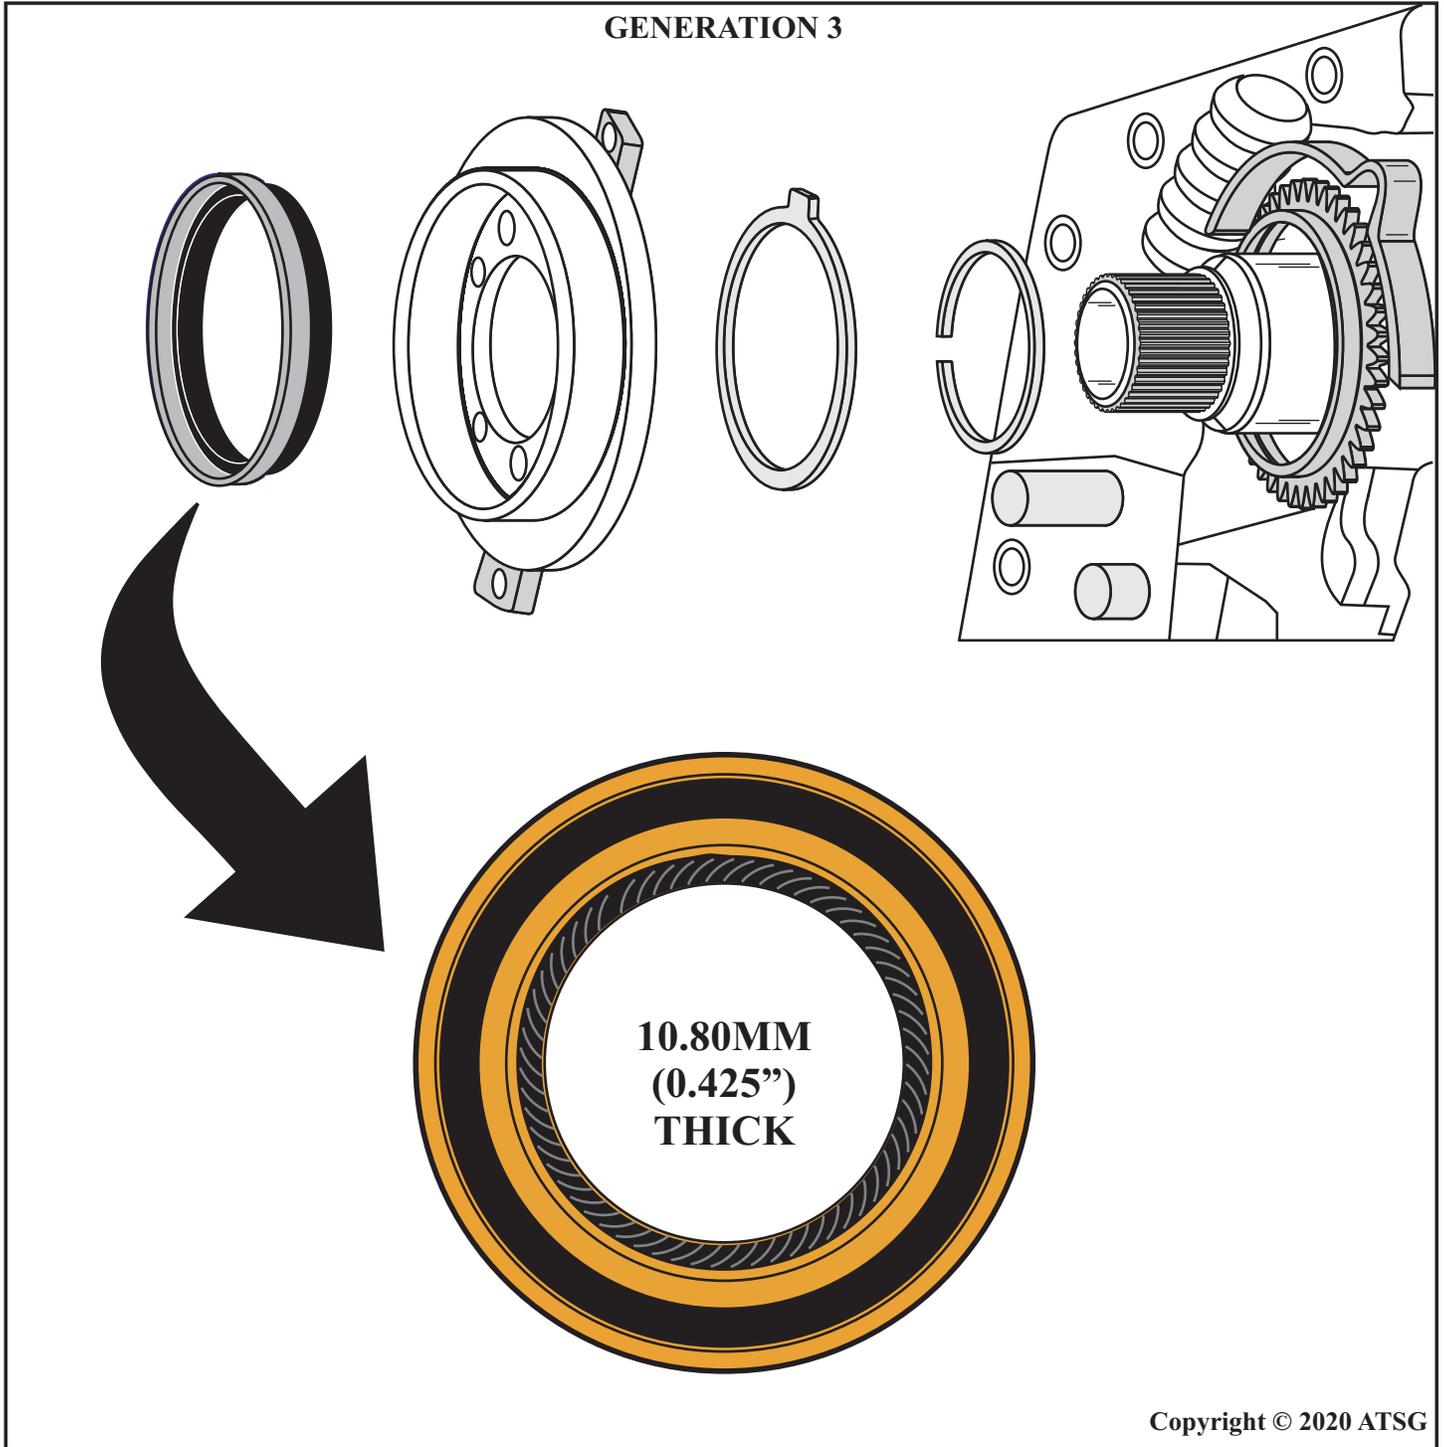
Figure 3

The Generation 3 front seal is shown in figure 3, it is 10.80mm (0.425") thick. This is for the off axis chain driven pump. Inside front seal diameter may also vary.
