Technical Service Information

NISSAN RE0F11A (CVT7)

FLARED 1-2 & 2-1 SHIFT

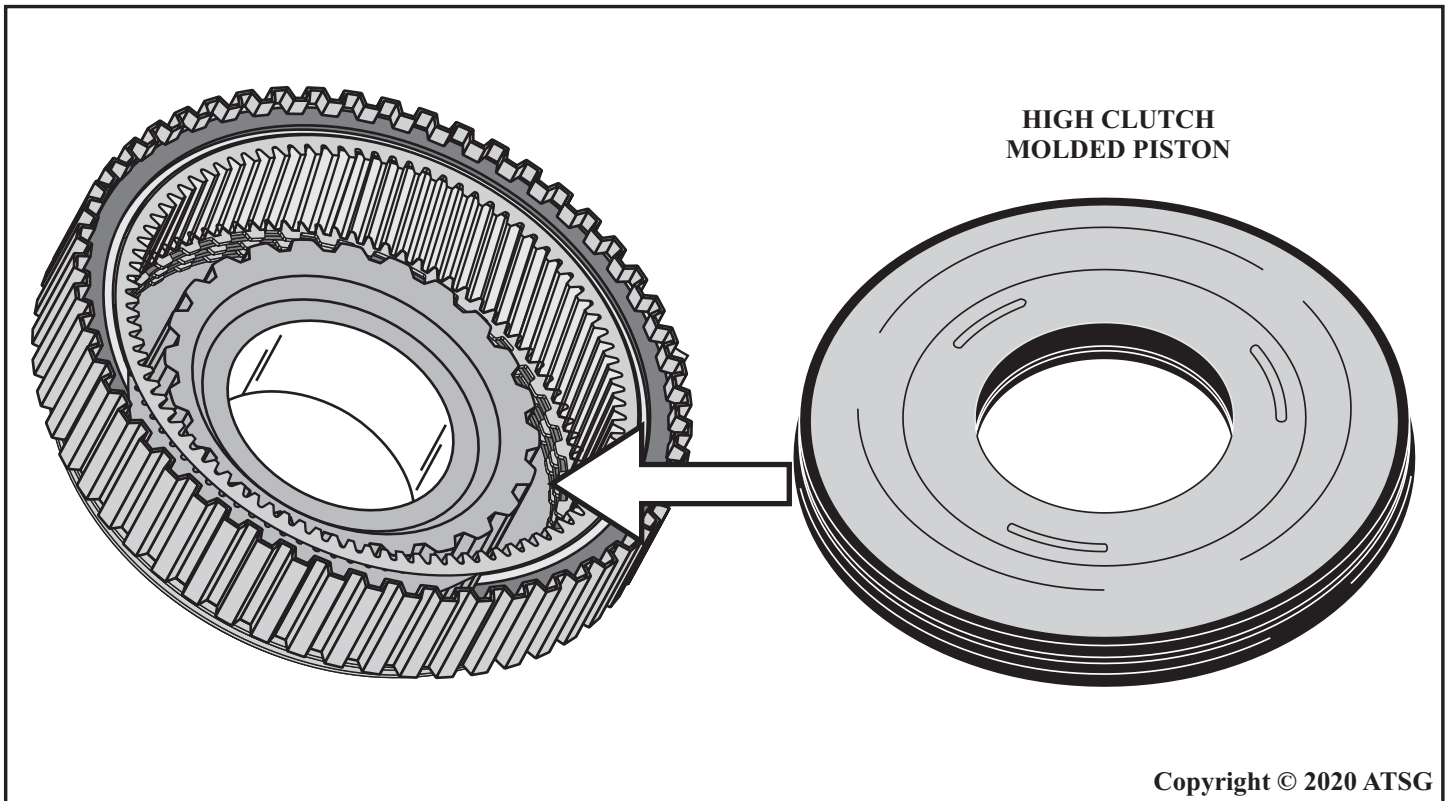
Figure 1

CAUSE: The high clutch bonded piston was compromised, refer to figure 1.

CORRECTION: Replace the high clutch piston.

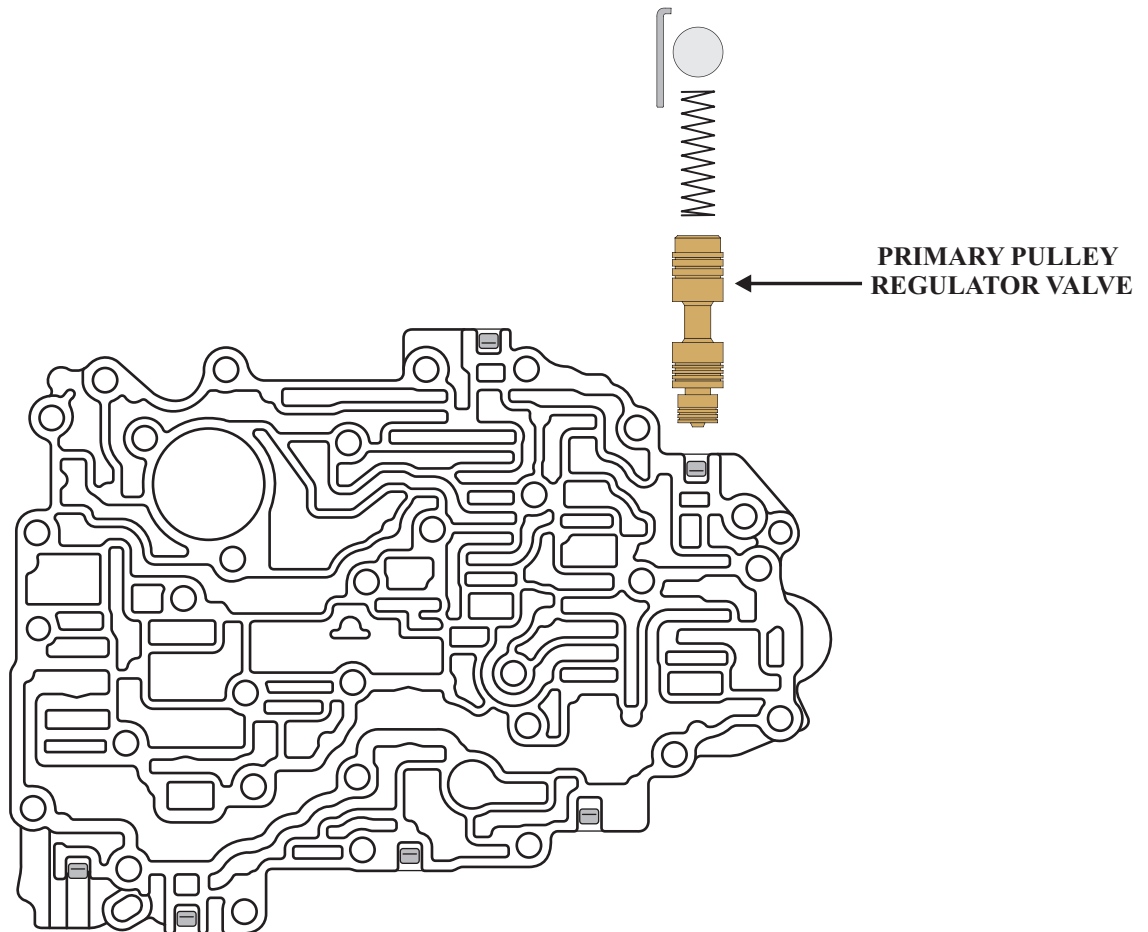
Figure 3

SUMMARY: A number of CVT transmissions would not be capable of a flared shift due to design which may use a clutch for forward and reverse engagement but use only pulleys for gear ratio changes. The CVT7 is unique in that it uses a low brake and a high clutch to make an actual 1-2 shift then reverts to pulley operation for higher gear ratio changes. This is why the CVT can have a flare on the 1-2 or 2-1 shift as the pulleys range from a low wrap to a high wrap and vice versa. The flare has been mistaken for a pressure problem which could lead the technician to suspect a slipping pulley or the pump flow control valve seen in figure 2. The valve is well known to wear. A worn secondary regulator valve in the valve body can also cause these symptoms due to the fact that this valve shown in figure 3 is also prone to wear.
