Technical Service Information

KIA A6MF2H HYBRID ENGINE STALLS IN DRIVE

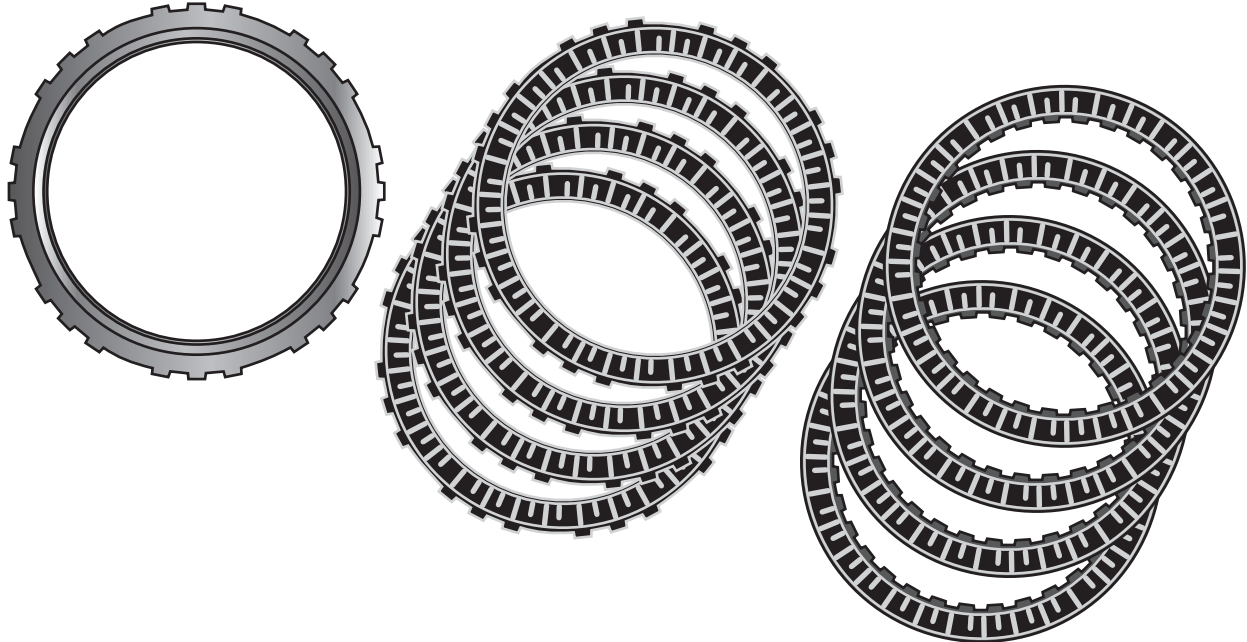
Figure 1

COMPLAINT: A 2012 Kia Optima Hybrid equipped with a 2.4 Liter Engine and the A6MF2H Transmission has a complaint of the engine stalling as soon as the shifter is pulled into the drive position. When the transmission was disassembled for inspection, the engine clutch friction plates were found to be burnt and welded together, refer to figure 1.

ENGINE CLUTCH FRICTIONS BURNT

CORRECTION: A new oil pump was installed into the transmission with a new set of engine clutch friction plates. The vehicle was road tested and operated normally throughout the extensive road test.

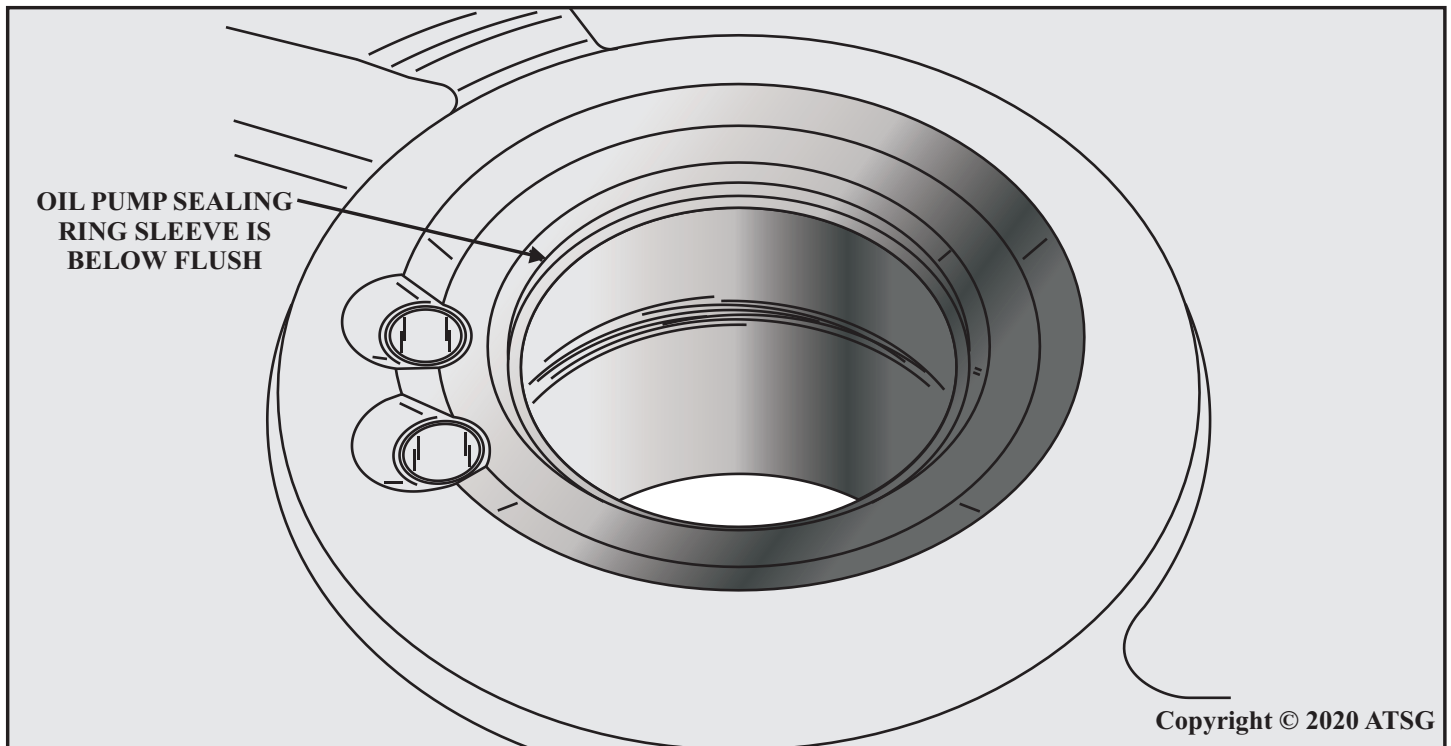
Figure 2

CAUSE: The oil pump sealing ring sleeve had shifted inward as seen in figure 2 causing sealing ring leakage and the failure of the engine clutch friction plates. The sleeve should be flush with the pump cover, it is not. If you look closely you can actually see two sets of sealing ring wear patterns, the second set was created after the sleeve moved. After the sleeve moved one of the three Teflon® sealing rings is not even riding in the sleeve refer to figure 3.
