# Technical Service Information

## FORD 6F35

### TRANSMISSION CASE DAMAGE

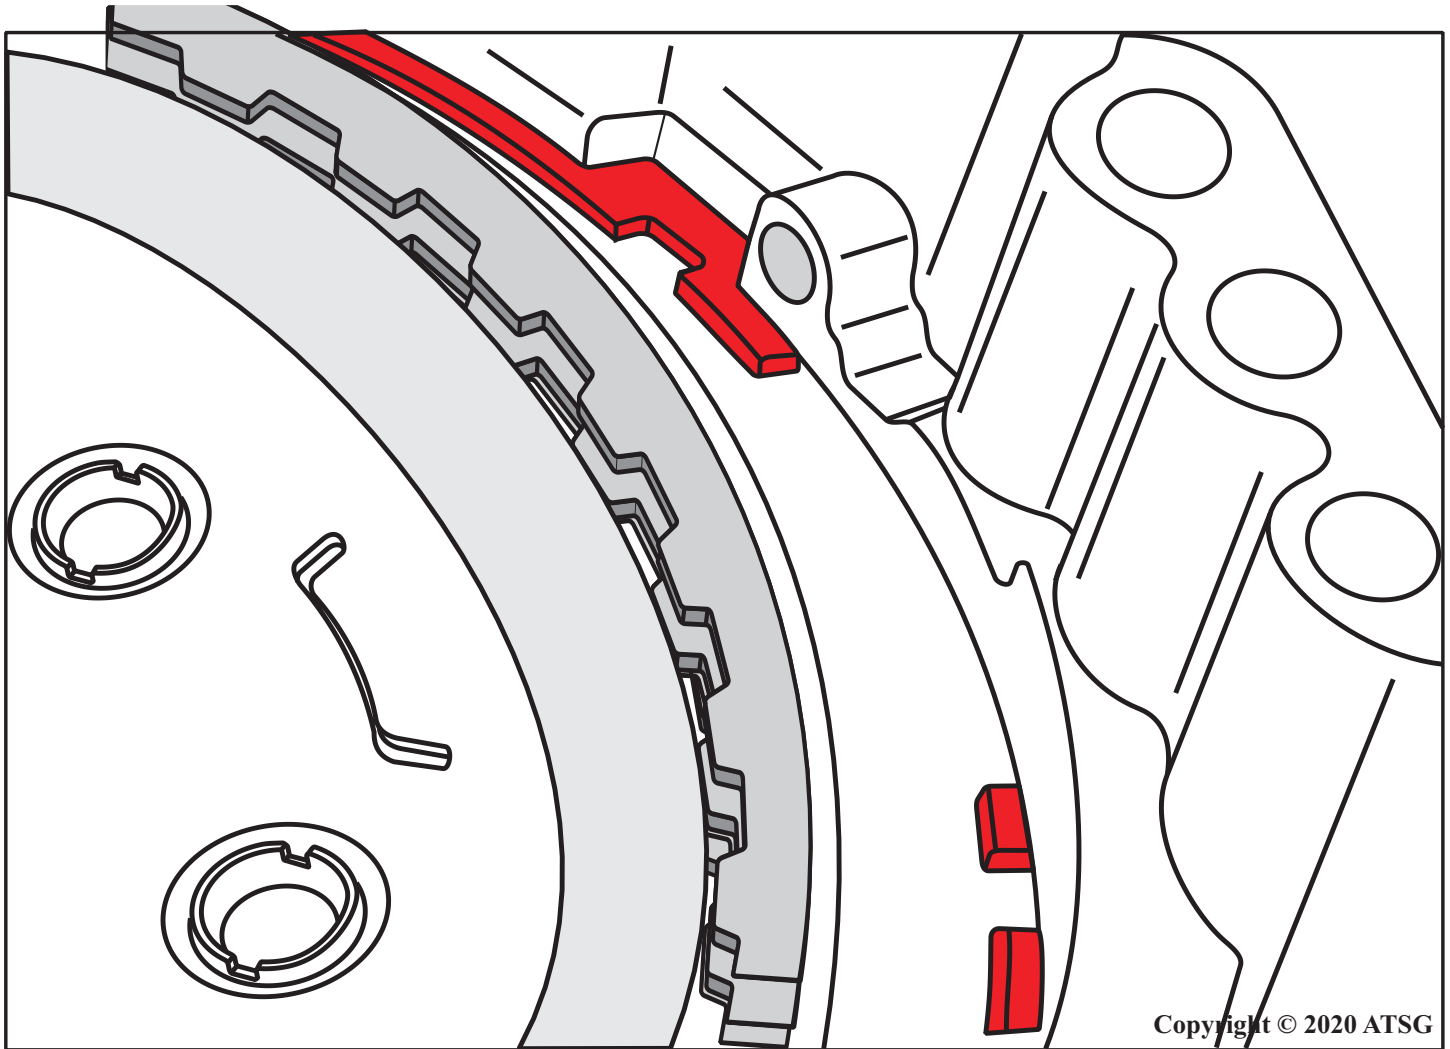
Figure 1

**COMPLAINT:** A 2013 Ford vehicle with a 6F35 Transmission comes into the shop for an internal transmission related problem. Upon disassembly, once the 1-2-3-4 clutch retaining snap ring is reached, the technician notices several case lugs have broken away from the transmission case.

**CAUSE:** The 1-2-3-4 clutch retaining snap ring gap was installed incorrectly. Also noticed is the fact that the snap ring gap has not been installed in its correct location. Although this mistake can be made on the bench by a technician that is not aware of how it should be installed, this transmission has never been repaired until now meaning this was mistakenly done at the factory during the assembly process.

**CORRECTION:** The snap ring gap must be installed at the three o'clock position with the bottom of the transmission facing the six o'clock position as shown in figure 1. If one or two lugs are broken out, just install the snap ring gap in its correct position. If too many lugs are broken out, the transmission case will require replacement. This seems to be a problem isolated to the 2013 model year as far as only the factory mistake goes.
