Technical Service Information

AUDI OCK (DL382-7F) SHIFTER RETURNS TO PARK

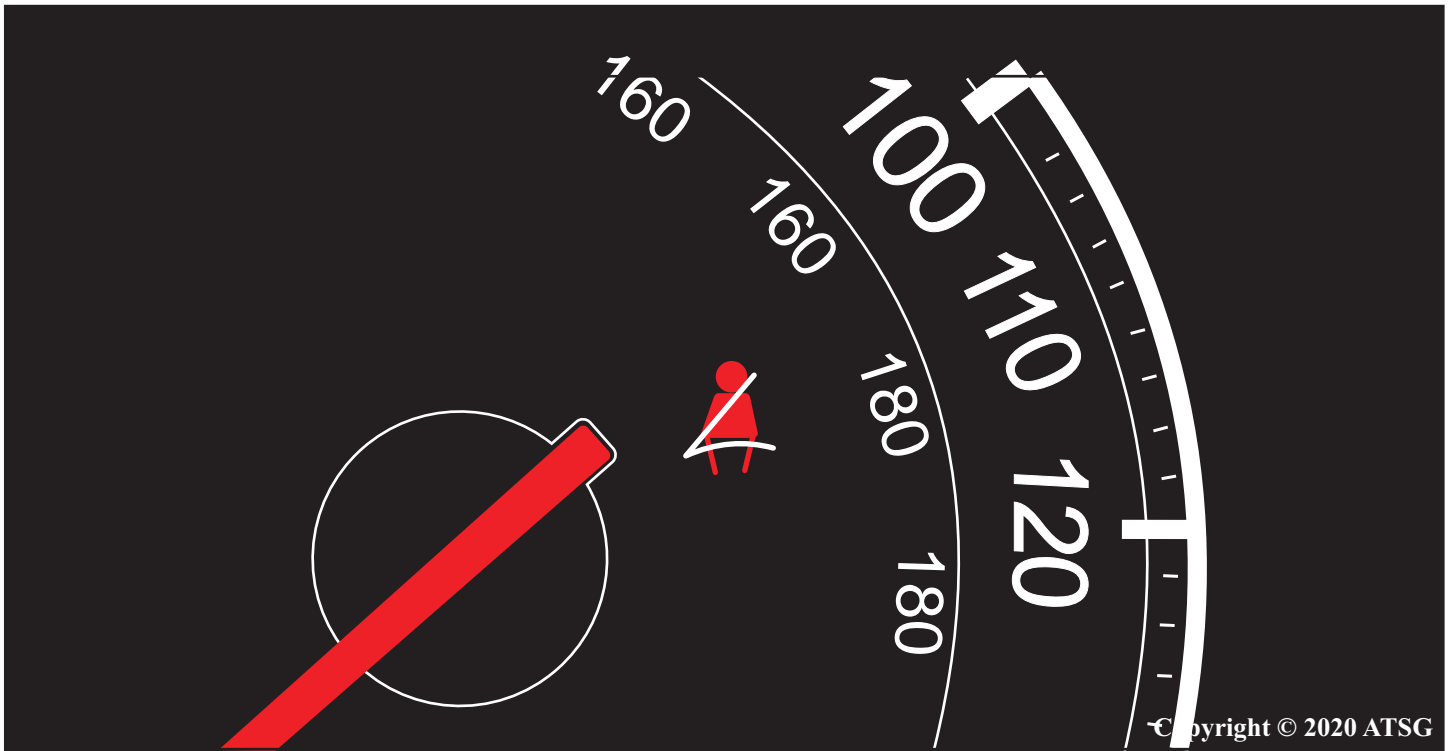
Figure 1

COMPLAINT: A 2017 Audi A4 equipped with the OCK (DL382-7F) Seven Speed DSG Transmission has a complaint of the shifter not staying in the drive position. The shifter automatically returns to the park position. Trouble code P17F9 “Park Lock Mechanical Malfunction” is stored and the “Fasten Seat Belt Lamp” is illuminated, refer to figure 1.

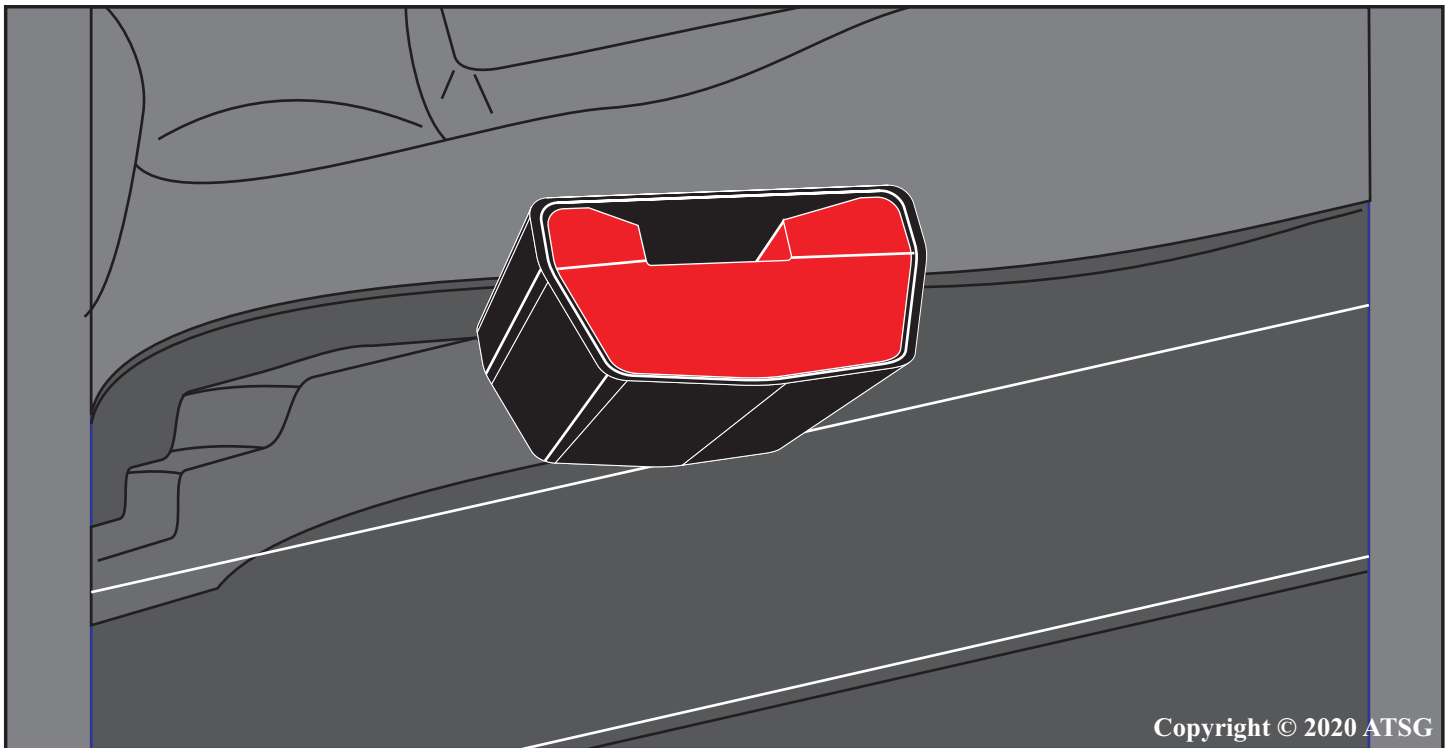
Figure 2

CAUSE: The drivers seat belt was not fastened, refer to figure 2.

CORRECTION: Fasten the drivers seat belt.
