Technical Service Information

FORD 6F50/55 NO REVERSE ENGAGEMENT, FORWARD GOOD

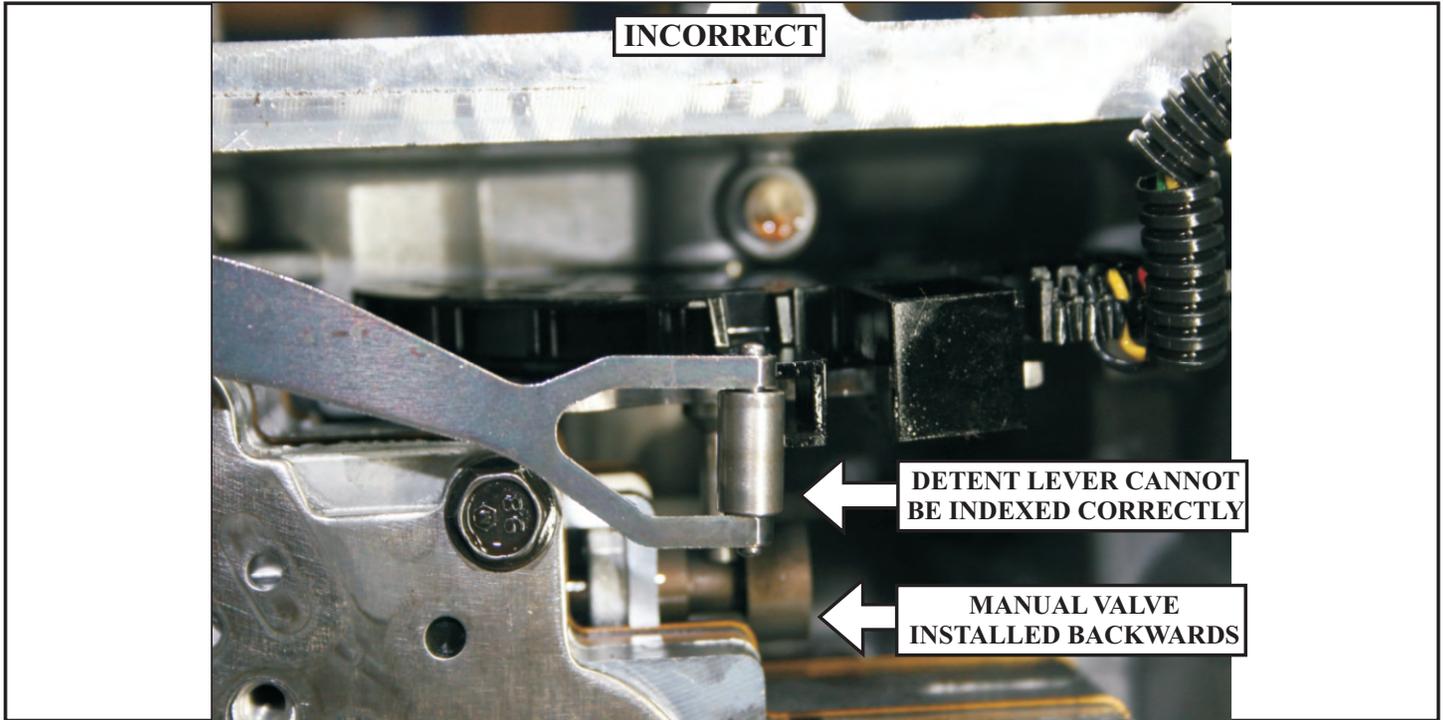
Figure 1

CAUSE: The manual valve was installed in the wrong direction as seen in figure 1. The incorrect installation of the manual valve caused the detent lever to mis-position the transmission range sensor, refer to figure 2, causing the no start in neutral and the TRS erratic signal.
