ALLISON 1000

P0776 SET

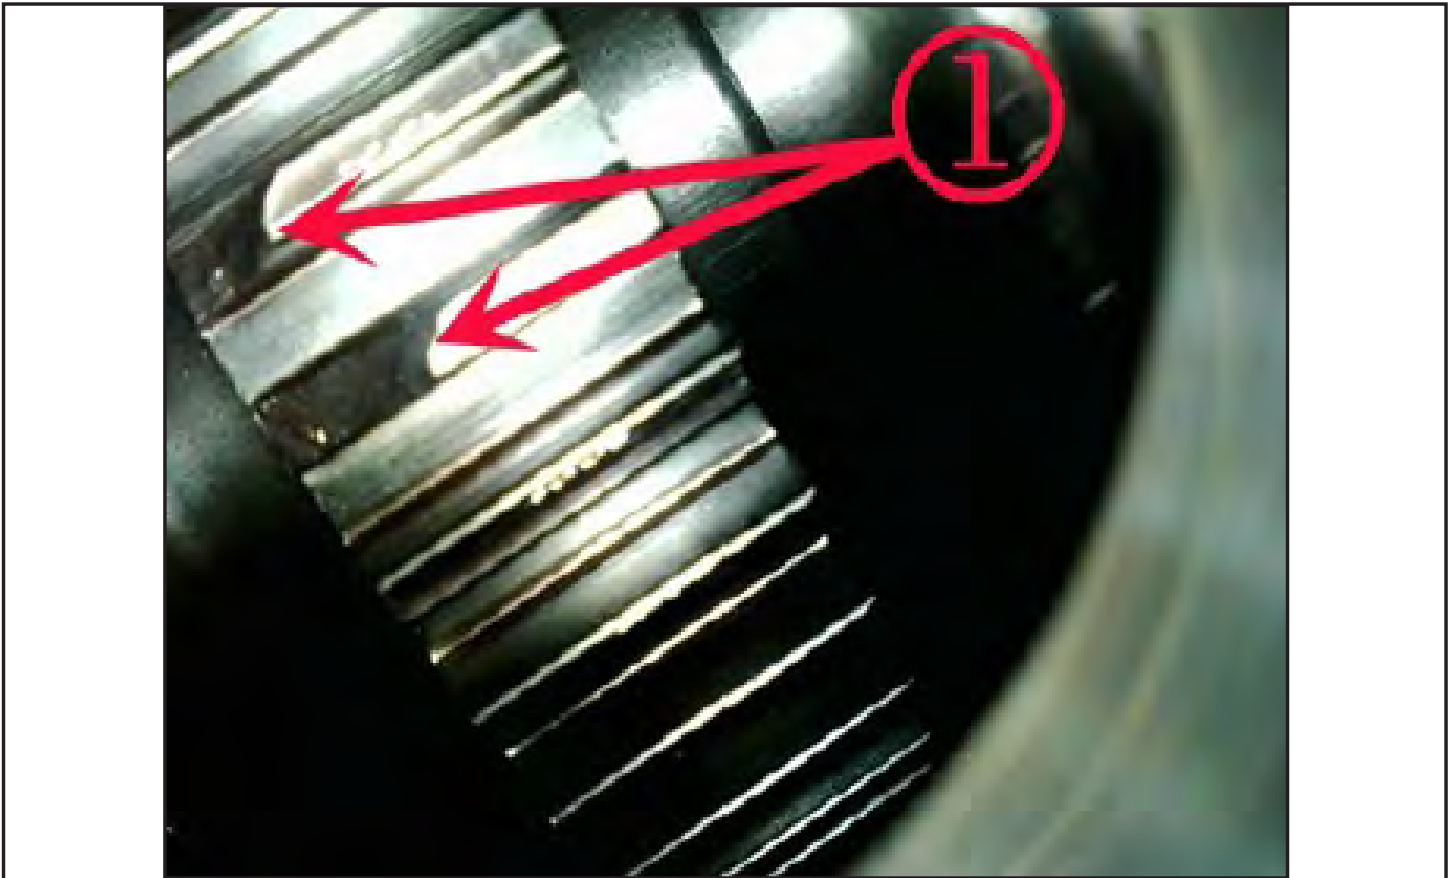
Figure 1

CAUSE: The output speed sensor tone wheel has a chipped tooth, refer to figure 1. Less than one whole tooth was missing, this was enough to cause a disruptive signal causing the above complaints.

CORRECTION: Replace the output speed sensor tone wheel.
