SUBARU TR580/TR690 LINEARTRONIC

TCC SOLENOID AND VDC CODES

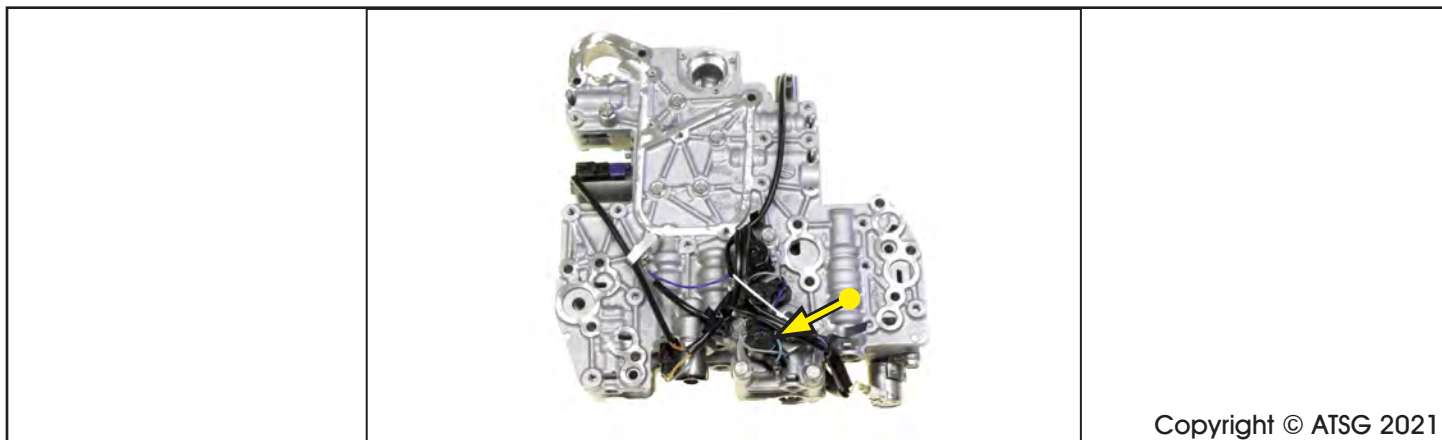
Figure 1

COMPLAINT: A Subaru with a Gen 1 TR690 or Gen 2 TR580 Lineartronic CVT has arrived in your shop with a variety of codes. The most frequent codes are for the lock up solenoid electrical circuit P2764 and P2770, most often these codes set when hot. There may be vehicle dynamic control (VDC) codes such as C0044 no communication with the TCM, C0045 TCM malfunction and C0057 ECM malfunction. These codes are listed in the VDC system or under the ABS system depending on model and year.

CAUSE: A shorted or open TCC duty solenoid. See figure 1 for Gen 1 TCC solenoid location and figure 2 for Gen 2 TCC solenoid location.

CORRECTION: Replace the Lock up solenoid. The TCC solenoid is not available separately from Subaru. There are after market replacements available. Transmission Parts Now in Oregon is a reliable source for the TCC solenoids.
