Technical Service Information

FORD 8F35

NO OR INTERMITTENT LOSS OF REVERSE

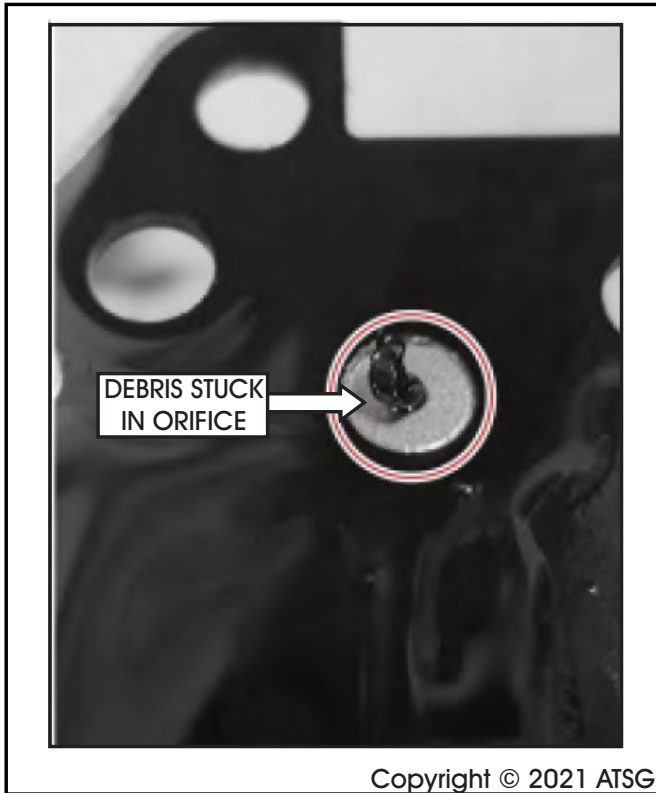
Figure 1

CAUSE: A piece of debris has become lodged in the Solenoid D spacer plate orifice as seen in figure 1.
