2015 HONDA FIT CVT GTAA**DTC U0401**

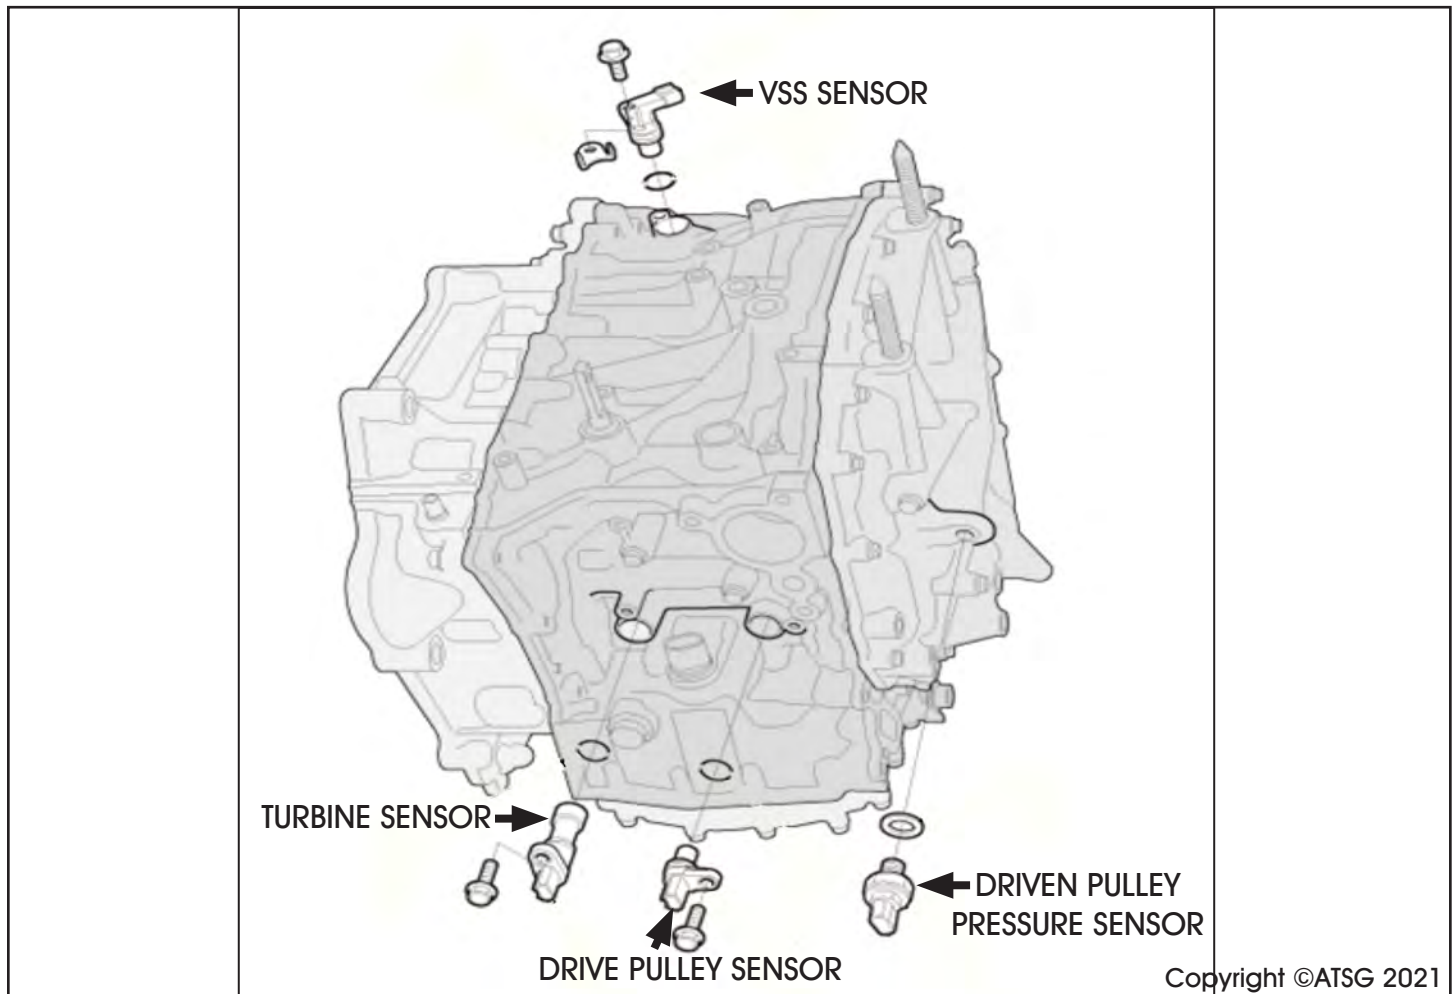
**Figure 1**

CAUSE: It was discovered that there was no drive pulley signal while road testing the vehicle. The drive pulley sensor had a poor connection at the connector pins. See figure 1.

CORRECTION: Resize the pin connectors and apply Stabilant 22 contact enhancer.
