## **CHEVROLET SPARK CVT7 (JF015E)**

### **NO CONVERTER CLUTCH APPLICATION**

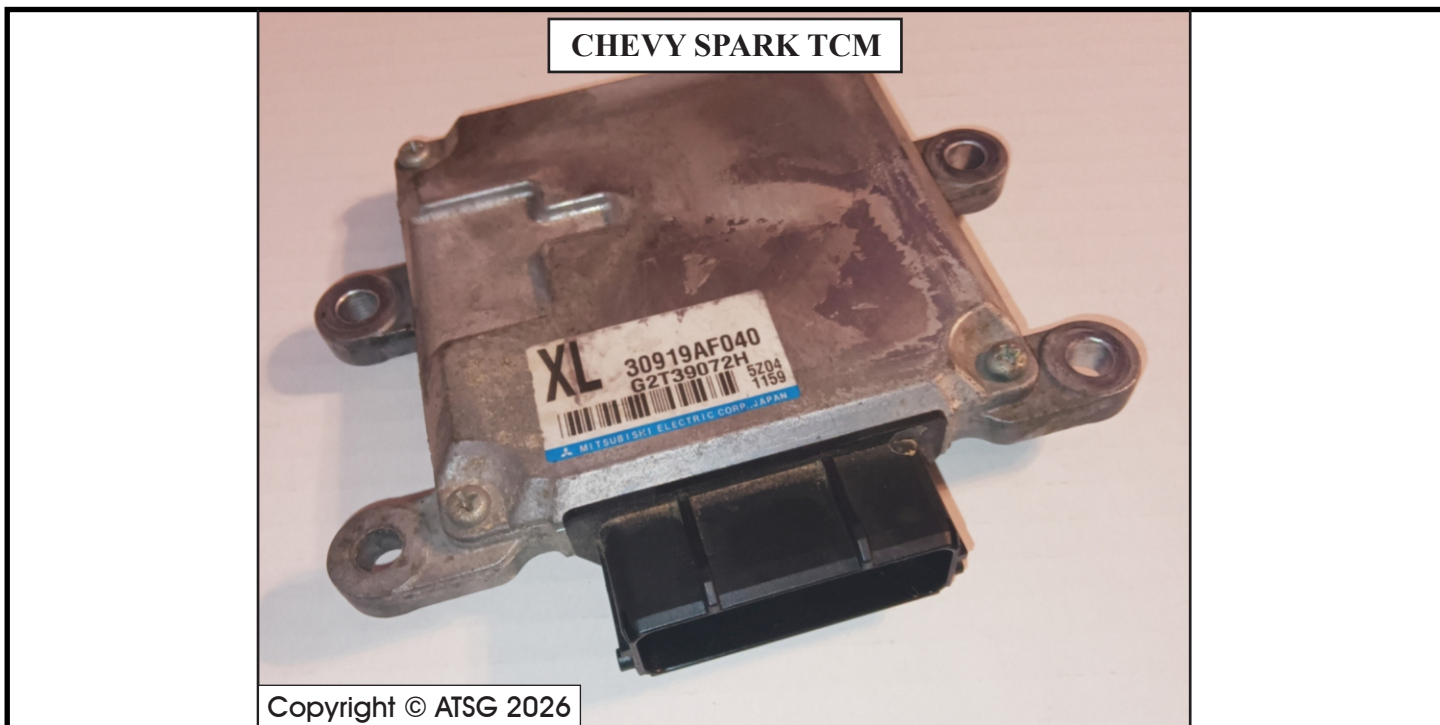
**Figure 1**

**CAUSE:** The shop felt that the only other logical step was to replace the Transmission Control Module (figure 1).

**CORRECTION:** Once the TCM was replaced, the converter clutch applied correctly and P0741 no longer set.

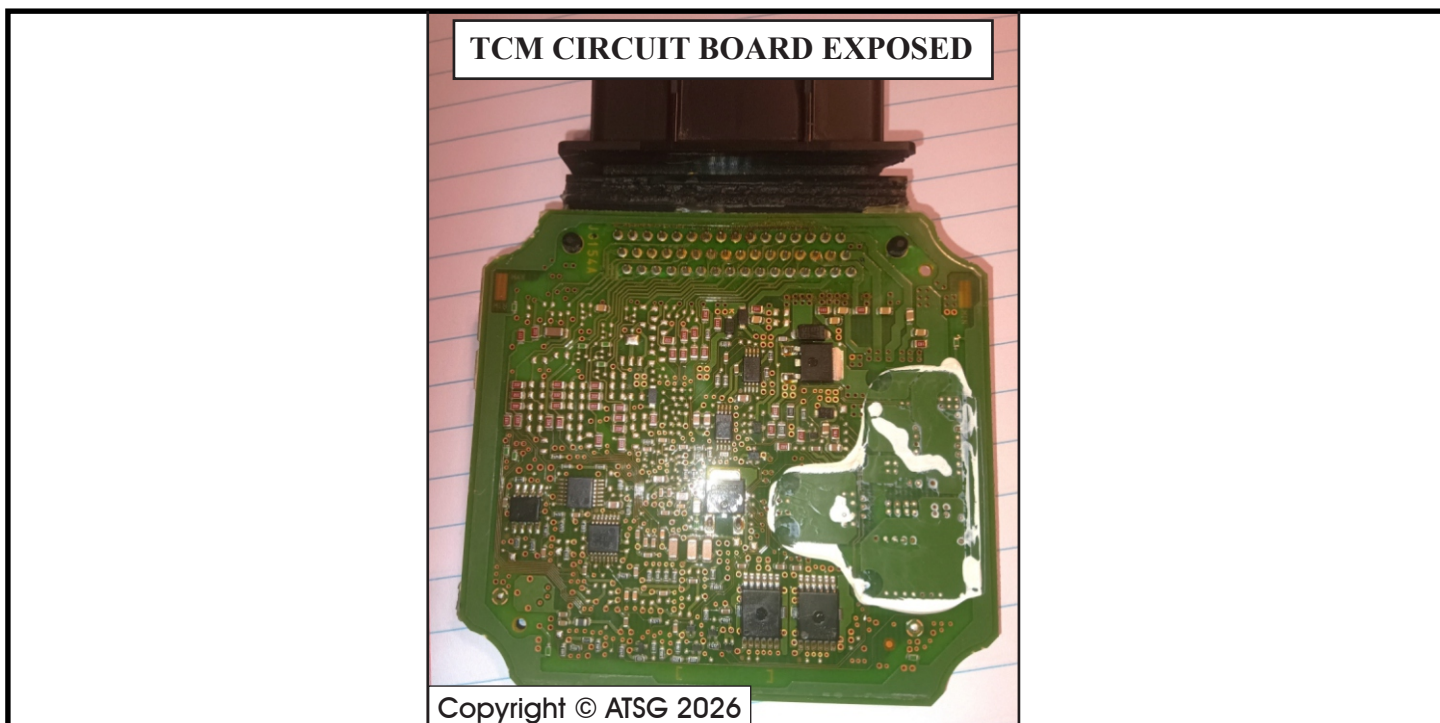
**Figure 2**

The original TCM was opened to see if the cause of the problem was visible (figure 2). At first glance nothing was obvious. But, after closer scrutiny, a break was found in what would be the converter clutch solenoid circuit, yet an electrical solenoid code was never set (figure 3).
