**GM 9T60/9T65**  
**MOMENTARY NEUTRAL**

**COMPLAINT:** A 2018 Buick Enclave, LaCrosse or a GMC Terrain equipped with the 9T60 (RPO M3W) or 9T65 (RPO M3G) may have a complaint of a momentary sharp deceleration during a 1-2 upshift or a momentary neutral condition during a 2-4 upshift with the transmission stuck in second gear. The Malfunction Indicator Lamp (MIL) is illuminated and diagnostic trouble codes P2820 "Transmission Control Solenoid 9 Stuck Off" or P2821 "Transmission Control Solenoid 9 Stuck On" is set during cold ambient temperatures.

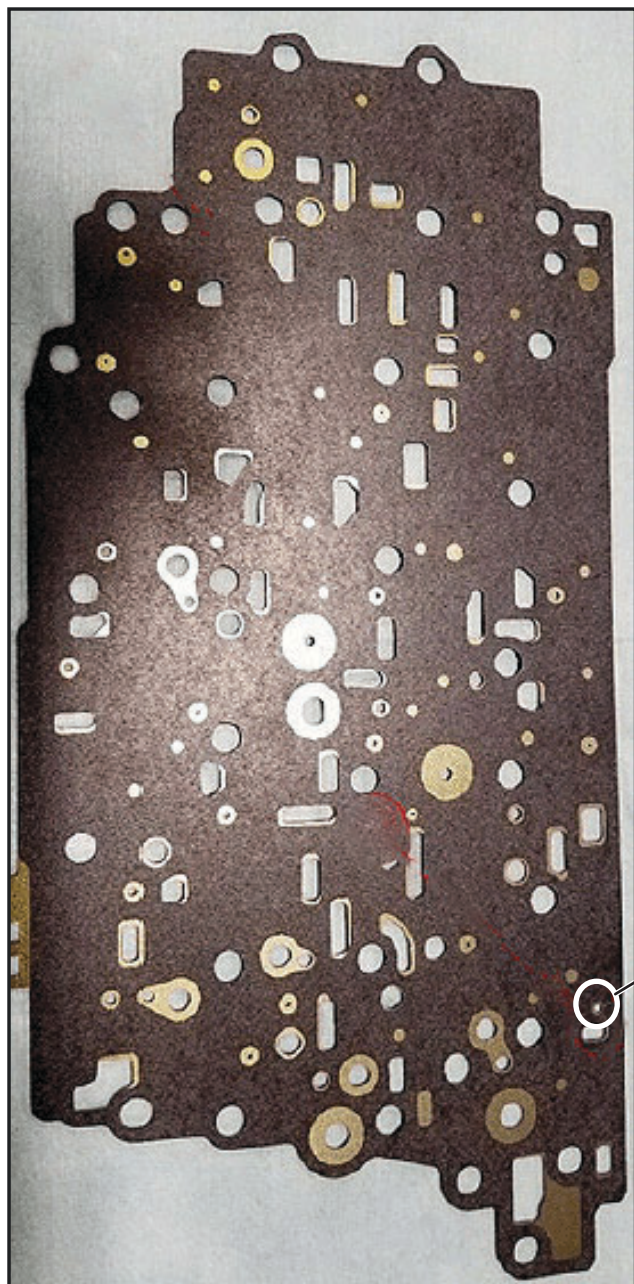
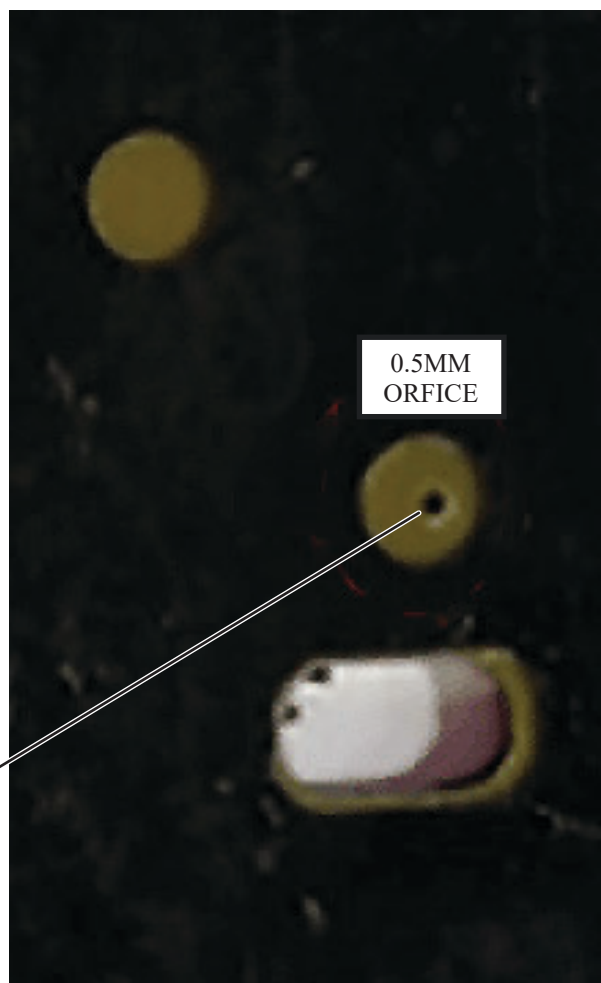
**Figure 1**

**CAUSE:** These complaints are caused by the spacer plate located between the valve body and the transmission case containing an undersized orifice, refer to figure 1. The undersized orifice causes the clutch select valve to move too slowly which results in a delay to release the selectable one-way clutch which causes a momentary transmission tie-up during the 1-2 shift and a momentary neutral condition on the 2-4 upshift.

**VALVE BODY TO TRANSMISSION CASE SPACER PLATE**

**CORRECTION:** Inspect the valve body spacer plate orifice shown in figure 1 for proper sizing. If the orifice is 0.5mm, replace the spacer plate using the part number listed under "Service Information". The updated spacer plate will have an orifice that measures 2.0mm as shown in figure 2

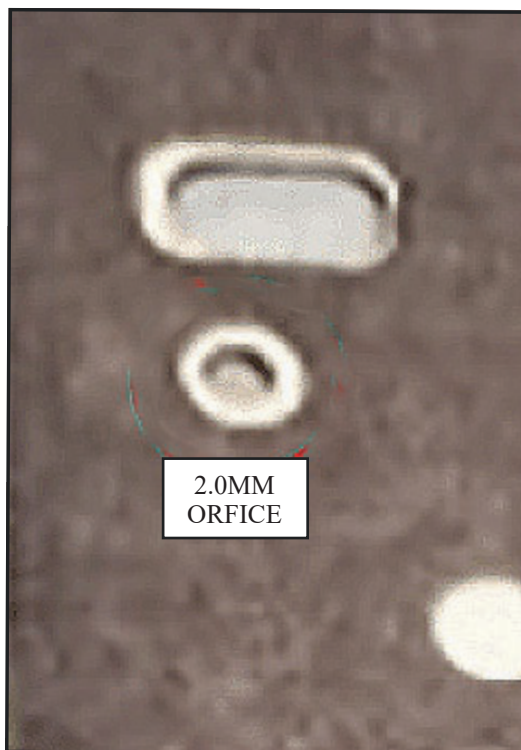
**Figure 2**

**VALVE BODY TO TRANSMISSION CASE SPACER PLATE**

Valve Body To Transmission Case Spacer Plate With 2.0MM Orifice.....24292010  
Updated spacer plate part number listed is for the 9T45, 9T50 and 9T60

Valve Body To Transmission Case Spacer Plate With 2.0MM Orifice.....24292011  
Updated spacer plate part number listed is for the 9T65
