## **FORD 4R75**

### **BRUTAL 1-2 AFTER REBUILD**

**COMPLAINT:** A 2010 Ford E150 with a 4R75 transmission has come into the shop for an overhaul. 2 weeks later the vehicle returns to the shop with a complaint of a brutal 1-2 shift. The customer said the transmission had been working correctly up until now. The shop installs a scanner and sees that there are no codes present.

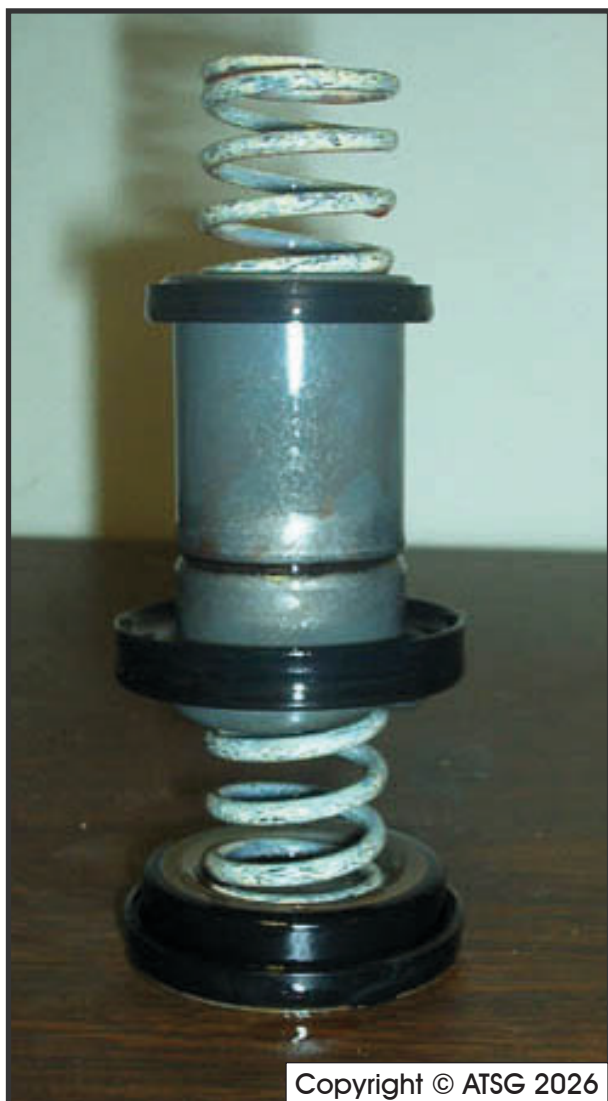
**Figure 1**

The tech checked line pressure and EPC duty cycle. Both were correct, which verifies the brutal 1-2 is not an external issue. The shop decides to check the 1-2 accumulator assembly to see if a spring has broken or if something had happened to the molded piston. When the 1-2 accumulator was removed everything looks good (see figure 1). The shop decided to try a lighter accumulator spring to see if they could soften up the 1-2 shift. This did no good. Next, they tried adding Ford XL100 friction modifier to the ATF to see if this would soften the shift (see figure 2). It did not.

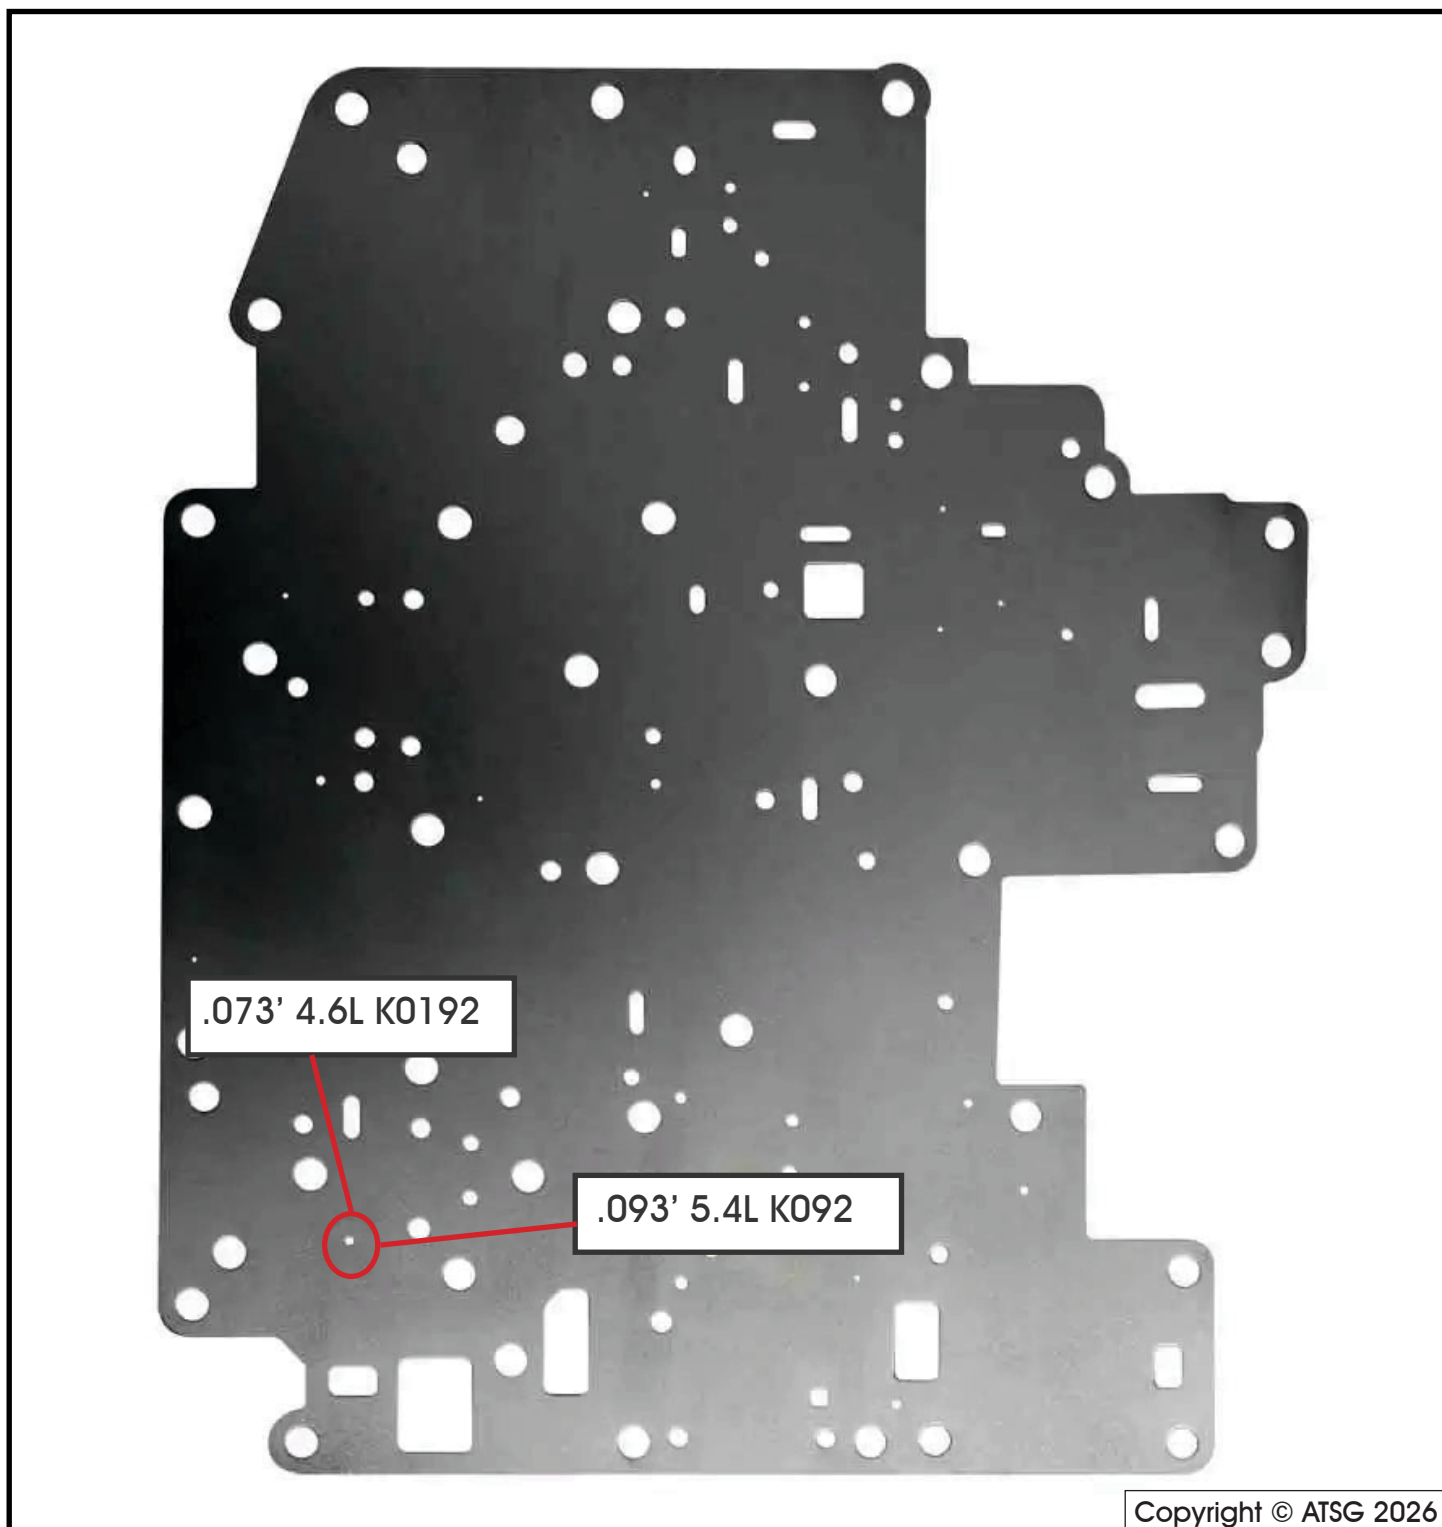
**Figure 3**  
**AUTOMATIC TRANSMISSION SERVICE GROUP**

The tech had used the same Superior plate on all 3 valve bodies, When the plate was checked it was the .093" feed hole for the 5.4L PN K092 even though the tech ordered the .073" feed hole PN K0192 for the 4.6L engine. This would explain a brutal 1-2 shift but not the fact that it did not happen for 2 to 6 weeks before the brutal shift occurred.

**CORRECTION:** The valve body spacer plate was replaced with the .073" feed hole and the vehicle did not come back. Superior said to always order the .073" plate and if it is the 5.4L engine to just open it up to .093" .
