## **DODGE RFE SERIES**

### **DRAIN BACK ISSUES**

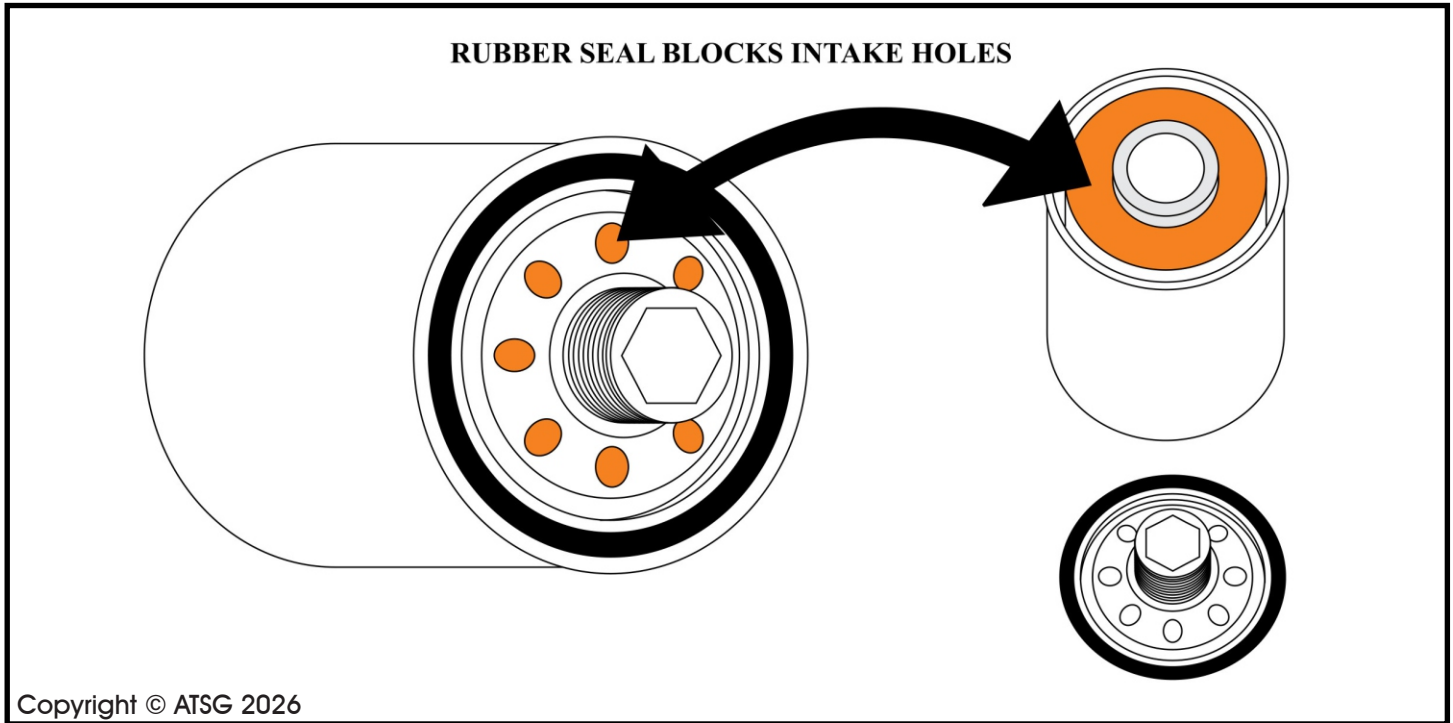
**Figure 1**

**CAUSE:** An OEM cooler filter from the Dodge dealer is causing the drain back problem to occur after it sits overnight. ATSG ran into a similar issue years ago with substandard filters that had a rubber seal which restricted oil flow (see figures 1 and 2). This is the exact opposite. The rubber seal allows the ATF to drain down causing similar complaints and these filters came right from the Dodge dealer.

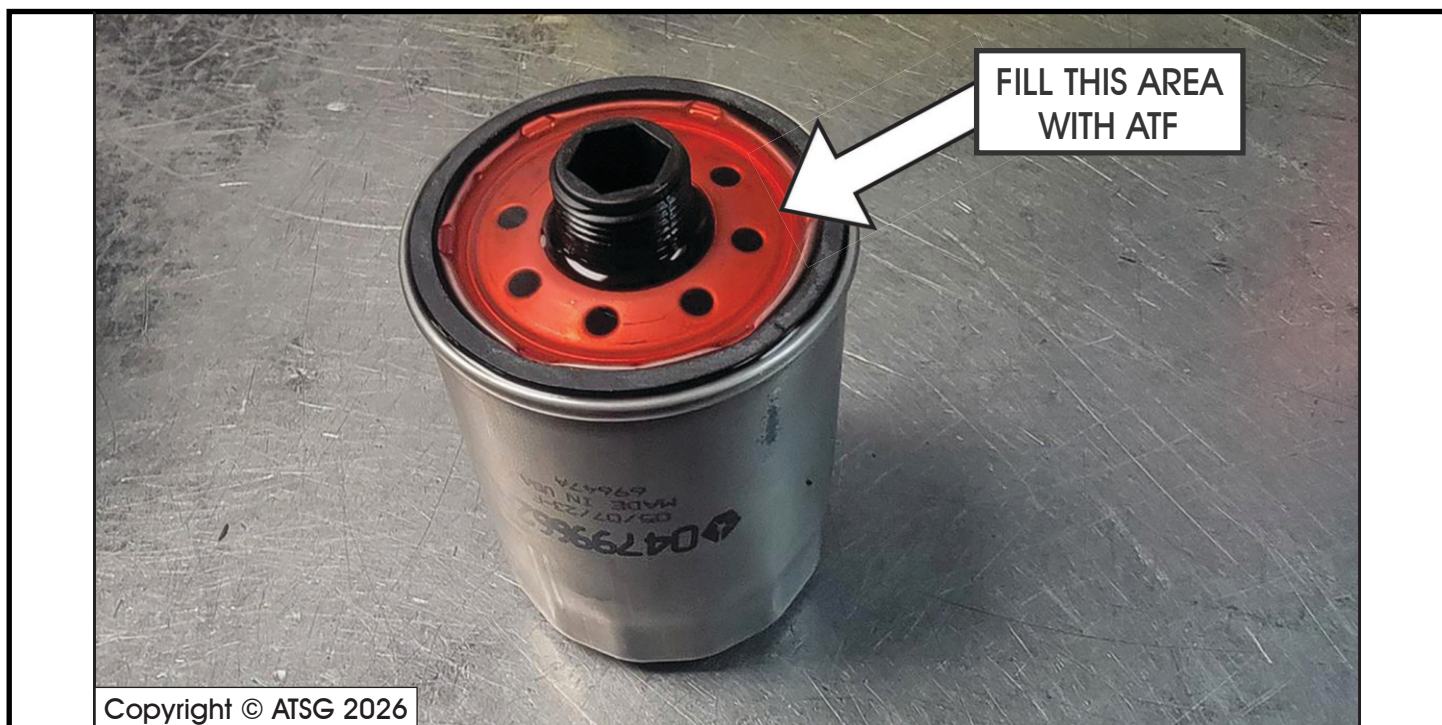
**Figure 3**

The way to check this is to fill the OEM filter with ATF over the rubber seal area as shown in figure 3. Let the filter sit overnight, if the oil drains into the filter as seen in figure 4, this filter is defective.
