**FORD 8F35****IN & OUT OF L/U BEFORE/AFTER REBUILD**

**COMPLAINT:** A 2019 Ford Edge comes into the shop for rebuild. It also has a complaint of going in and out of lock up. The shop rebuilt the transmission and installed a new Ford valve body, along with a remanufactured torque converter for the lock up complaint. On the road test the transmission still went in and out of lock up. The shop decided to replace the PCM because the valve body and torque converter had already been replaced and made no change. A new PCM was installed and programmed. On the road test the transmission still went in and out of lock up.

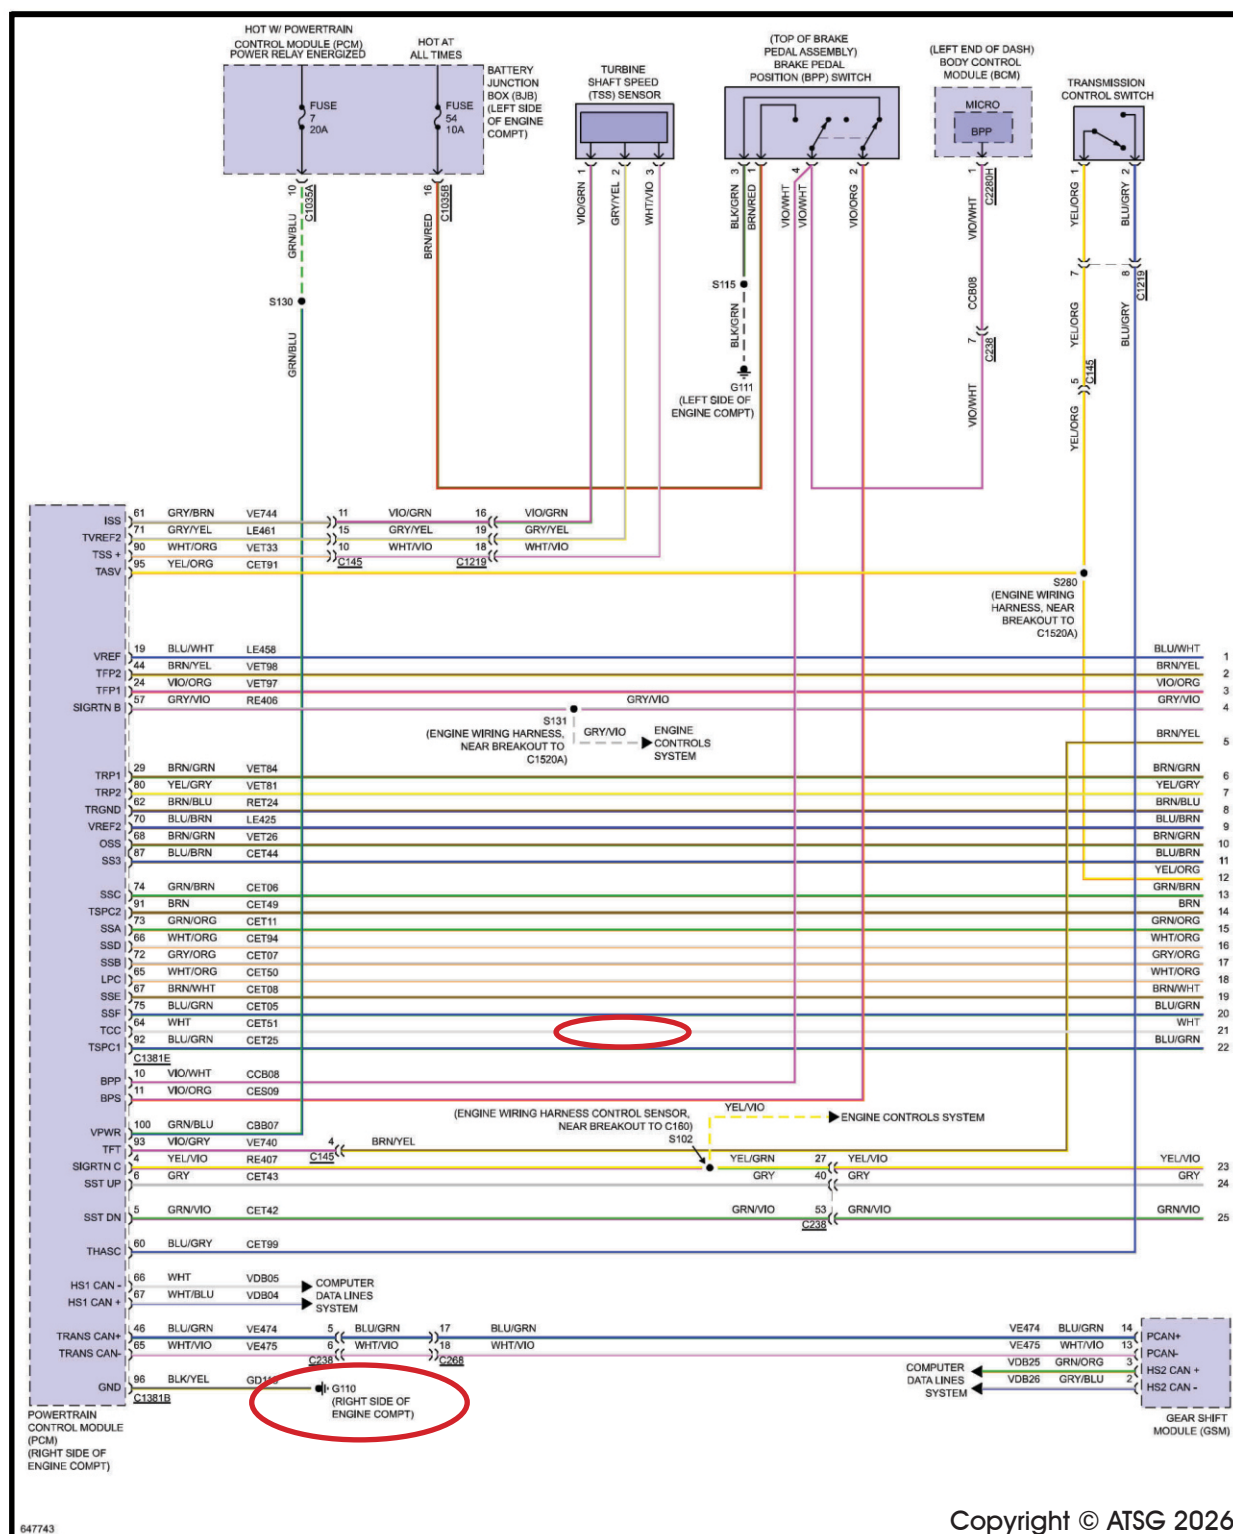
### Figure 1

ATSG had the technician use the scanner to check live data for the misfire monitors, TPS, MAF. There were no issues seen. The technician tried cleaning the MAF and thought it was somewhat better. Next, ATSG had the technician cut the white wire for the TCC solenoid ground and ground it on the road test (See figure 1). Lock up now stayed on. This indicated that there was a compromised ground. If you look once again at figure 1 you will see G110 on the right side of engine compartment is the PCM ground.

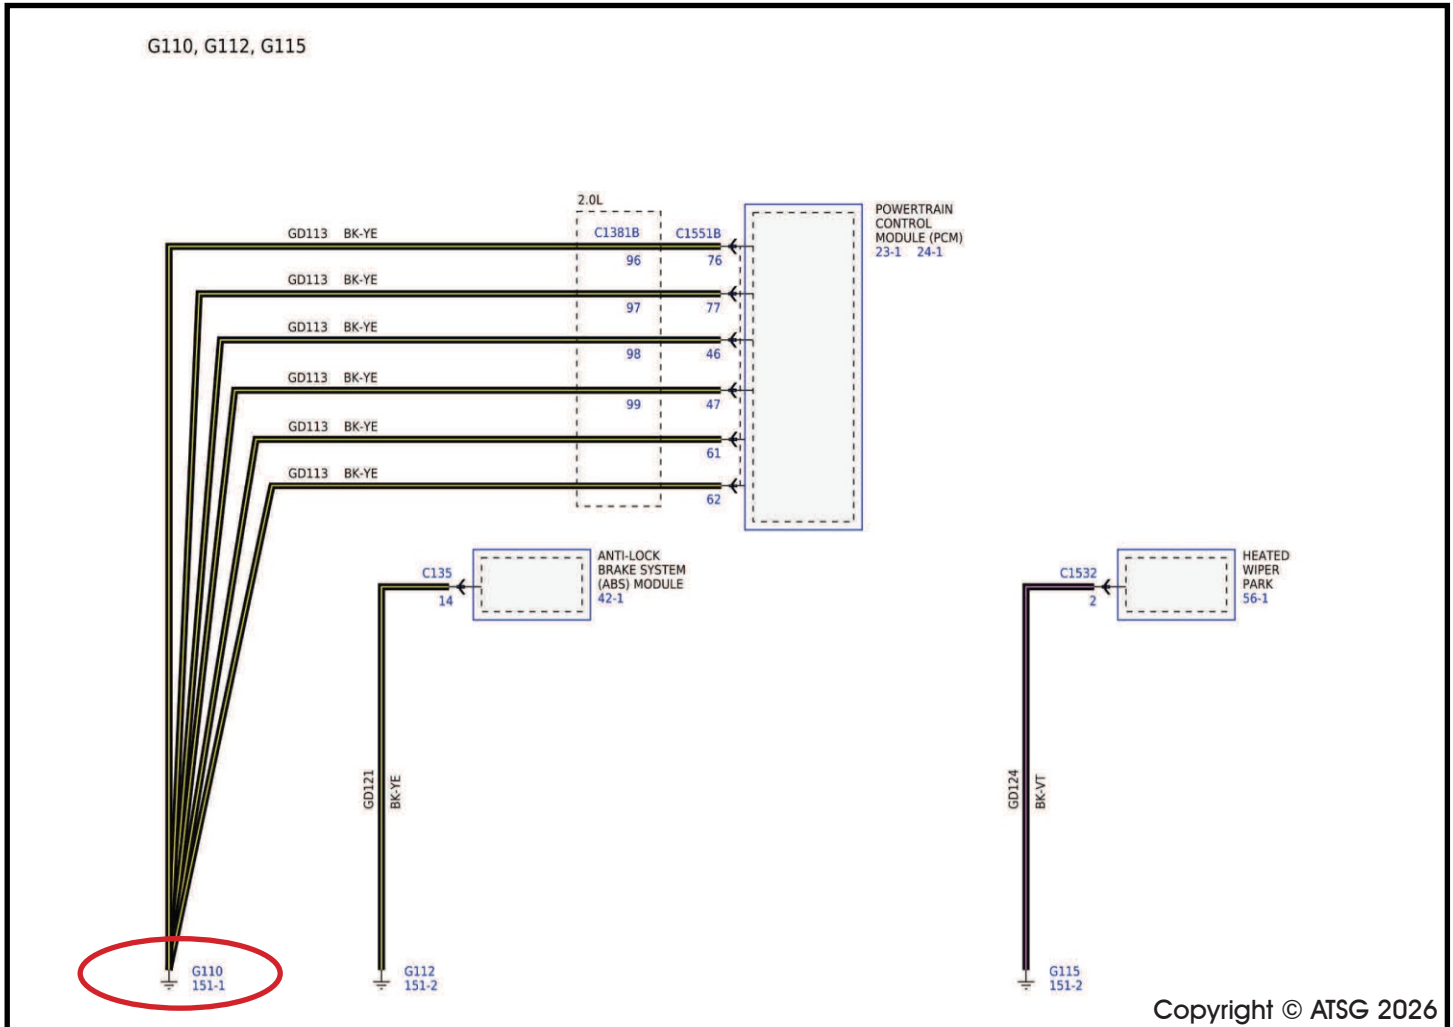
**Figure 2**

**CAUSE:** The technician noticed in the wiring diagram (see figure 2), that the G110 ground is a gang ground. This made it easier to locate on the right side of the engine. Once it was located, the problem was obvious as its location made it susceptible to the elements causing corrosion compromising the circuit.

**CORRECTION:** Clean corrosion from G110 gang ground.
