**HYUNDAI/VELOSTER D6GF1****NO ENGAGEMENTS**

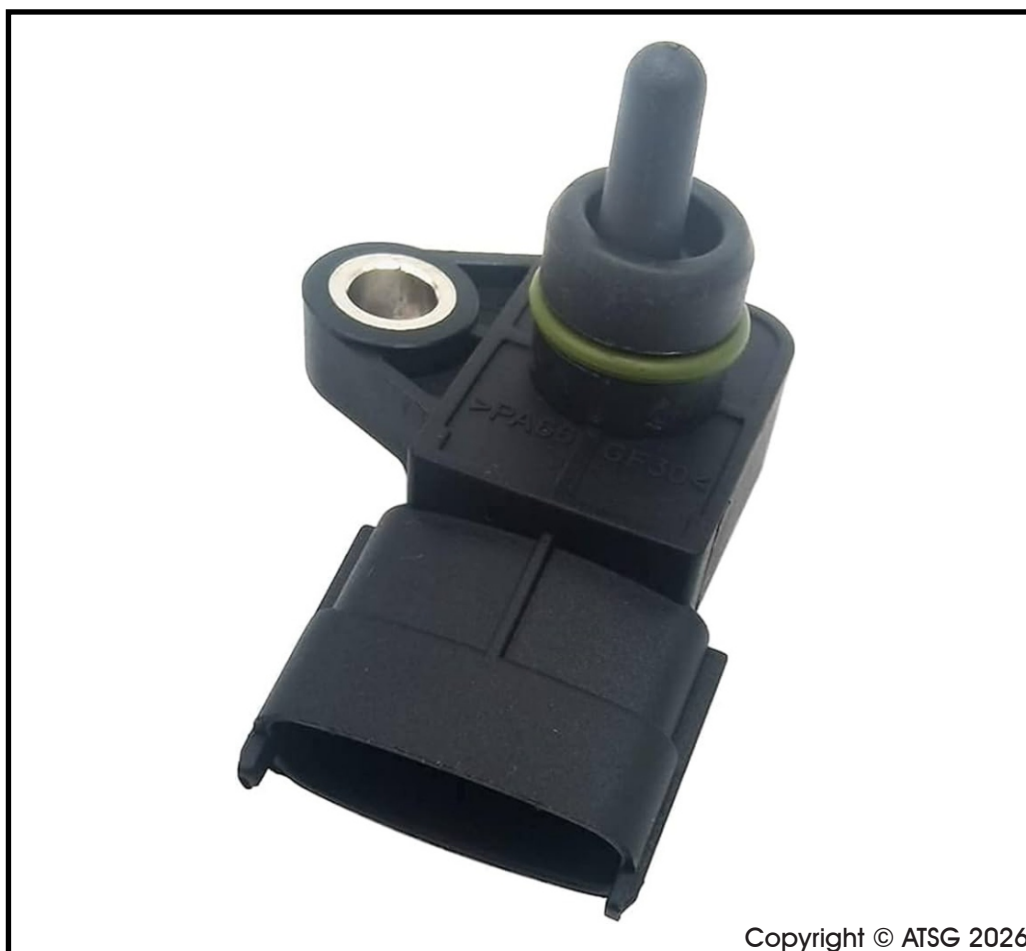
**Figure 1**

**CAUSE:** The P0108 was not allowing the clutch relearn to be completed.

**CORRECTION:** Replace map sensor (figure 1).
