**GM 10L80****UNABLE TO SHIFT MESSAGE DISPLAYED**

**COMPLAINT:** A GM vehicle equipped with a 10L80 and the Electronic Transmission Range Select feature may have an "Unable To Shift" message displayed in the instrument cluster (figure 1), and possibly diagnostic trouble codes P17F3 "Transmission Park Position Switch Stuck On" or P189D "Transmission Park Position Switch Stuck Off". There may also be a complaint of the transmission stuck in park. All of these complaints occurred after the valve body assembly was replaced.

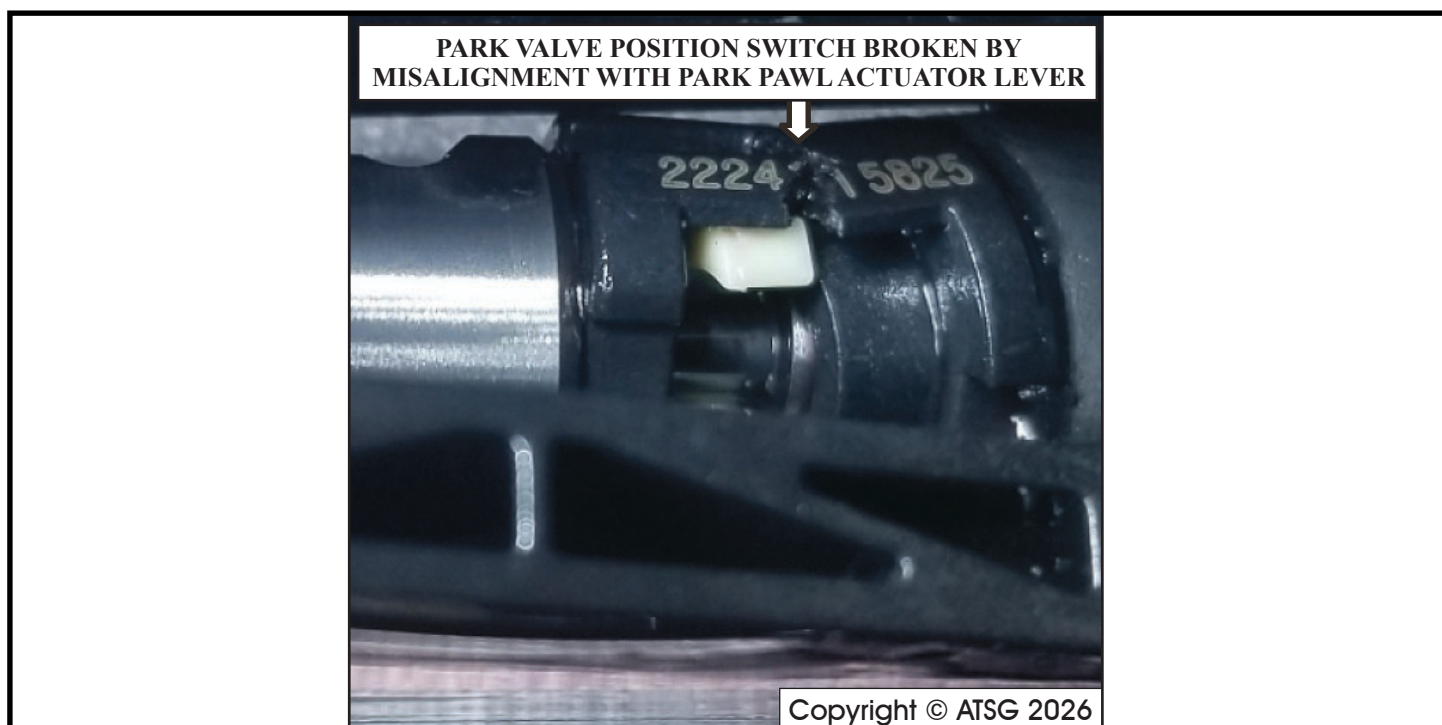
**Figure 2**

**CAUSE:** The park valve position switch is part of the Electronic Range Control System (ETRS). This was broken due to the misalignment of the park pawl actuator lever with the park valve position switch (figure 2).

**CORRECTION:** Since the park valve position switch is not serviced separately, another valve body assembly will have to be purchased.

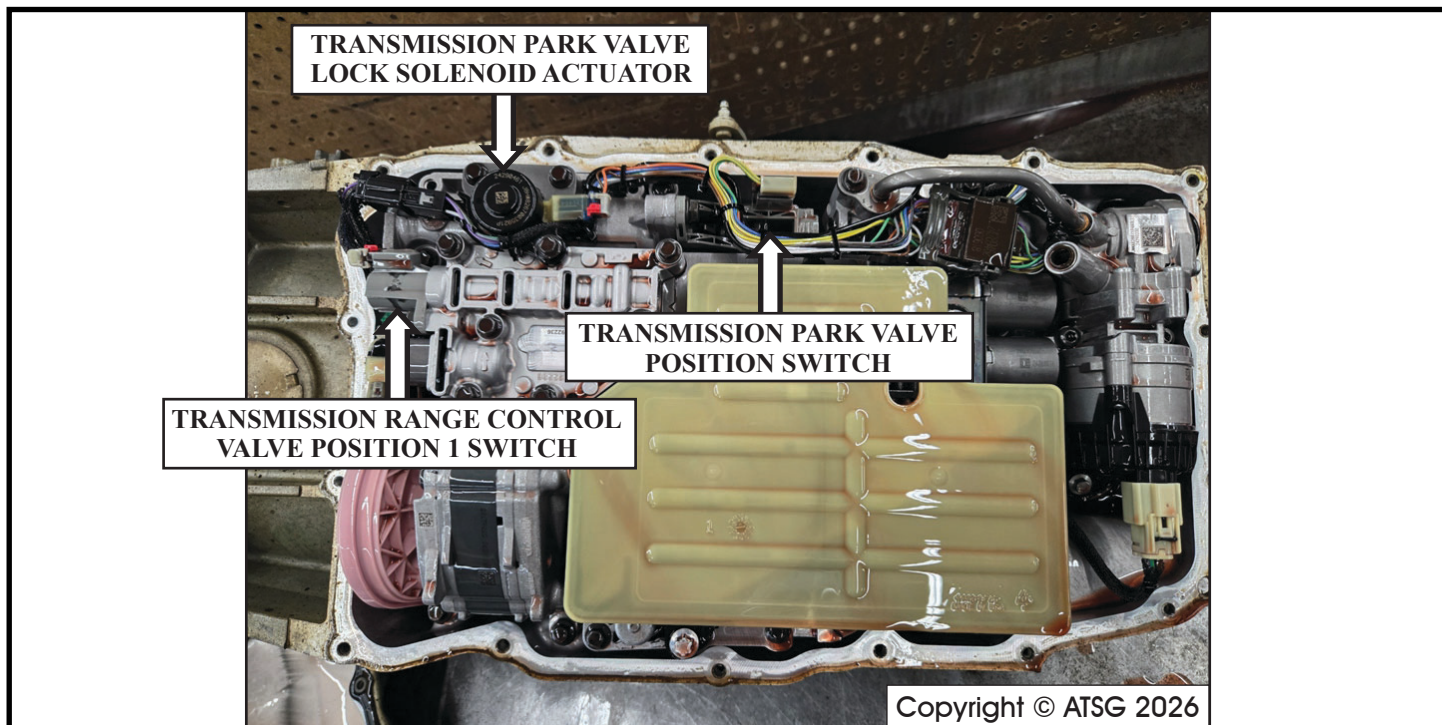
**Figure 5**

The ETRS components are located in the transmission as seen in figure 5.

The Transmission Range Control Valve 1 Position Switch receives a 9 volt supply from the TCM. It detects the position of the ETRS valve located behind the switch in the valve body. The Transmission Park Valve Position Switch also receives a 9 volt supply from the TCM and detects the position of the park servo valve.

The Transmission Park Valve Lock Solenoid Actuator when energized will extend its pin to lock the park servo in the applied position. This will hold the park pawl the "out of the park" position.

A dedicated internal wire harness to accommodate the ETRS components is also required.

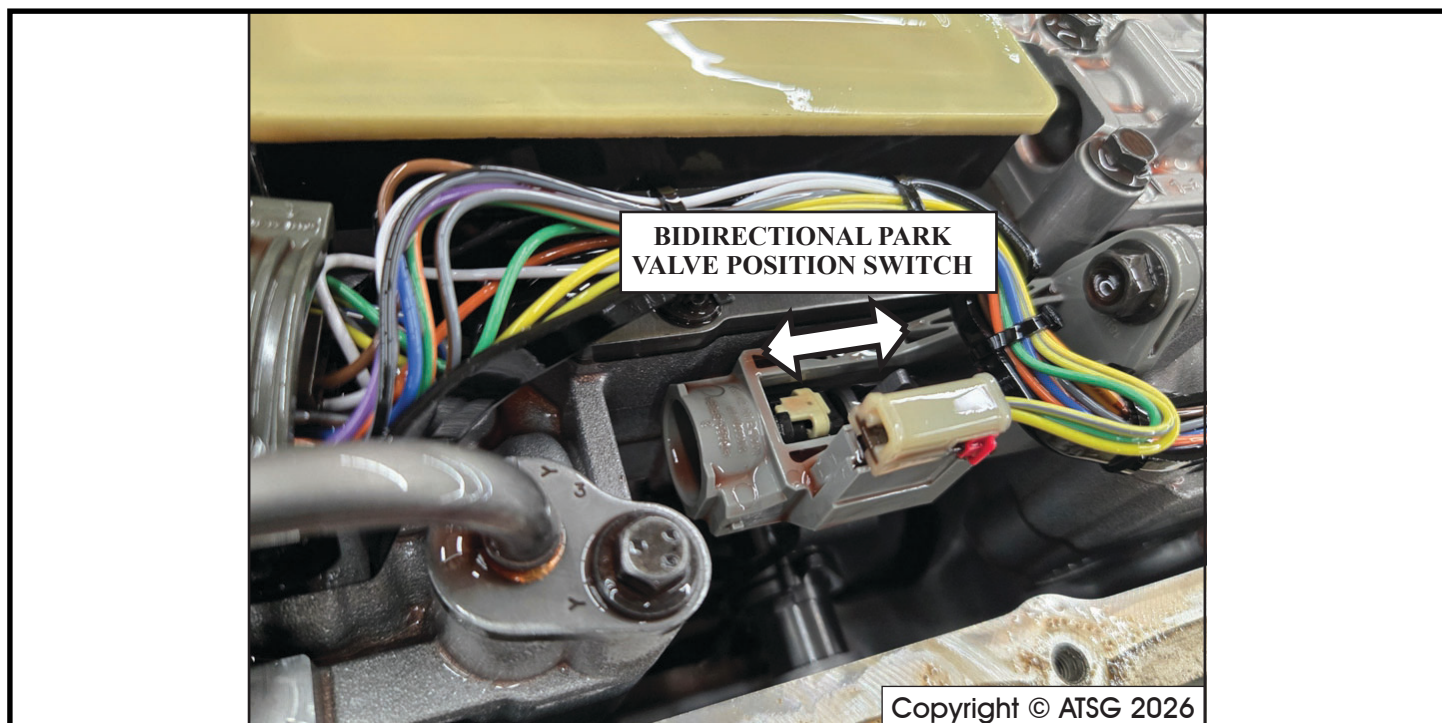
**Figure 6**

The bidirectional Transmission Park Valve Position Switch will respond to gear shift lever selection which the TCM will use to control its movement (figure 6).
