## **LAND ROVER ZF9HP48 JUMPS OUT OF PARK**

**COMPLAINT:** A 2019 Land Rover EVO comes into the shop with a ZF9HP48 transmission needing to be rebuilt. Once it was rebuilt and installed, the shifter would pop out of park and sets DTC P07E4 which means it is unable to engage park. Even with the harness disconnected from the transmission, park would not engage. The tech chose to replace the park solenoid which did not remedy the problem.

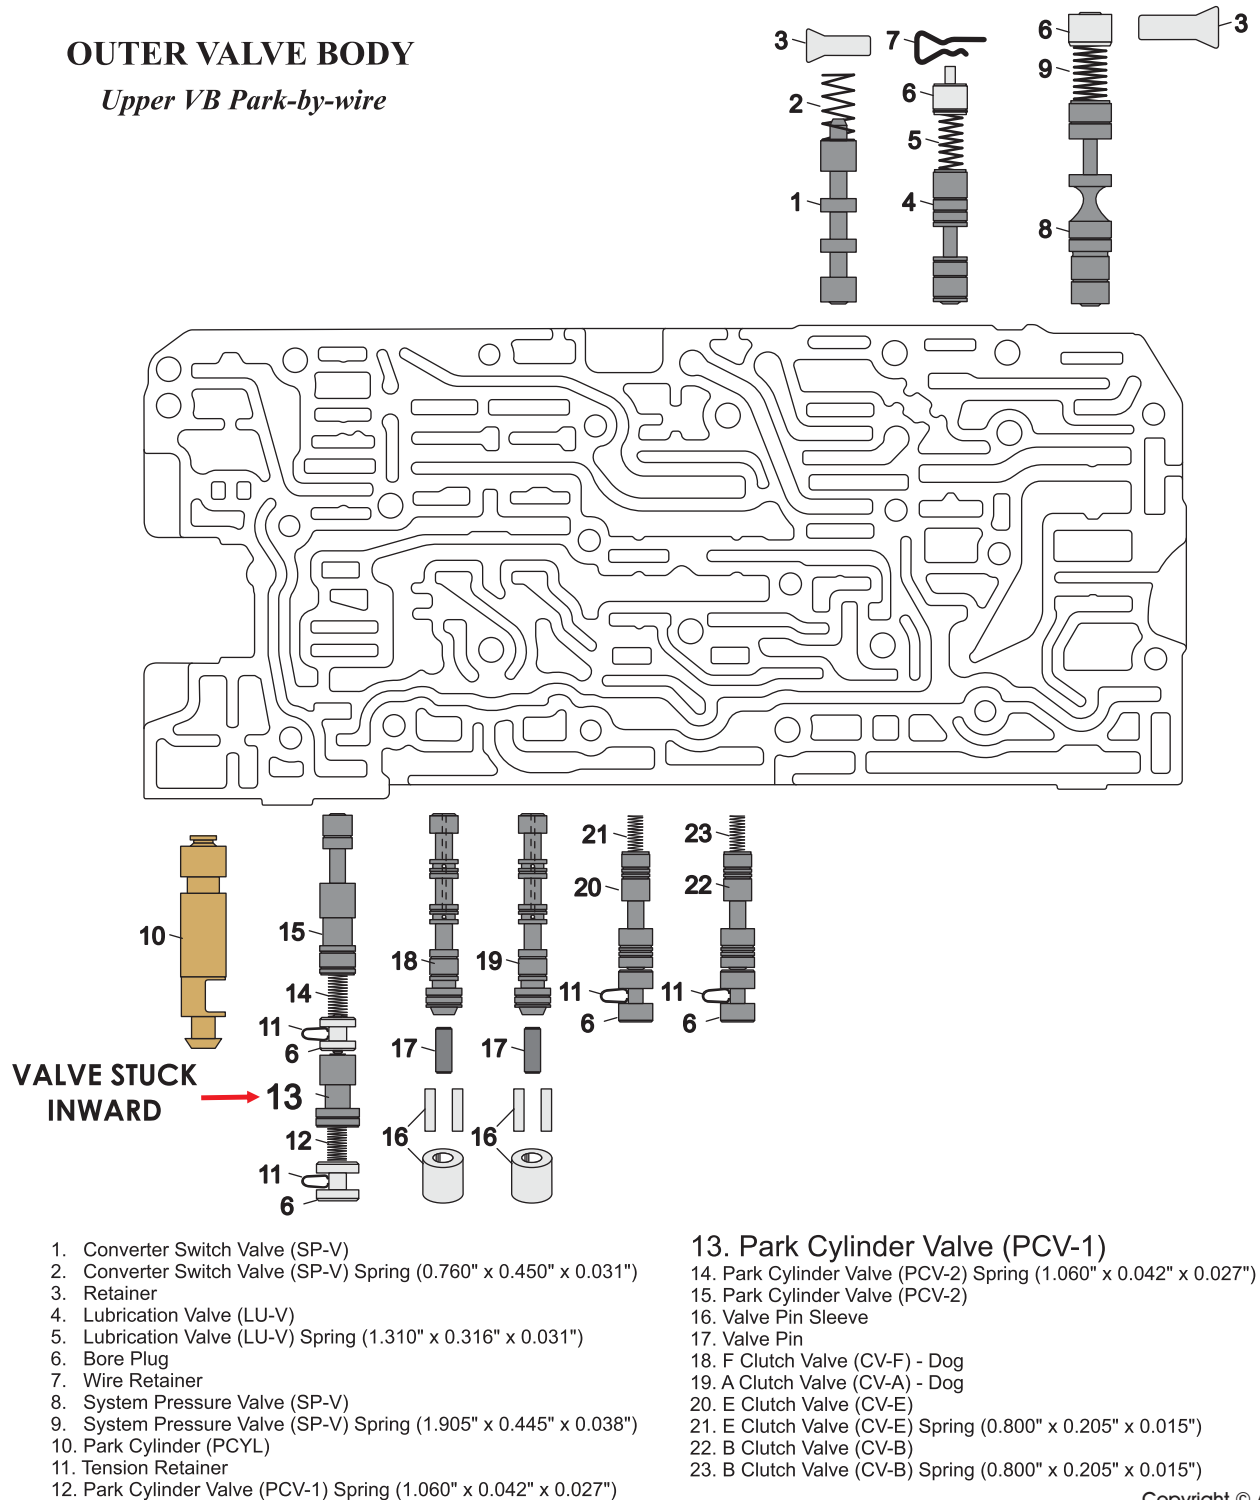
**Figure 1**

**CAUSE:** The valve body was then removed for further inspection when the park cylinder valve (PCV 1) was found to be stuck inboard. This is what caused the jumping out of park complaint after rebuild.

**OUTER VALVE BODY**

*Upper VB Park-by-wire*

**CORRECTION:** Free up the park cylinder valve (PCV 1) (figure 1).
