**FORD 10R80**  
**PUMP WEAR ISSUES**

**COMPLAINT:** A Ford vehicle equipped with a 10R80 Transmission is exhibiting symptoms that point to a low line pressure condition. The transmission may delay on garage shifts, slip in gear, fall out of gear or set gear ratio error codes.

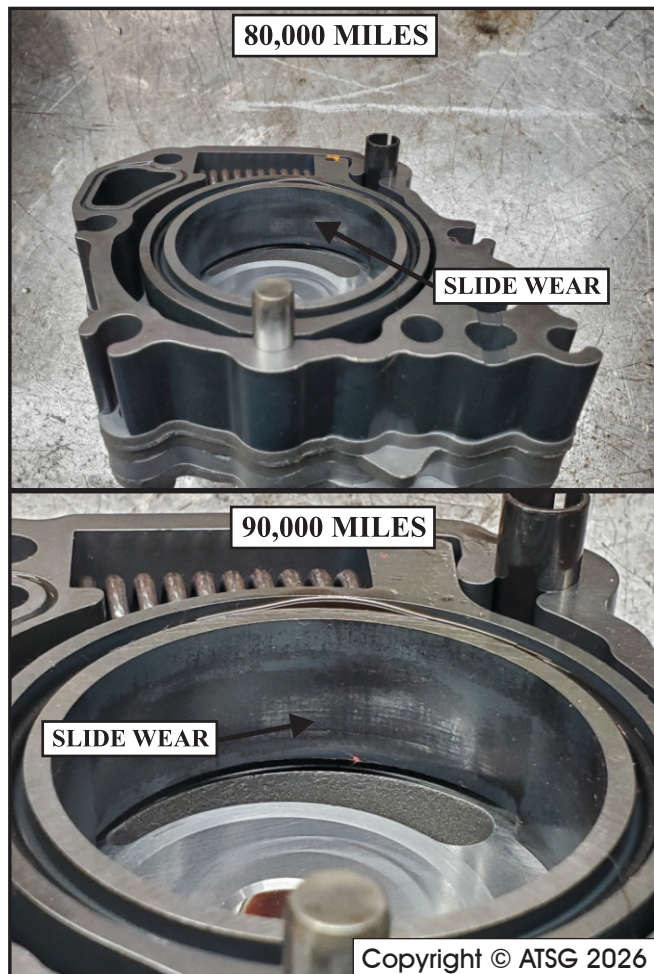
Figure 1

**CAUSE:** Wear has occurred in the transmission fluid pump vane contact area of the slide which is seen in figure 1. This came out of a vehicle with 80,000 miles showing on the odometer. The wear factor is a bit more severe in figure 2 from a vehicle with 90,000 miles showing on the odometer. On a vehicle with 100,000 miles showing on the odometer the wear factor is even more severe than the previous examples (figure 3).

**CORRECTION:** Replace the transmission fluid pump assembly.

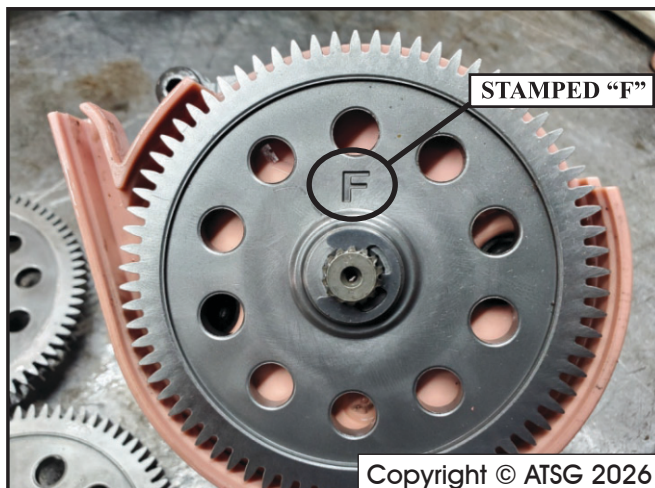
Figure 4

Some transmission fluid pump driven gears will have an "F" stamped on the front of the gear as seen in figure 4. The reason why some gears have this and some don't is unclear. The gear however, is direction sensitive and should be installed in the direction shown in Figure 4. As if "F" could indicate "FRONT" to ensure it is installed correctly. If gear is not stamped with a F, it should be marked prior to removal.
