**GMC YUKON 4WD**

**FUSE #19 REPEATEDLY BLOWS**

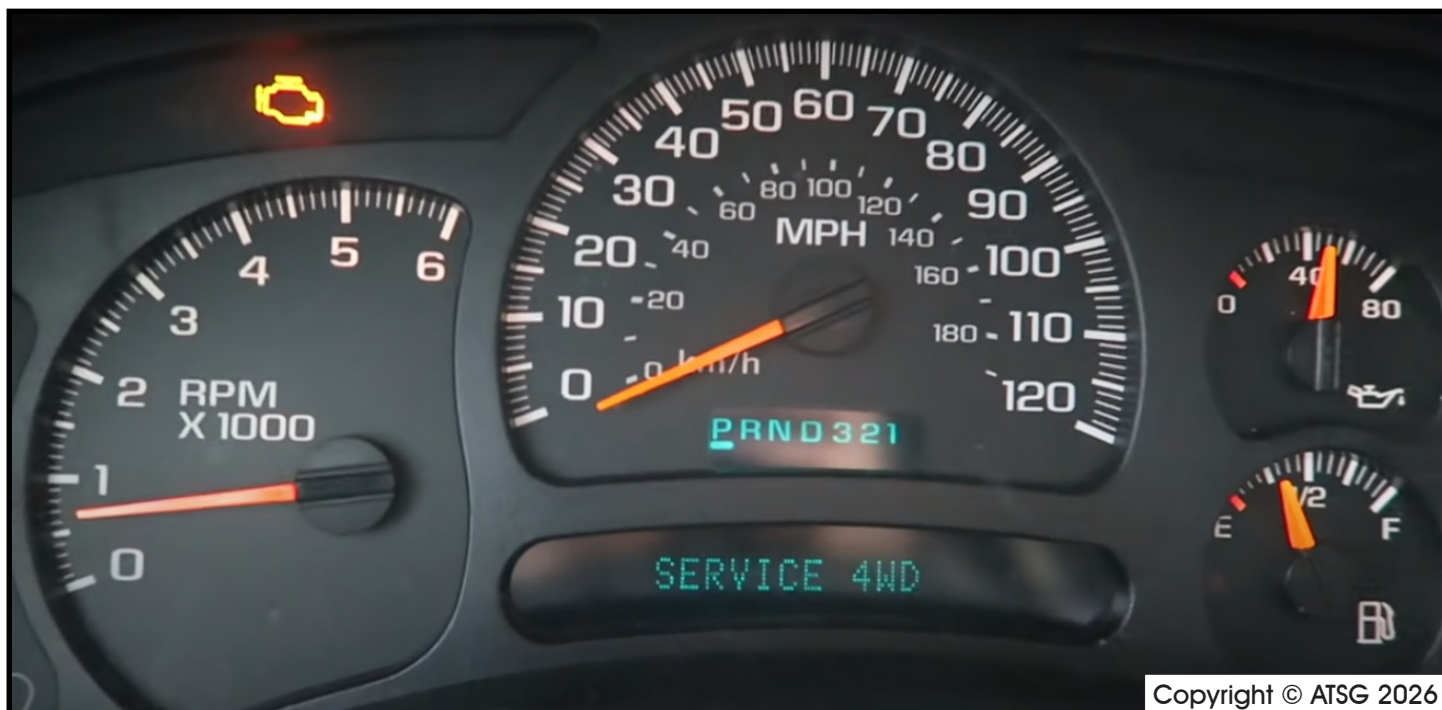
**Figure 1**

**COMPLAINT:** A 2011 GMC Yukon with a 5.3 liter engine, a 6L80 transmission and an MP3023 transfer case has a complaint of a "Service 4WD" message in the driver information center, refer to figure 1. In addition, the 15 amp fuse #19 in the underhood fuse box repeatedly blows (figure 2). This can also cause the transmission to be stuck in a higher gear due to a loss of the solenoid power supply. The truck was still able to start and run with this fuse blown.

**CORRECTION:** Cleaning the connector and replacing the front drive axle actuator stopped fuse #19 from blowing. The trouble codes were cleared and the four wheel drive system now functioned as it was designed. This obviously eliminated the illumination of the warning message in the driver information center.

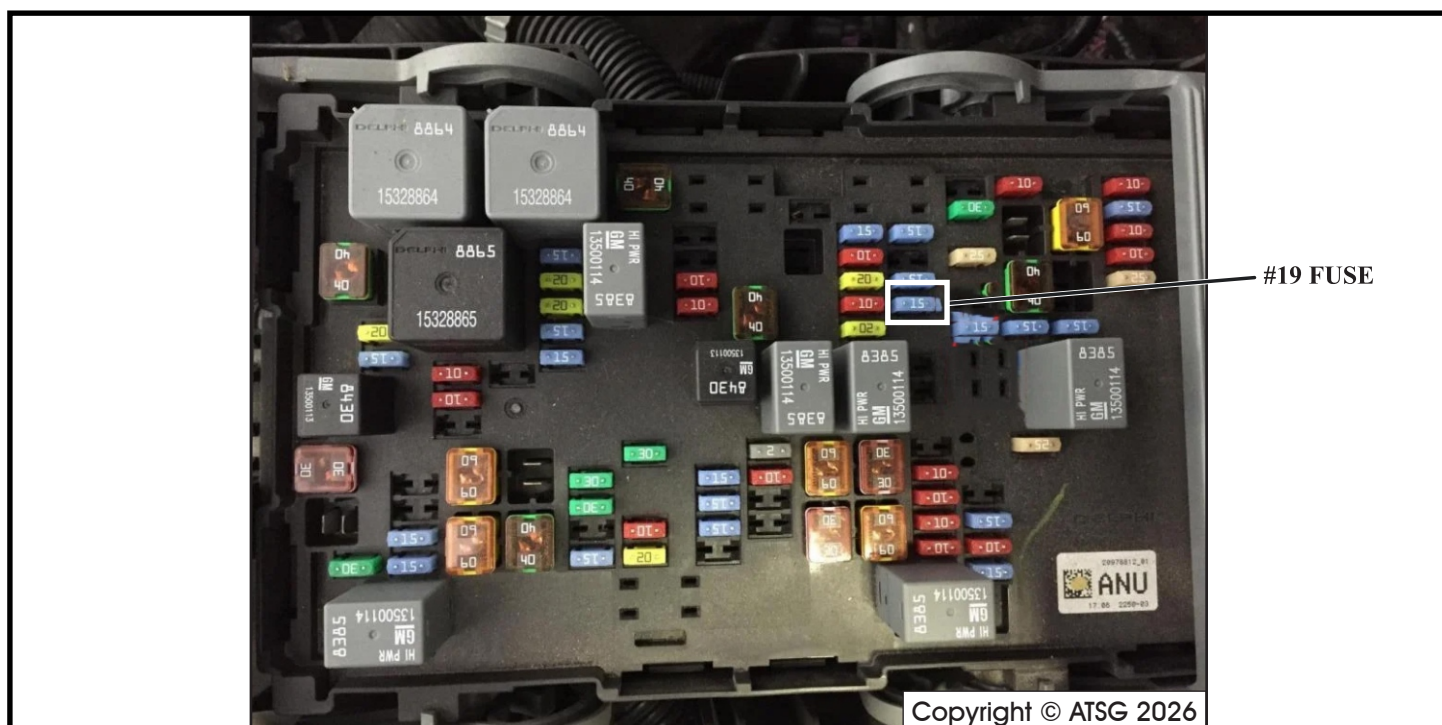
**Figure 2**

**CAUSE:** Since the fuse would blow as soon as the ignition switch was turned on, and it supplies power to the transmission solenoids from junction J127, the technician decided to disconnect the transmission case connector to see if the #19 fuse would blow or not. And it did.

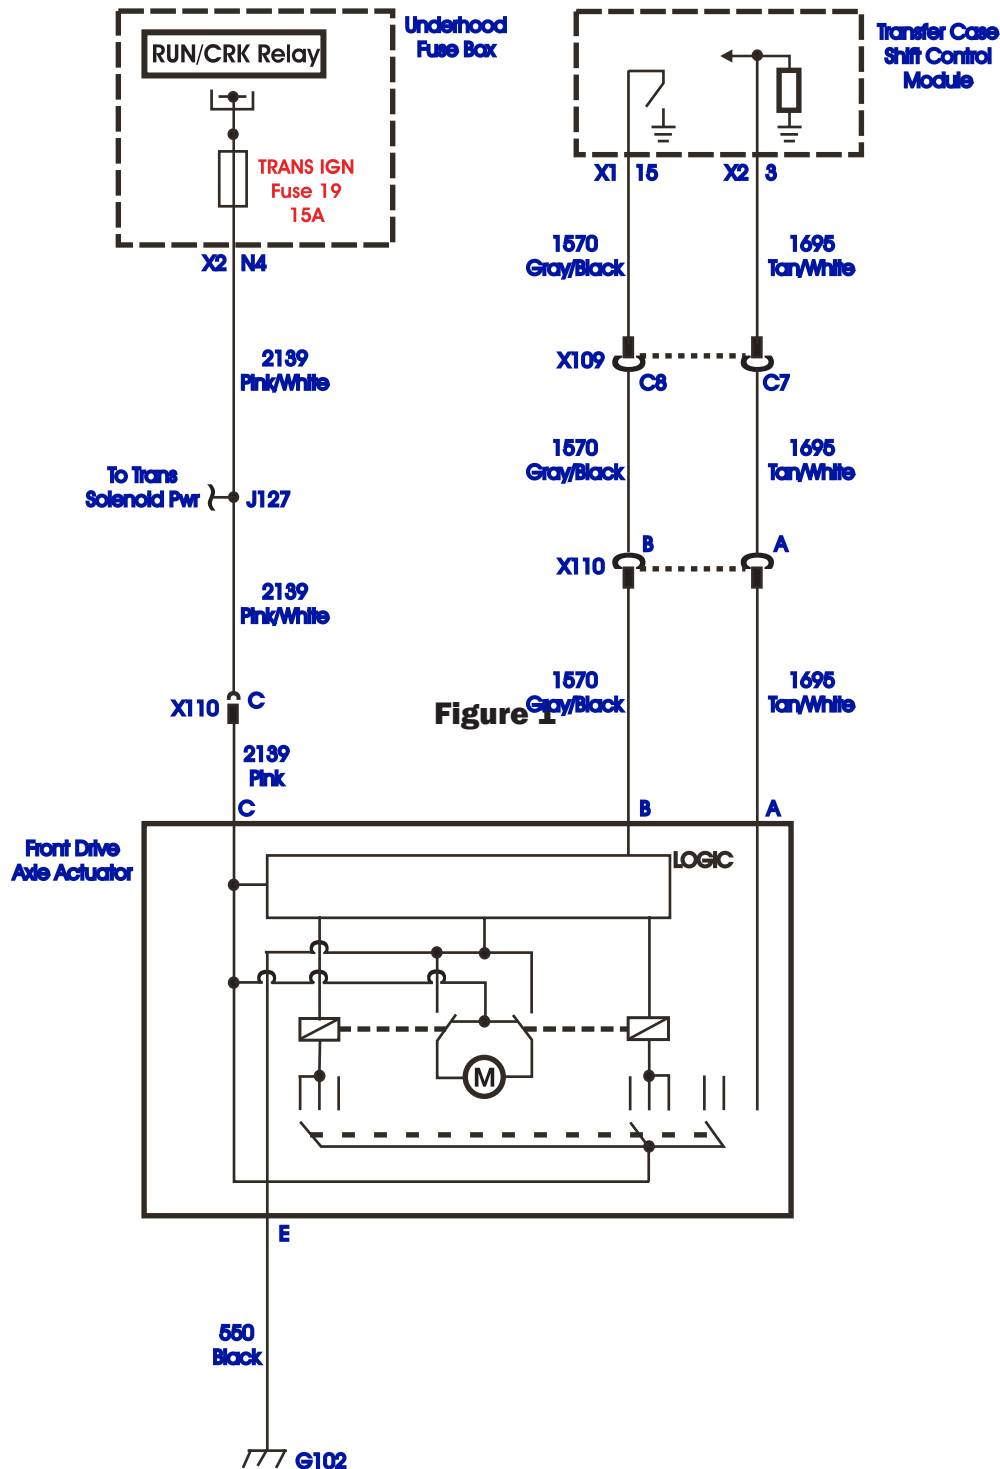
Following the wiring diagram in figure 3, fuse #19 also supplies power to the front drive axle actuator which led the technician to disconnect the actuator. When he unplugged it, he found the actuator connector was full of gear oil (figure 4). With it unplugged, the #19 fuse did not blow confirming this to be the cause.
