**FORD 6R80**

**NO START**

**COMPLAINT:** A 2013 Ford F150 equipped with the 3.5 liter Turbo engine and 6R80 transmission has a complaint of a no start condition. The shift quadrant indicator lamps do not illuminate. In addition, diagnostic trouble codes P0706 "Transmission Range Sensor Range Performance" , P0707 "Transmission Range Sensor Circuit Low Input", P1701 "Reverse Engagement Error" and P1921 "Transmission Range Signal" were set. With this information, the technician decides to inspect the transmission range sensor power supply at transmission case connector terminal 4. The inspection revealed voltage being much lower then the expected 12 volts in this circuit.

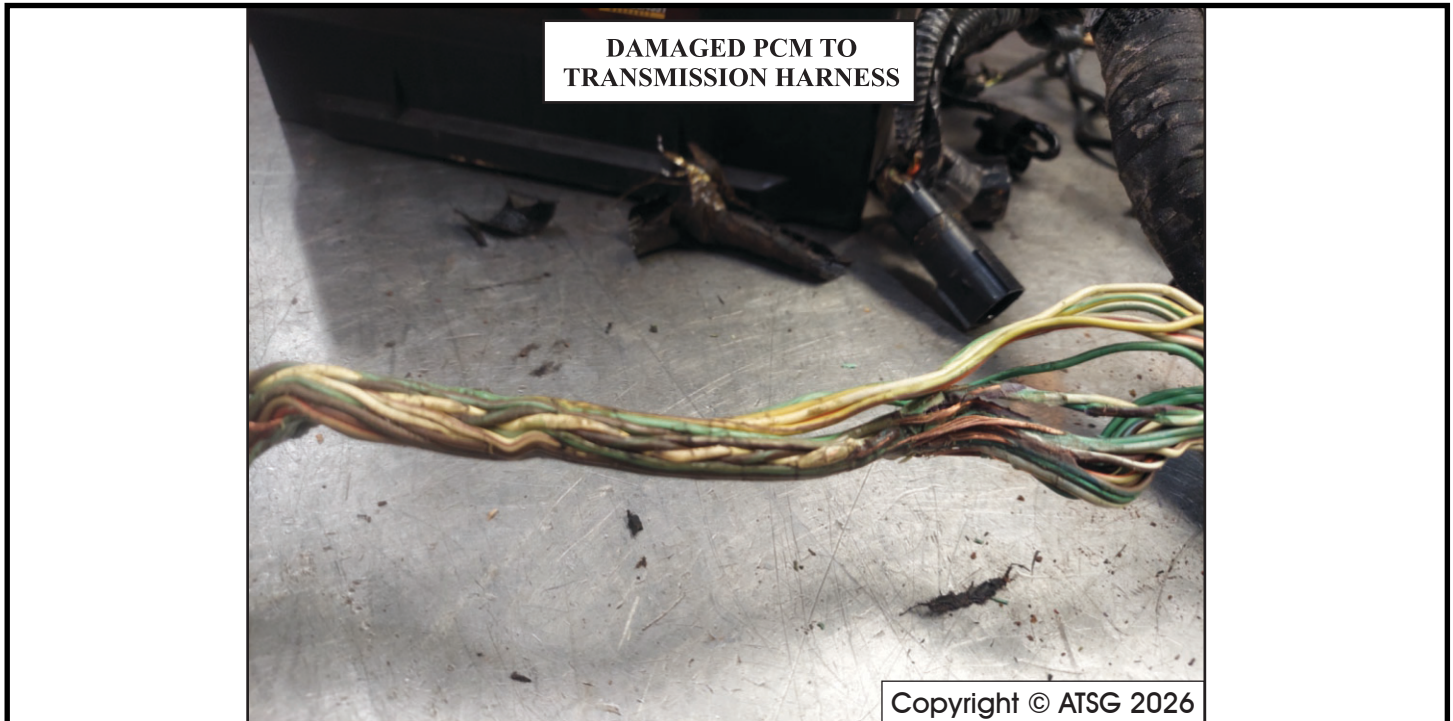
**Figure 1**

**CAUSE:** In the process of checking for power to the TRS, the technician found the wiring to be severely damaged by engine oil saturation (figure 1). This began a hunt to find where this oil was coming from. It was discovered that this 3.5 Liter Turbo engine uses a dedicated vacuum pump to supply vacuum for the brake booster. This vacuum pump is known to leak engine oil (figure 2). When it does, it runs down over the transmission converter housing and onto the wire harness going to the transmission (figure 3).

**CORRECTION:** Replacing the vacuum pump and gasket eliminates the oil leak (figure 6). The shop can decide if the wire harness is repairable or if it requires replacement.

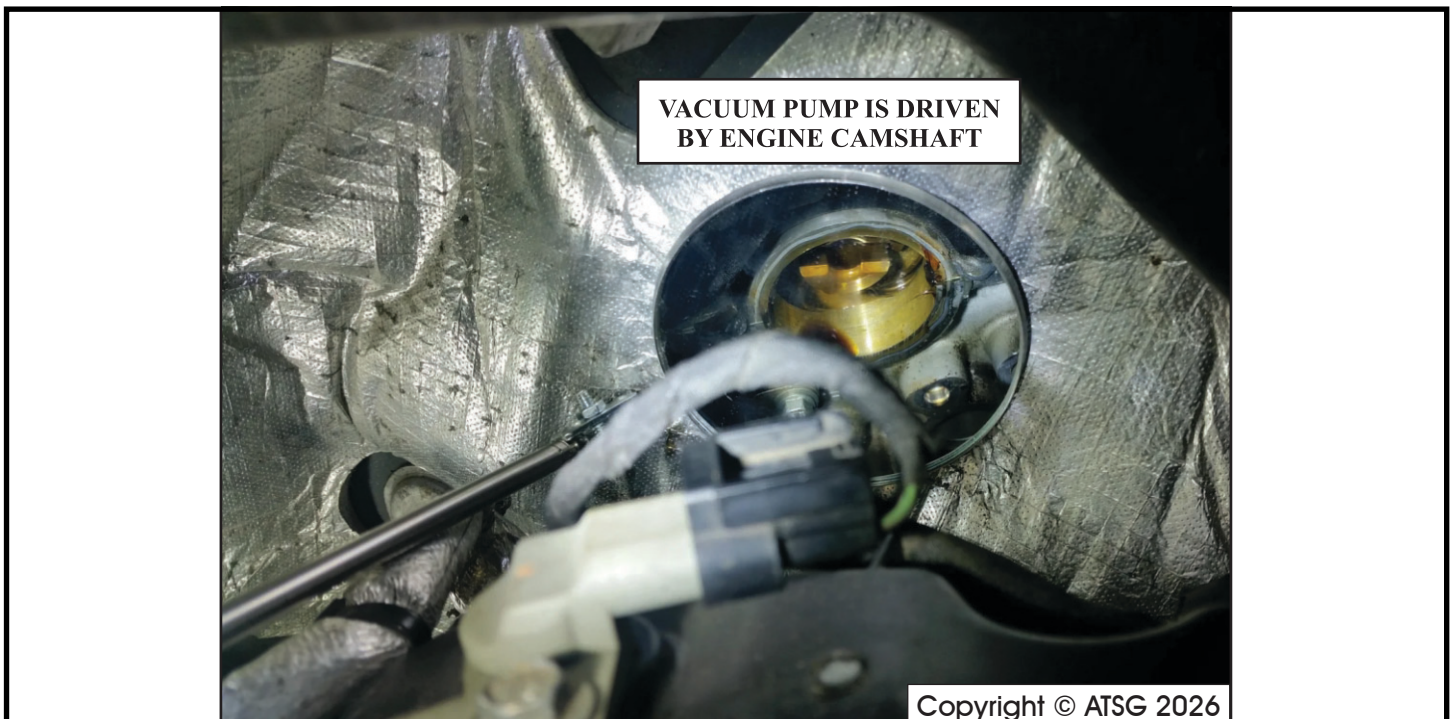
**Figure 4**

This vacuum pump is driven by the engine camshaft (figure 4), and is lubricated by engine pressure fed lube oil. The vacuum pump uses a rubber gasket to seal the pump to the engine. When this gasket fails, it causes engine oil to leak onto the transmission wire harness (figure 5).
