## **TOYOTA UB80E**

### **NO MOVE AFTER REBUILD**

**COMPLAINT:** A 2015 Toyota Camry comes into the shop needing a transmission. After installing a rebuilt transmission, the vehicle did not move forward or reverse.

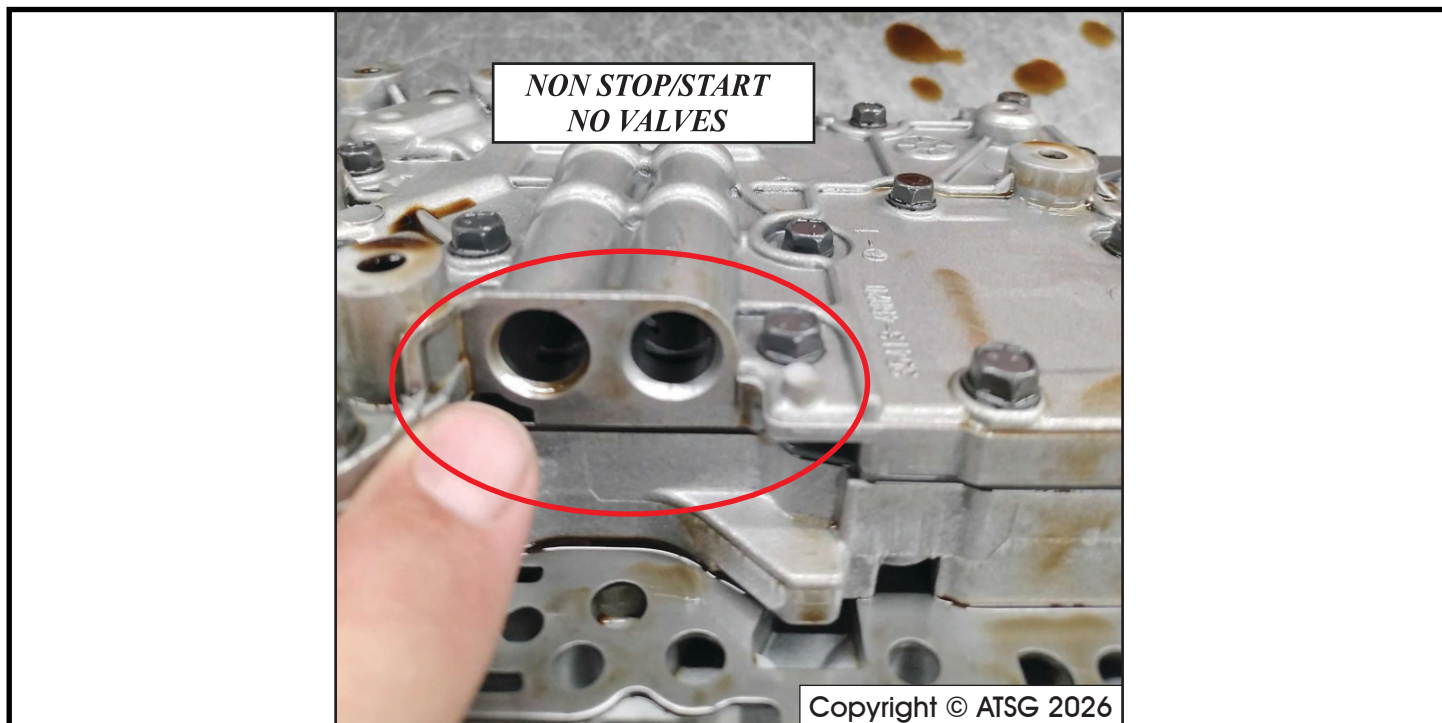
**Figure 1**

Due to the original transmission slipping and having poor shifts, the valve body was replaced during the rebuild process. When the original valve body was removed, it was compared to its replacement. In doing so, a significant difference was noticed. The original valve body had 2 open valve bores but the replacement had the 2 valves in the bore, see figures 1 and 2.

**CORRECTION:** With the correct Valve body installed and the C1 balance piston snap ring in the correct position, The transmission now moved forward and reverse.

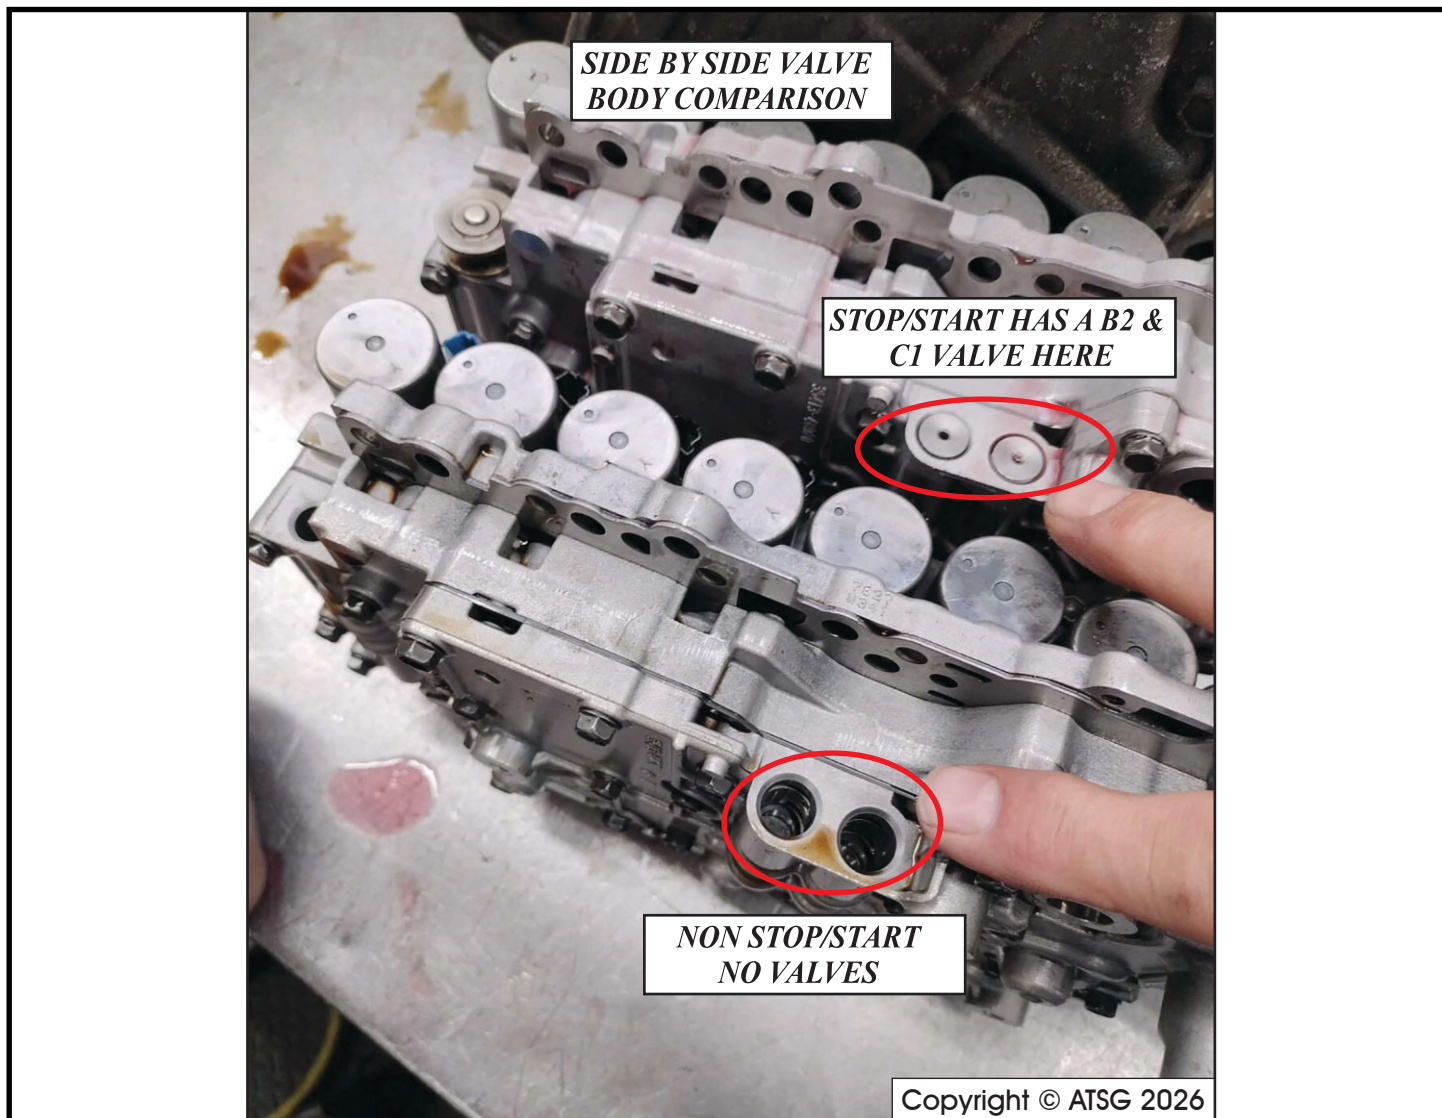
**Figure 3**

**CAUSE:** There are 2 different valve bodies for this transmission. The valve body that has two empty valve bores side by side is for NON-STOP/START applications. The valve body that has valves in these bores is for STOP/START vehicles (figure 3). This type of transmission used in ATSG's UB80 TechTran manual showing the one valve to be a B2 One-Way Check Valve and the other a C1 One-Way Check Valve. A no move condition will occur when a STOP/START Valve body is installed in a NON-STOP/START transmission which is what occurred here. Figure 4 provides a cutaway view from SONNAX showing these One-Way Check Valves used in STOP-START valve bodies.

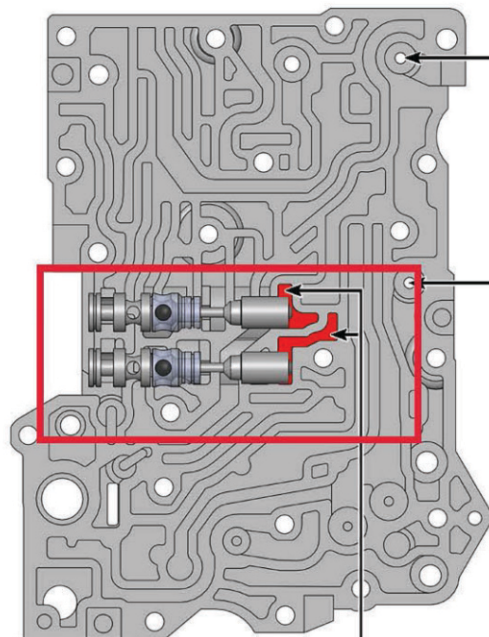
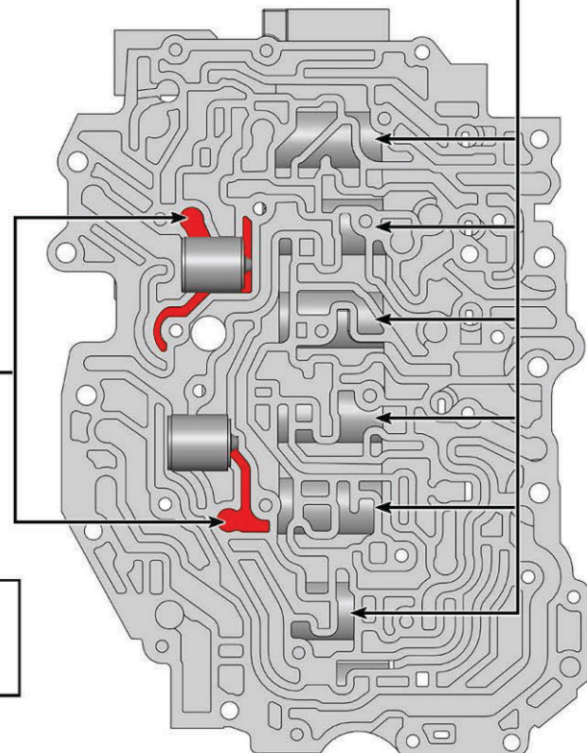
#### B2/C1 One Way Check Valve

- Forward slip
- No Forward
- B2/C1 clutch failure

NOTE: Only on Stop-Start models. Valve bodies without Stop-Start will have open bores here.

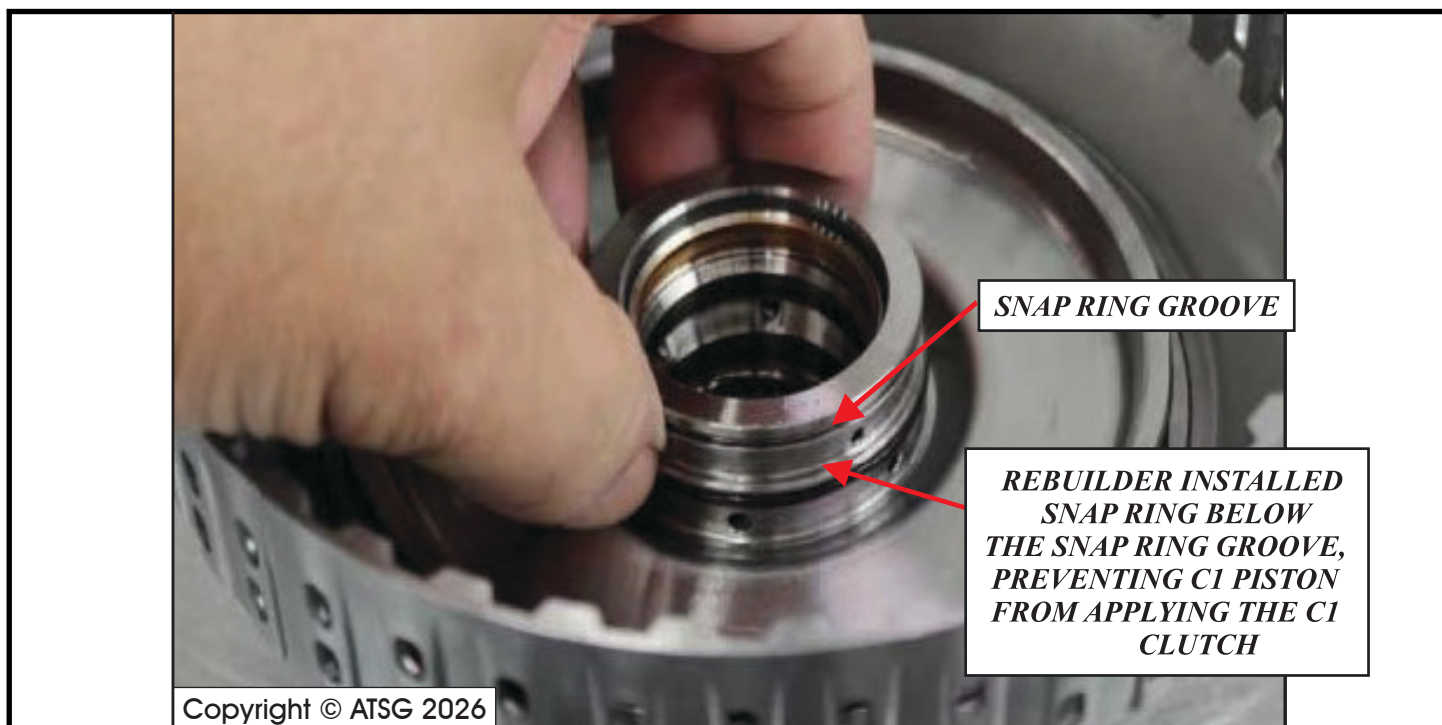
**Figure 5**

Once this was discovered, the original valve body was put back on the transmission as a test to see if the vehicle would moved in forward and reverse. When this was done, the transmission only had reverse. There was no forward gears. The transmission was then removed to inspect the C1 clutch. for inspection, in doing so they discovered the C1 balance piston snap ring was installed in an incorrect location which prevented the C1 piston from applying the C1 clutch , see figures 5 and 6.
