**GM 6L90**

**BINDS IN REVERSE AND FIFTH AND PULLS FORWARD IN NEUTRAL**

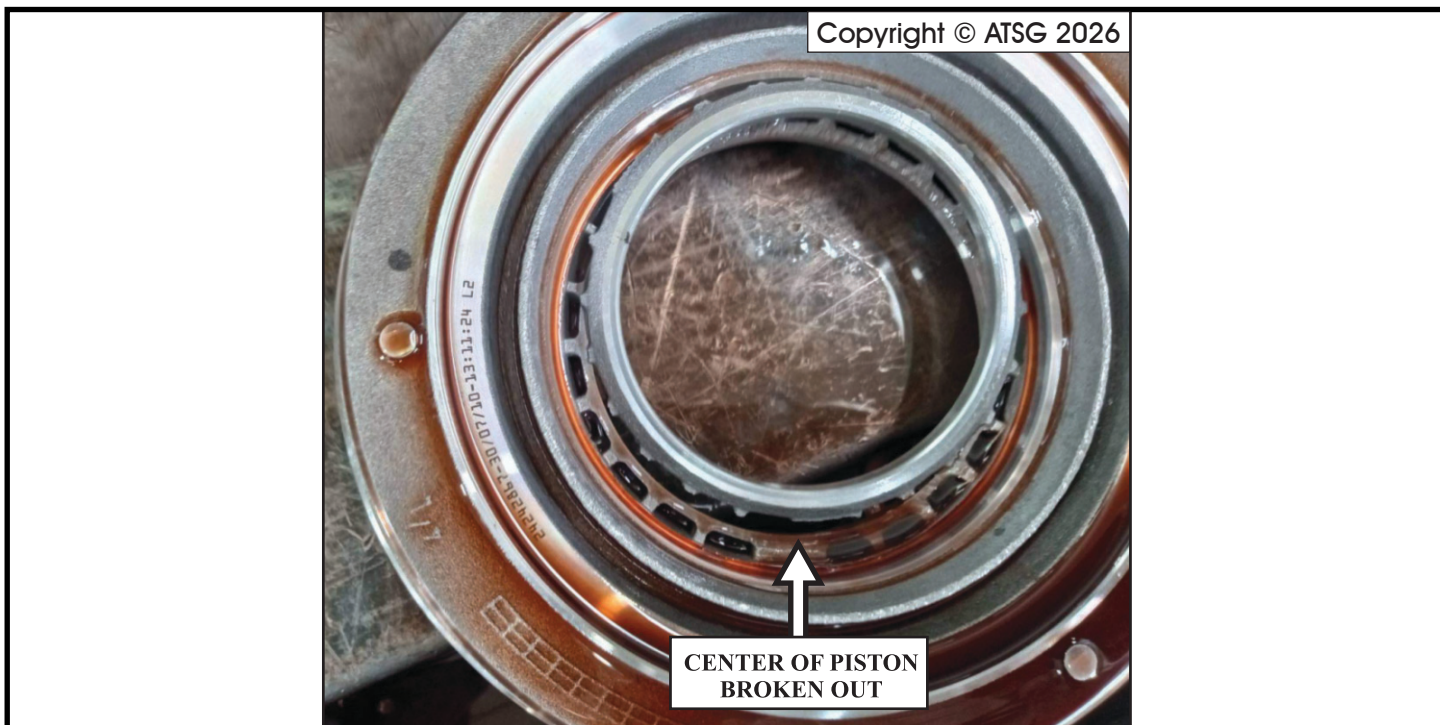
**Figure 1**

**CAUSE:** Regardless of the clean fluid, the technician was expecting to find the 1-2-3-4 clutch welded together. But when he went to remove the 1-2-3-4 clutch retaining snap ring, it was immediately noticed that the clutch pack was very tight making it difficult to remove.

What was found was the 1-2-3-4 clutch apply piston had broken away from its center (figure 1). This breakage kept the 1-2-3-4 clutch apply piston from releasing (figure 2), causing the clutch to remain mechanically applied at all times.

**CORRECTION:** Replace the 1-2-3-4 clutch apply piston seen in figure 3.
