**CHRYSLER 62TE****P0706 TRANSMISSION RANGE SENSOR RATIONALITY**

**COMPLAINT:** A 2018 Grand Caravan comes into the shop with a P0706 code for a Transmission Range Sensor Rationality problem. This sensor has four wires going to it with reference voltage in each of them being supplied by the PCM/TCM. These four wires are called the C1, C2, C3 and C4 circuits (figures 1 and 2).

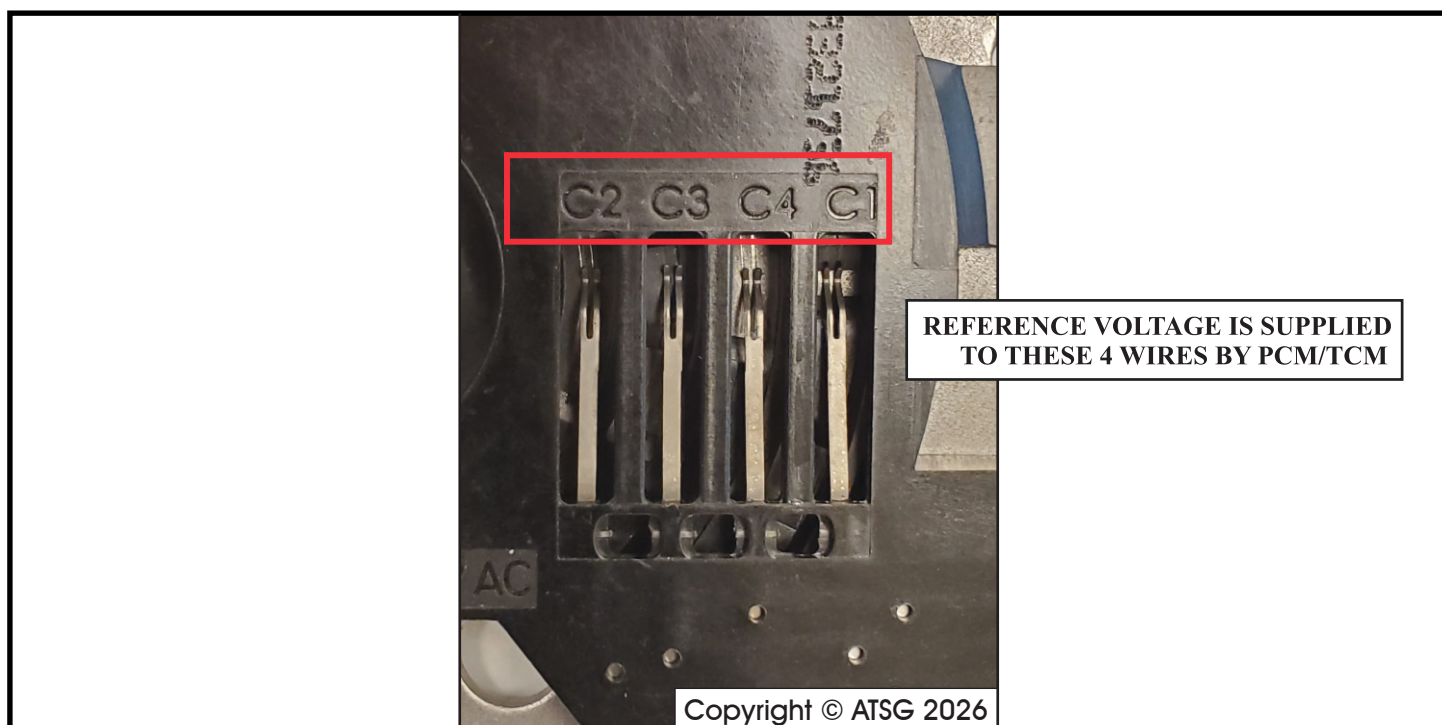
**Figure 2**

The retaining tab is designed to hold the circuit housing in place, so the circuit fingers seen in figure 2 maintains tension contact to the detent plate. When this tab is broken, it compromises the tension for any one of these circuit fingers. In this case, it happened to be the C2 circuit (figures 7 and 8).

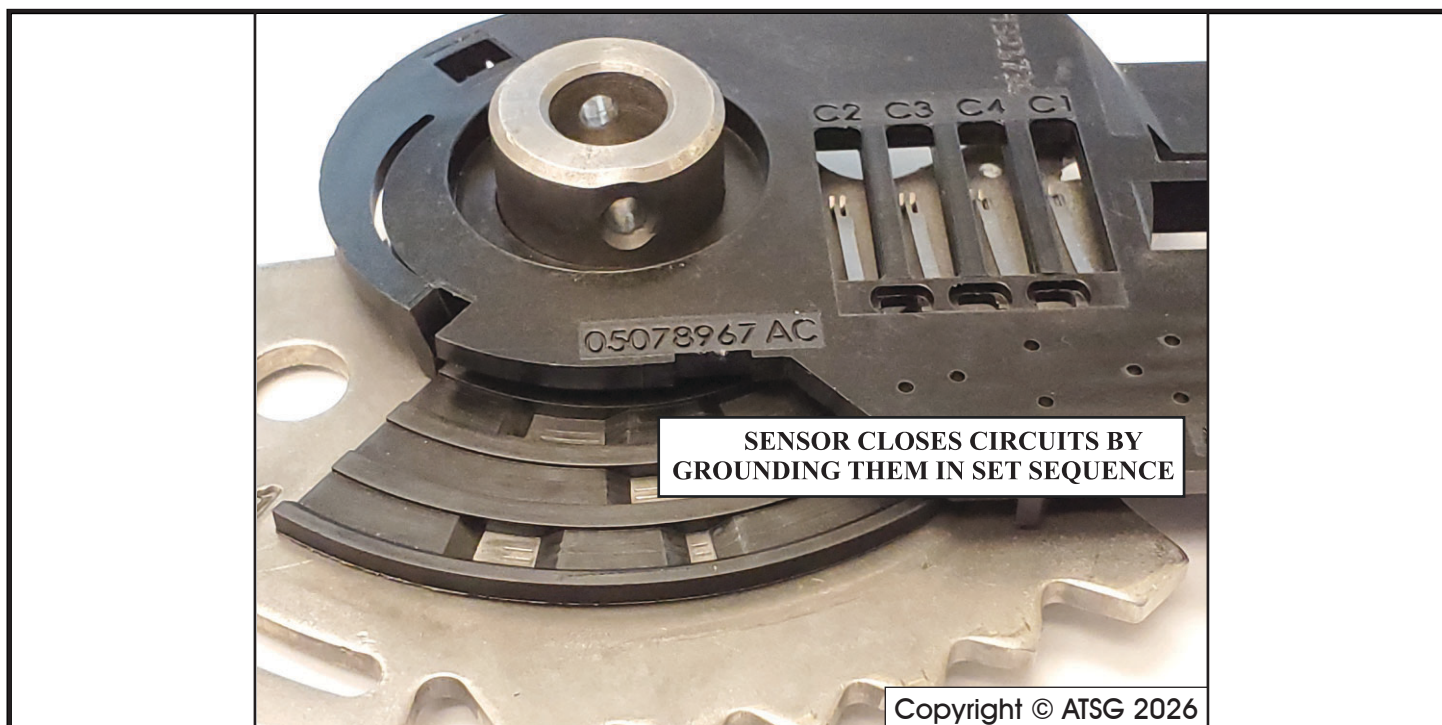
**Figure 3**

A scan tool provides a PID showing the open and closed status for each of these circuits. The sensor is designed in such a way as to close these circuits by grounding them in a set sequence (figure 3).

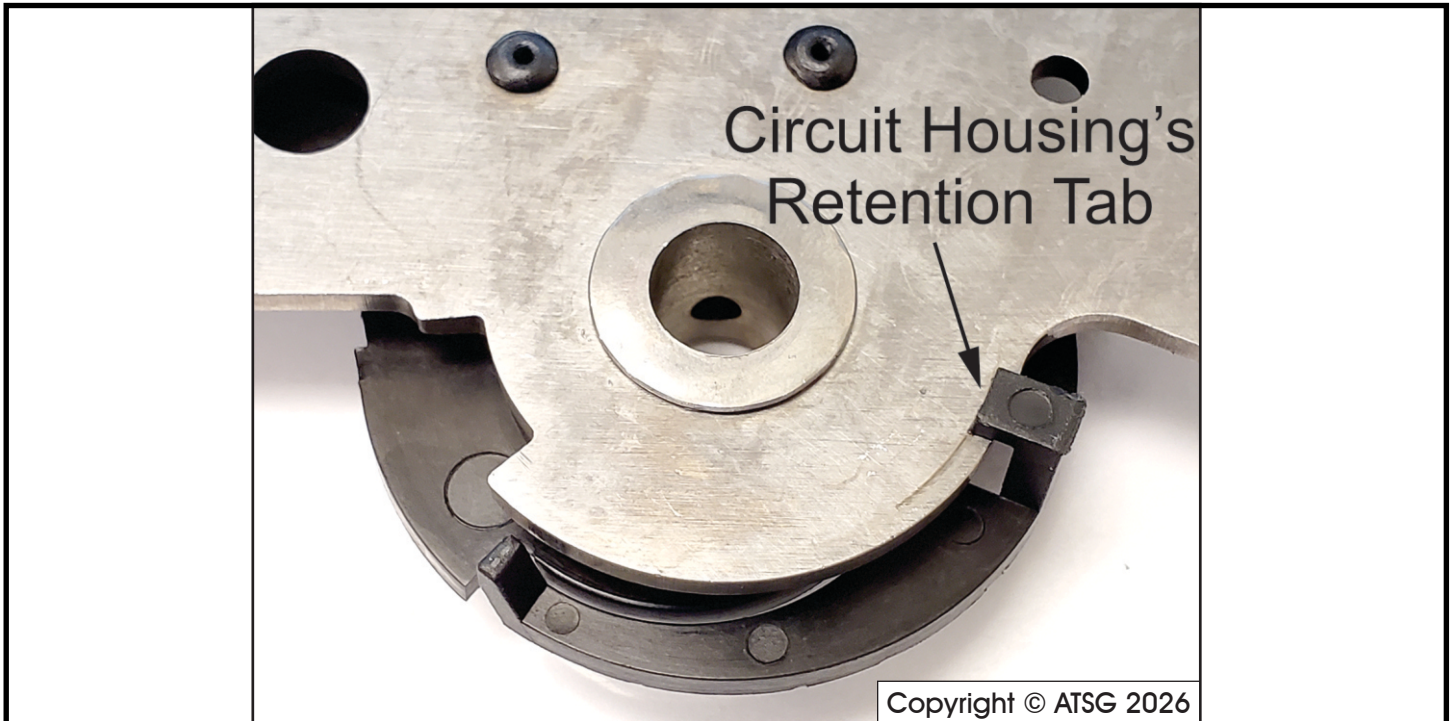
**Figure 5**

**CAUSE:** When each of these circuits were inspected, it was discovered that the C2 circuit always remained open. It should be grounded in all ranges except OD and 3. This typically would indicate that the wire to the sensor is broken preventing the circuit from being grounded. A bad connection would be another possibility. After inspecting the C2 circuit, it was discovered that there was something wrong with the sensor itself. This required pulling the unit and valve body to gain access to this sensor. It was then discovered that the retaining tab that holds the circuit housing to the detent plate was missing. Figures 5 and 6 show the location of this retaining tab.

**CORRECTION:** Replace the Transmission Range Sensor.
