## **CHRYSLER 845RE (8HP45)**

### **CANNOT ENGAGE PARK**

**COMPLAINT:** A 2019 Chrysler 300 with 3.6 liter engine and the 845RE transmission has a complaint of not being able to engage park. Diagnostic trouble codes P07B9 "Park Switch Circuit Low" and P1B13 "Park By Wire Unintended Out Of Park Position" are set, figure 1.

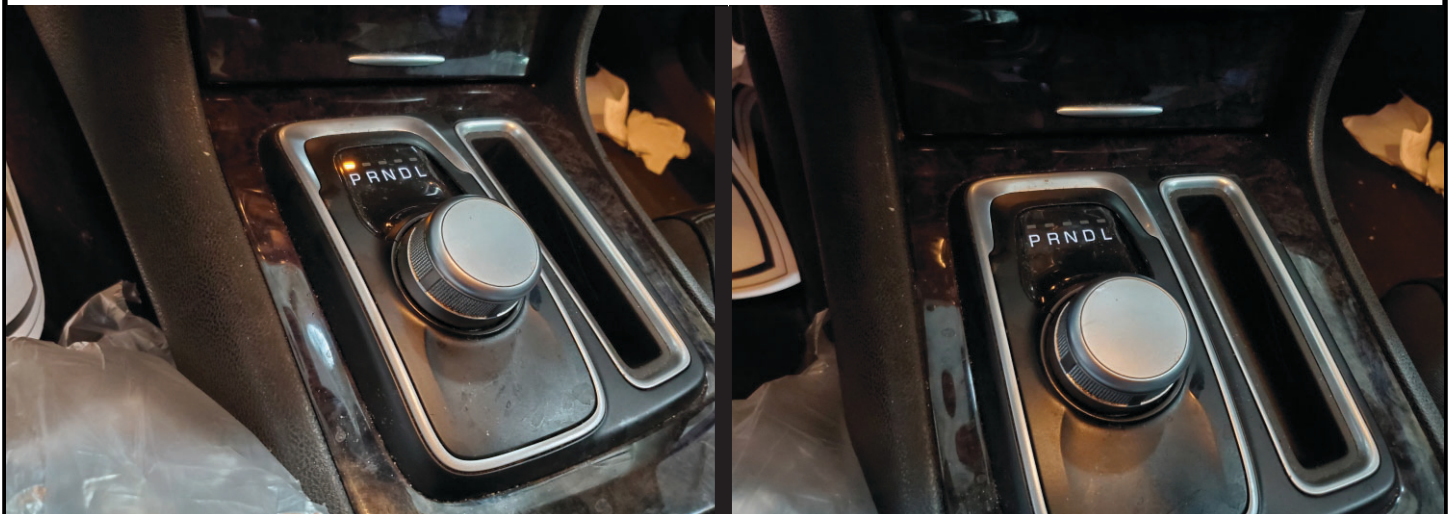
**Figure 2**

The "P" lamp is flashing on the console, figure 2, above the rotary shifter and on the instrument cluster. The cluster also displays error messages, figure 3.

**"P" LAMP FLASHING**

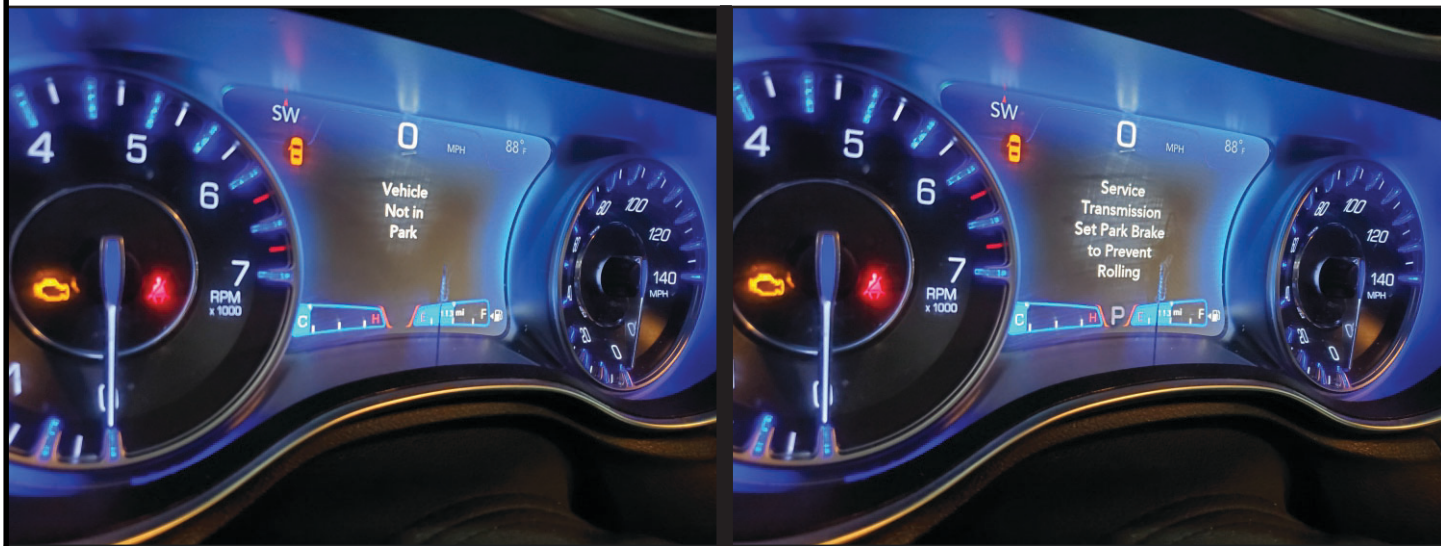
**Figure 3**

**WARNING MESSAGES DISPLAYED ON IC**

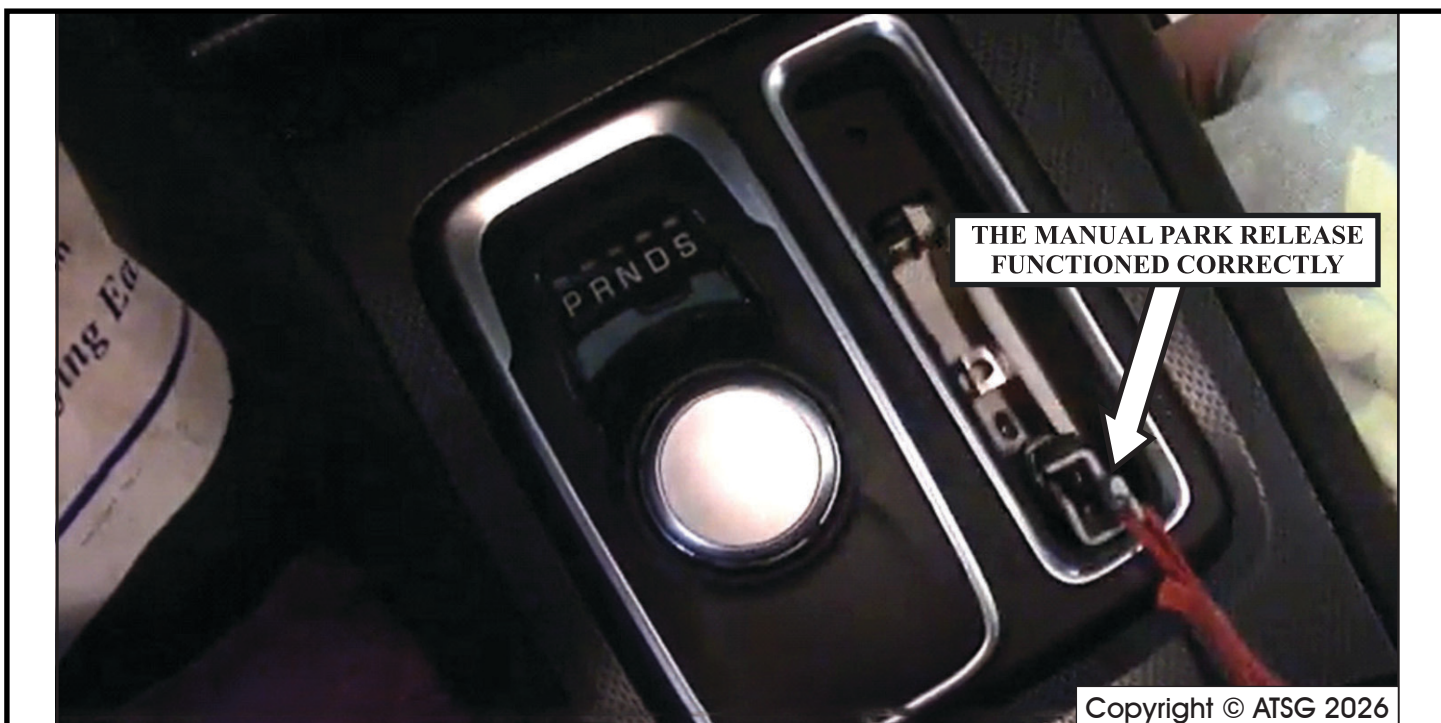
**Figure 4**

The purpose of diagnostic code P1B13 is to detect a disengaged park pawl when the PARK position is commanded and the conditions to engage PARK are met. A binding or obstructed Manual Park Release can cause this.

The manual park release was found to be unobstructed and operating properly, figure 4.

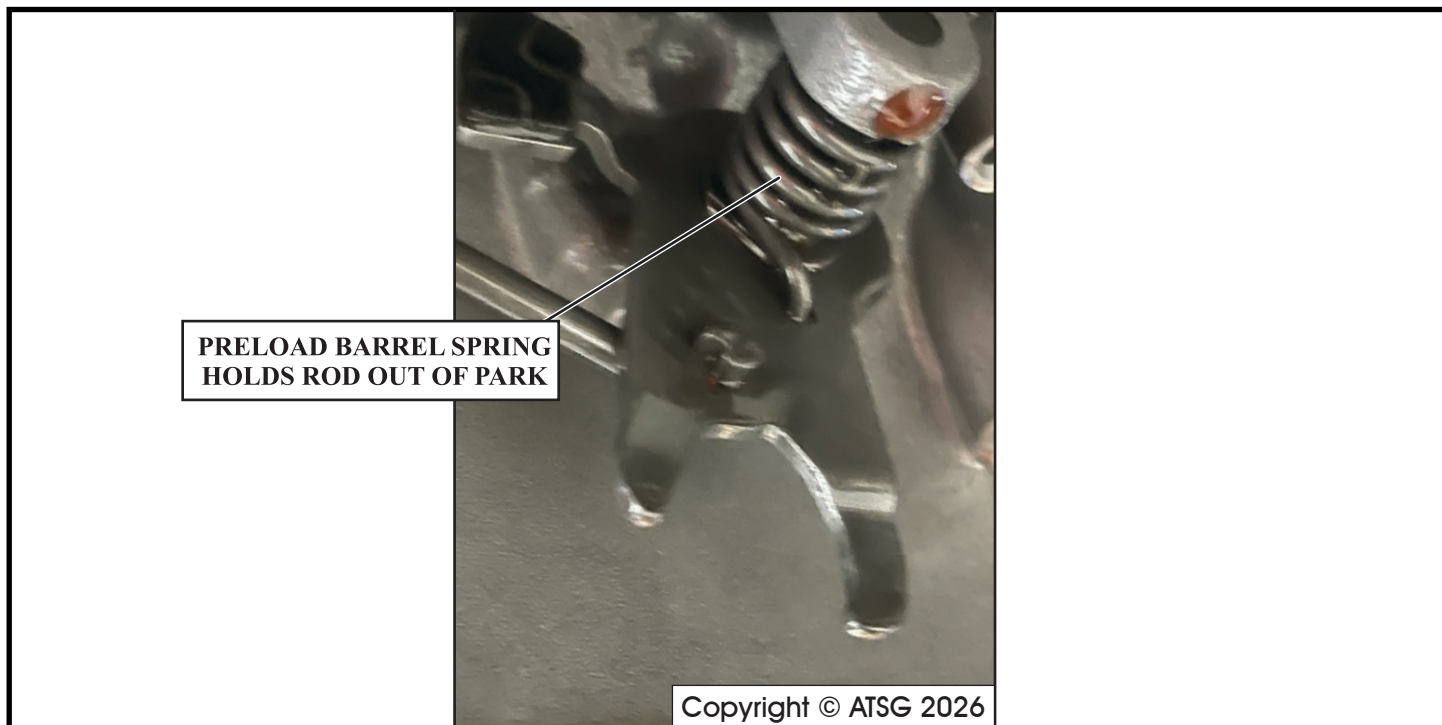
**Figure 5**

**CAUSE:** The Park-By-Wire uses a preload barrel spring, figure 5, on the park rod to push the rod into park. Solenoids are used to push it out of park and hold the rod in the out of park position. There is a sensor built into the TCM lead frame that monitors the position of the park rod, figure 6. This sensor had gone bad and was unable to determine the position of the park rod.

**CORRECTION:** Replace the Transmission Control Module.
