**GM 8L90****HARSH 6-5 DOWNSHIFTS**

**COMPLAINT:** A 2015 to 2022 Cadillac, Chevrolet or GMC vehicle equipped with the 8L90 transmission may have a complaint of a harsh downshift into fifth gear. Performing the clutch adapt procedure has no effect on the complaint.

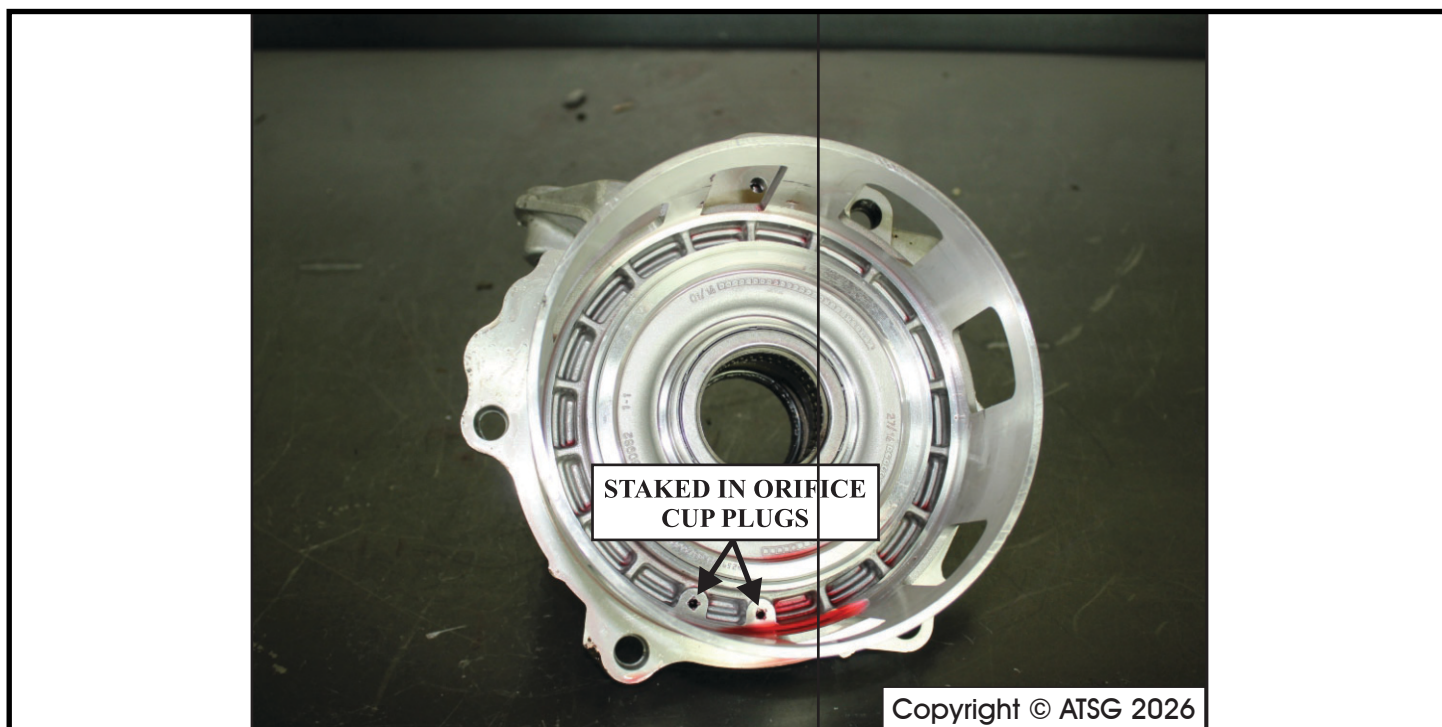
**Figure 1**

**CAUSE:** Upon disassembly of the transmission, the 1-2-3-4-5-Reverse clutch plates were in good condition considering the high mileage on the vehicle. Upon further inspection, the technician notices that the 1-2-3-4-5-Reverse clutch apply piston has two cup plugs staked into the outer perimeter of the piston (figure 1). One acts as an air bleed orifice and the second is a solid plug. The cup plug with the orifice was missing. The hole this orifice cup plug sits in is approximately 0.150". With it missing, the apply rate is compromised.

**CORRECTION:** The 1-2-3-4-5-Reverse clutch is a brake clutch. This means when it applies it will stop the reaction internal ring gear from rotating. If the rate of apply cannot be controlled, not only will adaptations not overcome this problem, the delayed apply stopping the gear train will cause a bump to be felt when it applies on the downshift.

During the transmission overhaul, this piston was replaced. Clutch clearance and transmission end play were set to factory specifications. When road tested, the 6-5 downshift complaint was eliminated and the transmission operated normally.

8L90 1-2-3-4-5-Reverse Clutch Apply Piston.....24272457 Piston.

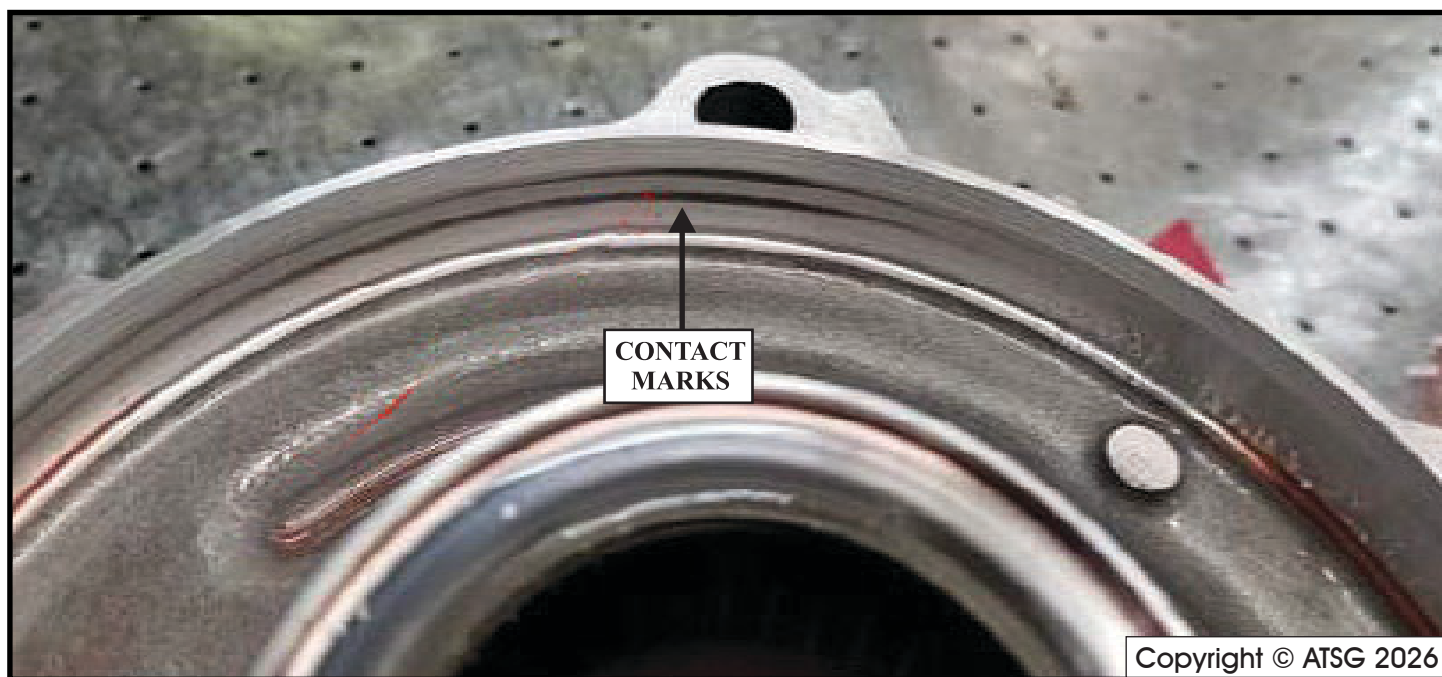
**Figure 2**

In addition to the apply piston missing an orifice, the technician also noticed that this piston made contact marks in the housing (figure 2). There was enough of a mark to consider if the extension housing should also be replaced.

The technician did a TSB search and found GM factory bulletin number 22-NA-246 which states that this is a normal occurrence and has no effect on clutch application. The extension housing does not need to be replaced for this reason. The 1-2-3-4-5-Reverse clutch apply piston also has a triangular shaped anti-rotation lug on the bottom which fits into a recess in the extension housing (figure 3). It is normal for the lug to have a polished appearance on the one side of the lug and the one side of the recess.
