## **NISSAN RE7R01B**

### **GEAR RATIO ERRORS**

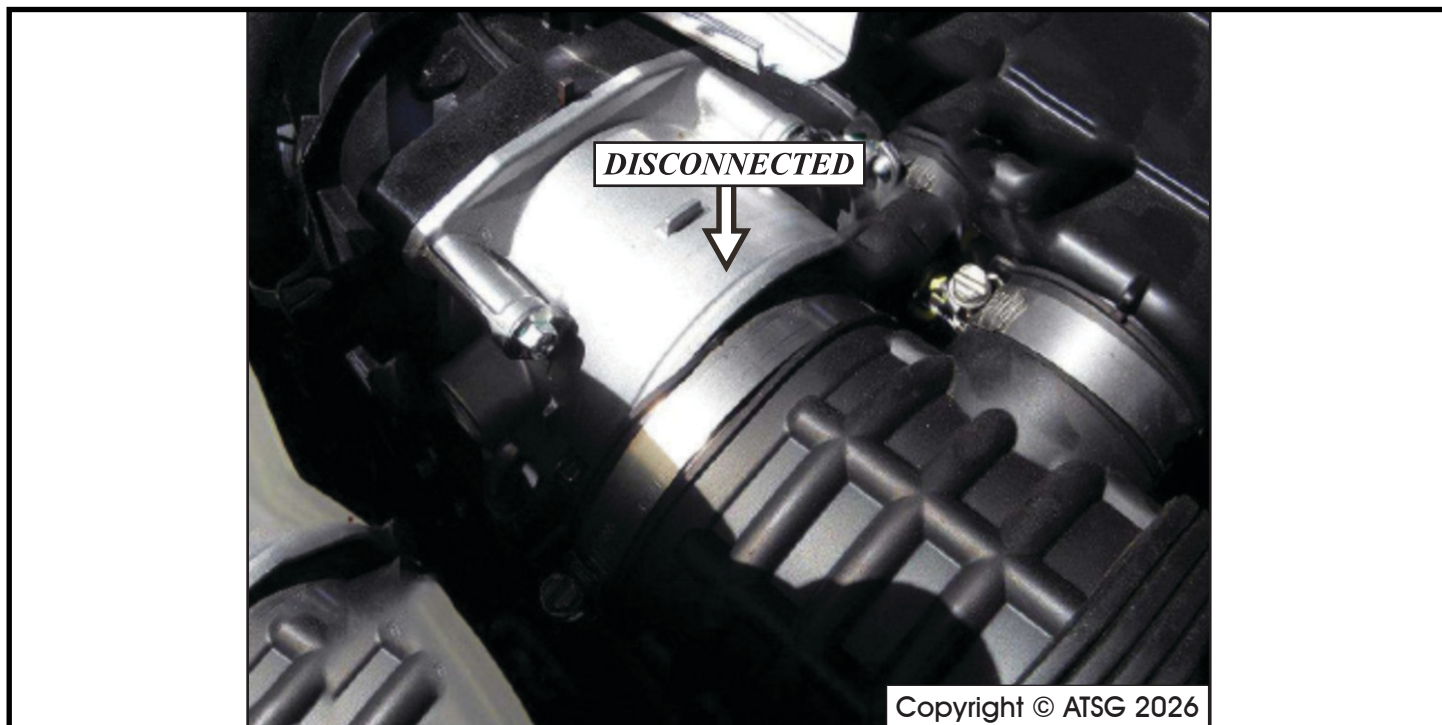
**Figure 1**

**CAUSE:** The cause of this complaint was found to be a loose or disconnected engine air intake duct at the throttle body as seen in figure 1.
