## **FORD 10R80**

### **INTERMITTENT SHIFT QUADRANT**

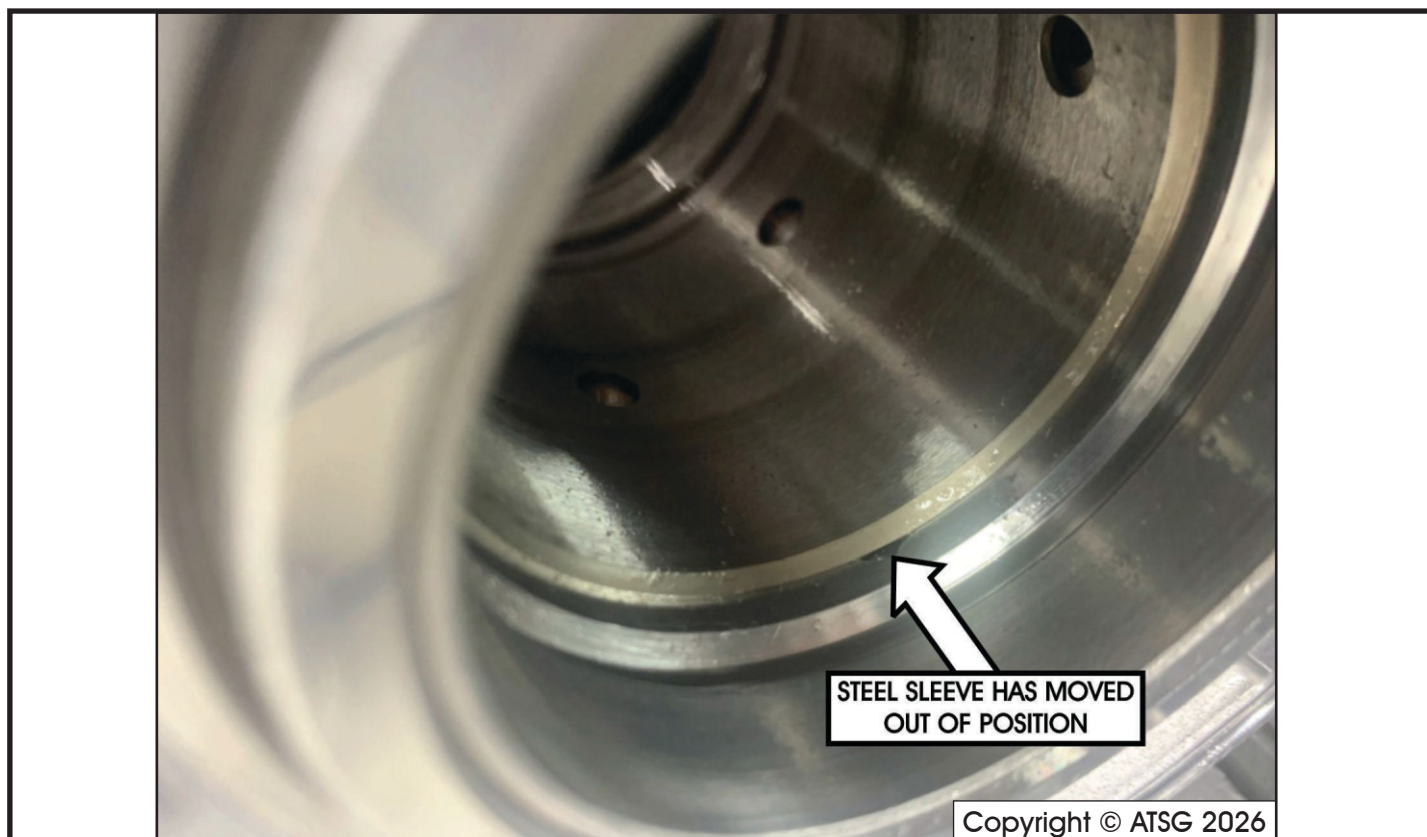
**Figure 1**

It is known that when the sleeve has turned in the C, D, and F drum, shift error can be intermittent which can cause P07F7 to set (figure 1). However, there has never been any reports in the past that the shift quadrant lights being erratic simultaneously with shift errors being caused by a drum issue.

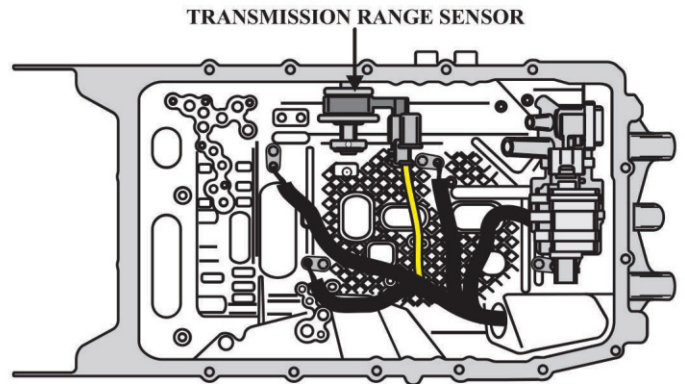
Figure 2

**CAUSE:** The shift quadrant lights are the result of inputs to the PCM from the Transmission Range Sensor (TRS). When the PID for this was viewed in a scan tool, it revealed the same intermittent readings (see figure 2). Strangely enough no codes were set for this erratic TRS signal. When the shop installed a new TRS, the problem which also eliminated code P07F7 from setting again (See figures 3 and 4). This is an example of how important it is to not be a pattern failure repair tech. The CDF drum is a common reason for erratic shifts and gear ratio error codes. In this case, it was caused by the TRS and not the drum.

The 10R80 TRS is a dual sensor which ranges in a duty cycle as the shifter is moved from park to sport positions. When the shifter is moved from park to sport the duty cycle increases. When the shifter is moved from sport to park the duty cycle decreases. There is no manual valve to index.

**CORRECTION:** Remove valve body and replace TRS.
