**NISSAN RE4R01A****AFTER REBUILD STALLS FORWARD & REVERSE**

**COMPLAINT:** A 2001 Nissan Frontier with an RE4R01A comes into the shop for overhaul. After installation of the transmission, the engine would stall anytime it was placed in drive or reverse.

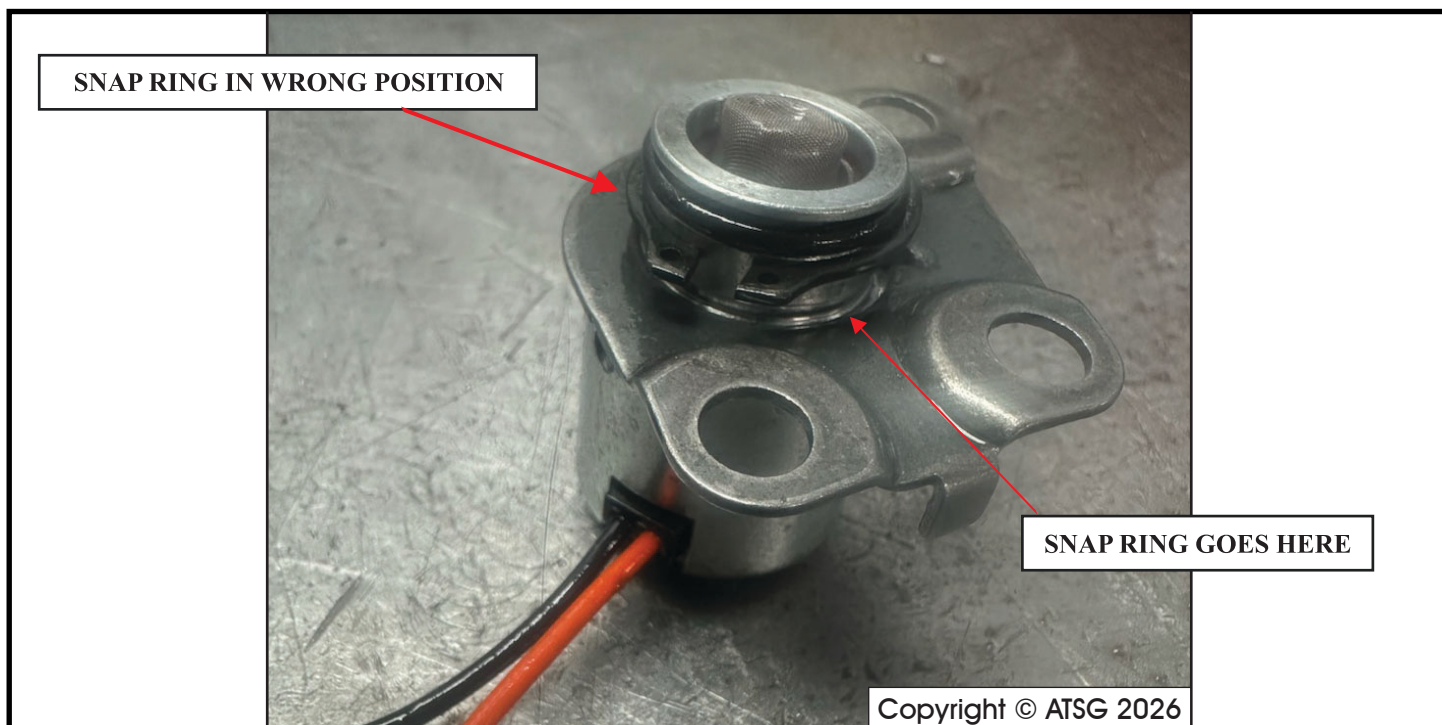
**Figure 1**

**CAUSE:** Knowing the TCC solenoid was changed during rebuild, it was inspected. When the solenoid was removed from the valve body, it was discovered that the snap ring retaining the bracket to the solenoid had not been fully seated into its groove. This caused the snap ring to move out of position as seen in figure 1.

With the snap ring out of place, pilot oil pushed the solenoid up out of the bracket causing it to drain. This allowed line pressure at the Lock Up Cap Valve to stroke the Lock UP Control Valve causing the converter clutch to apply. Refer to figure 2 for a view of the Lock Up Cap Valve and Lock UP Control Valve. This valve line up is referred to in a hydraulic diagram as the Torque Converter Clutch Control Plug (figure 3).

**CORRECTION:** Reposition and secure the snap ring into its correct location (figure 4).

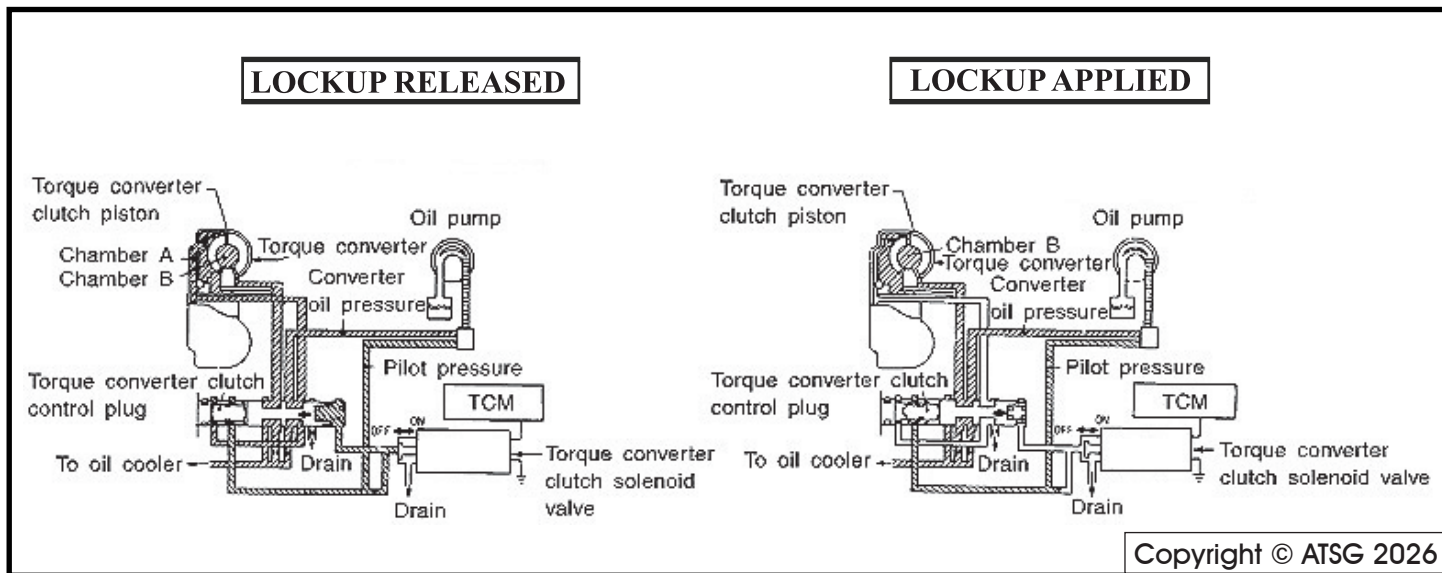
**Figure 3**

Once the vehicle is started and is placed into gear (Drive or Reverse), line pressure is sent to the control valve where it is then directed to the cap valve as seen in figure 3 (left side hydraulic). To prevent the lock up valve from applying, pilot pressure is sent to the normally closed solenoid and the spring side of the valve. With oil on both sides of this valve line up, the assembly is held in the converter clutch release position.

When the solenoid is energized, it will exhaust the pilot pressure used to hold the valve assembly in the release position. The Lock Up Cap then pushed the lock up control valve to the right, into the converter clutch apply position (figure 3 right side hydraulic).

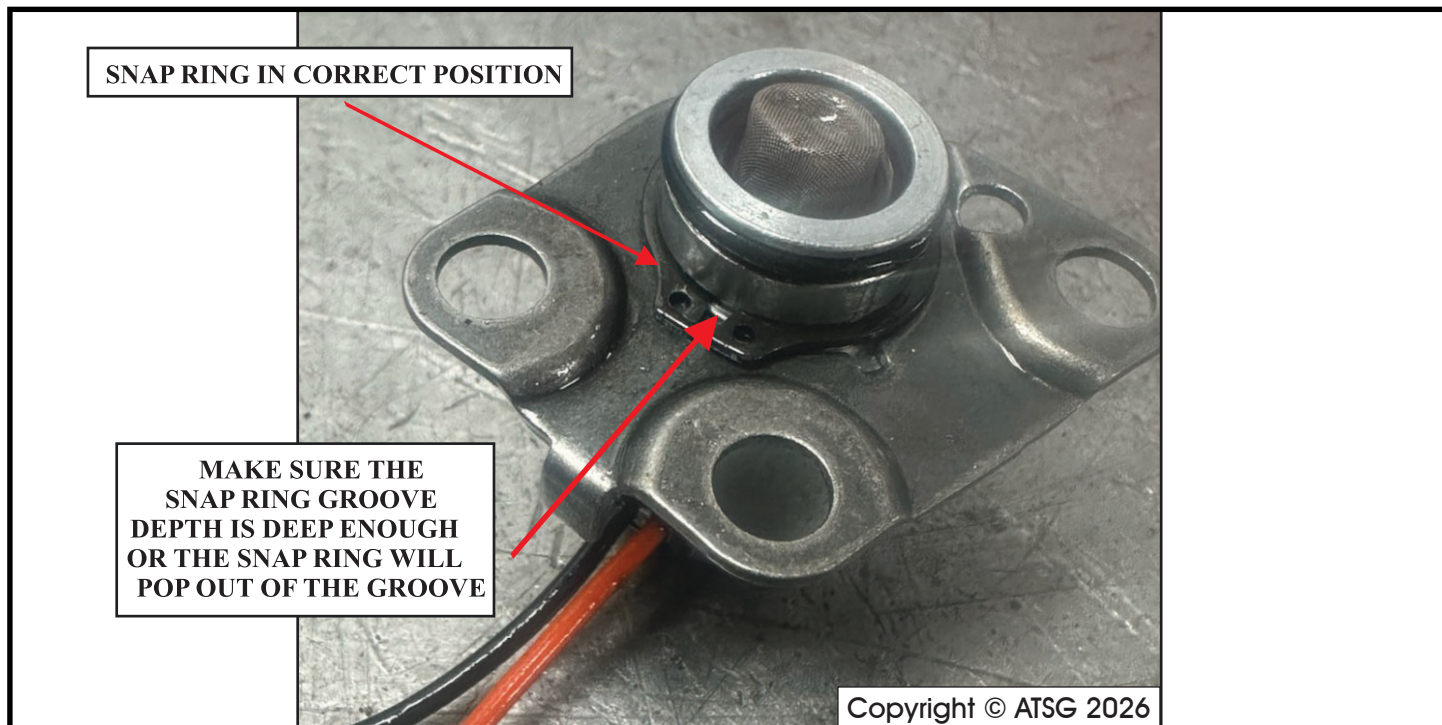
**Figure 4**

NOTE: ATSG has encountered solenoids that were made with too shallow of a snap ring groove allowing for it to pop out of place.
