Independent Expert Engineering Investigation and Review Panel

Report on Mount Polley Tailings Storage Facility Breach Media Presentation

January 30, 2015

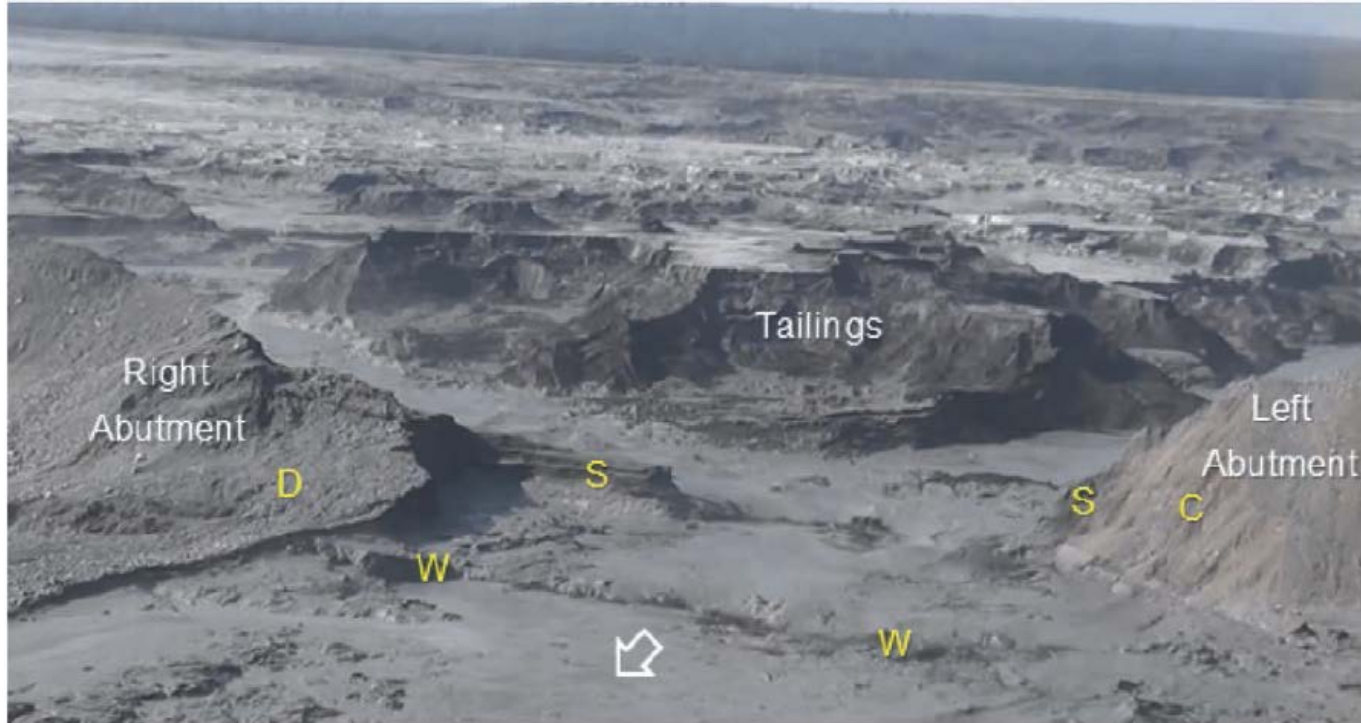
FIGURE 5.1.1: VIEW LOOKING UPSTREAM THROUGH THE BREACH (ARROW SHOWS DIRECTION OF OUTFLOW)

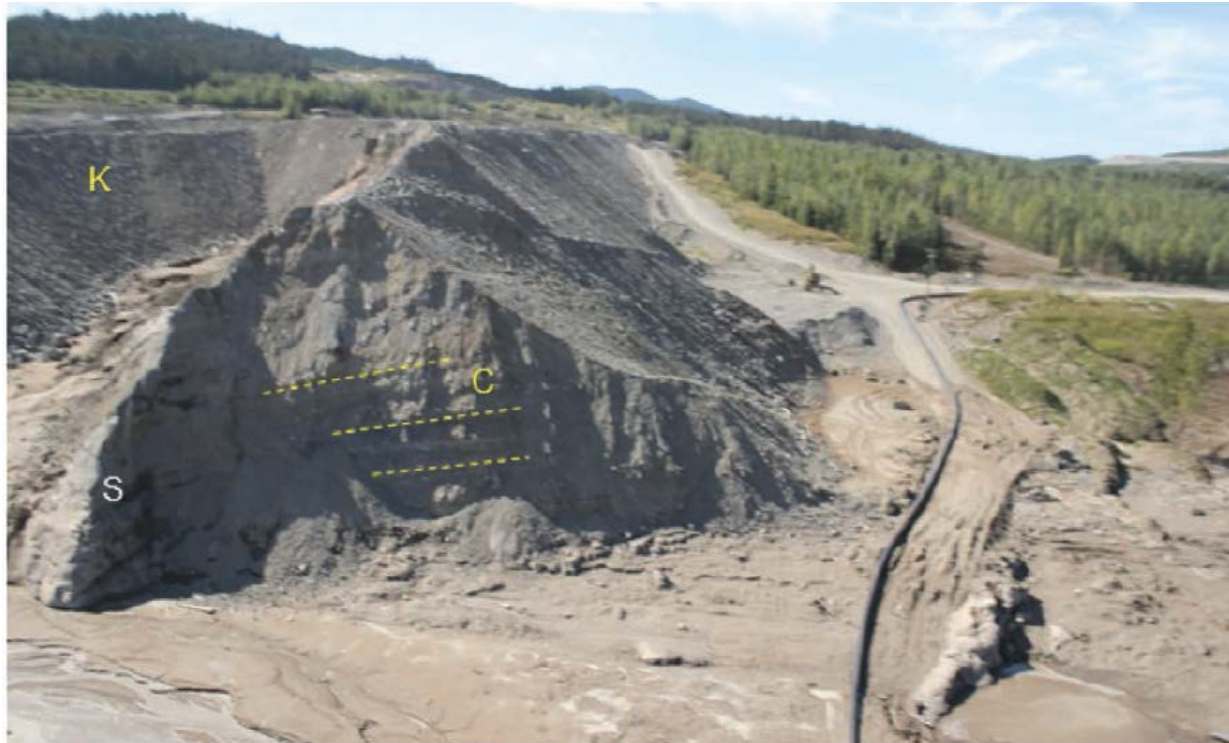
FIGURE 5.1.5: APPARENT BEDDING ROTATION ON LEFT ABUTMENT OF BREACH (SEPT. 4, 2014 PHOTO)

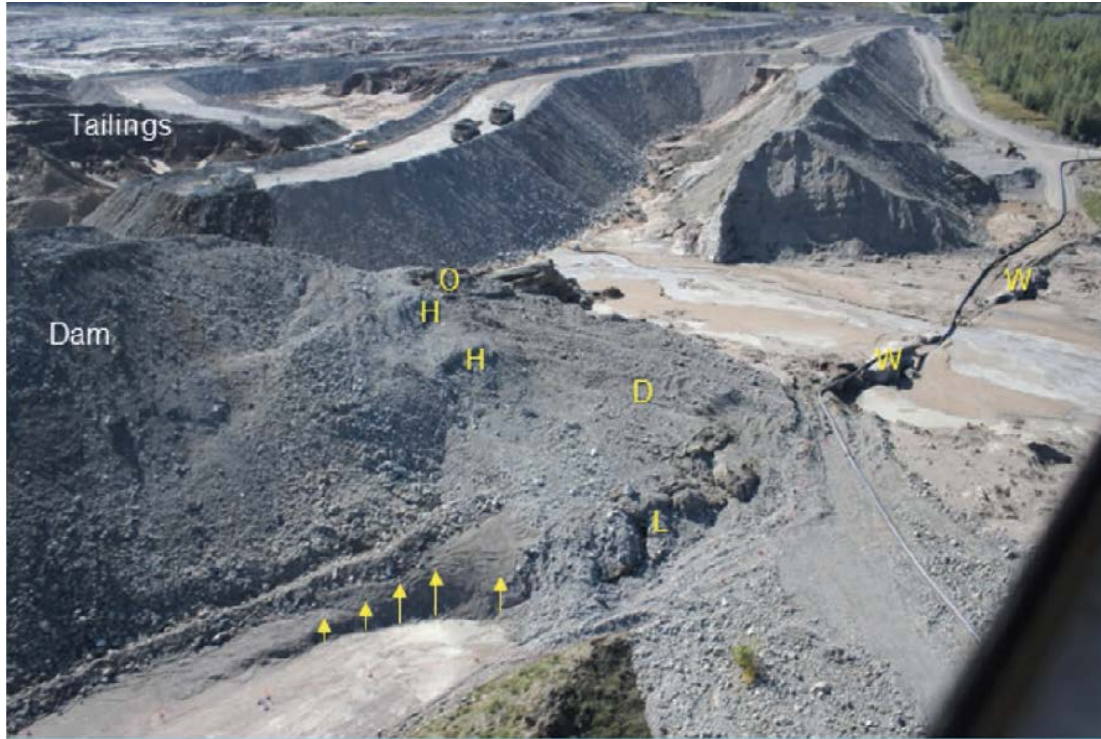
FIGURE 5.1.6: SLIDING-RELATED FEATURES AT RIGHT ABUTMENT (SEPT. 4, 2014 PHOTO)

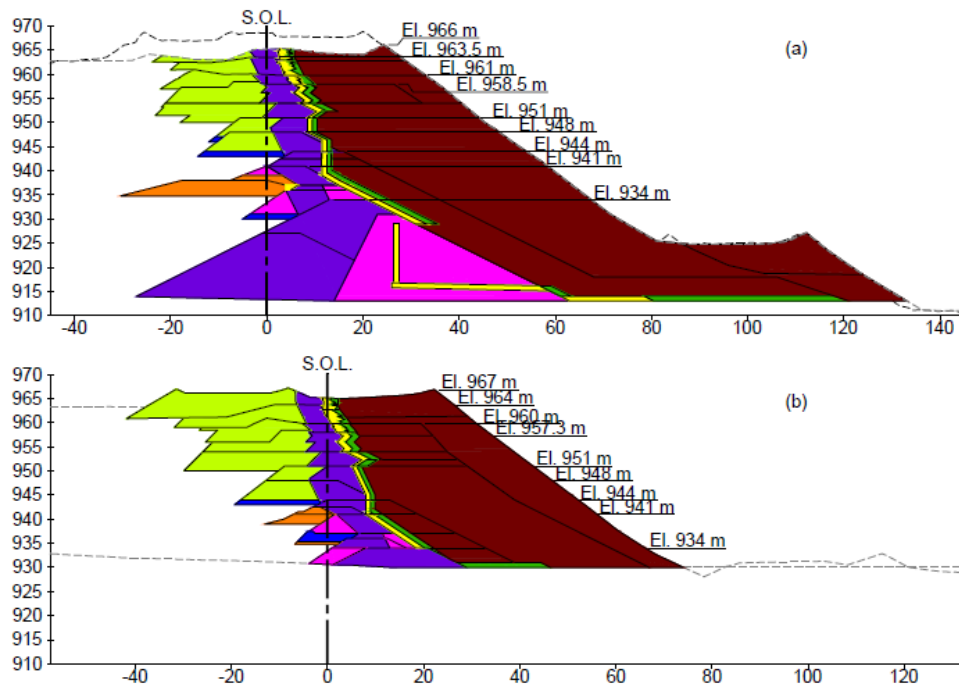
FIGURE 5.4.10: DAM CONFIGURATION ON AUGUST 3, 2014. (a) MAIN EMBANKMENT (b) PERIMETER EMBANKMENT AT BREACH SECTION

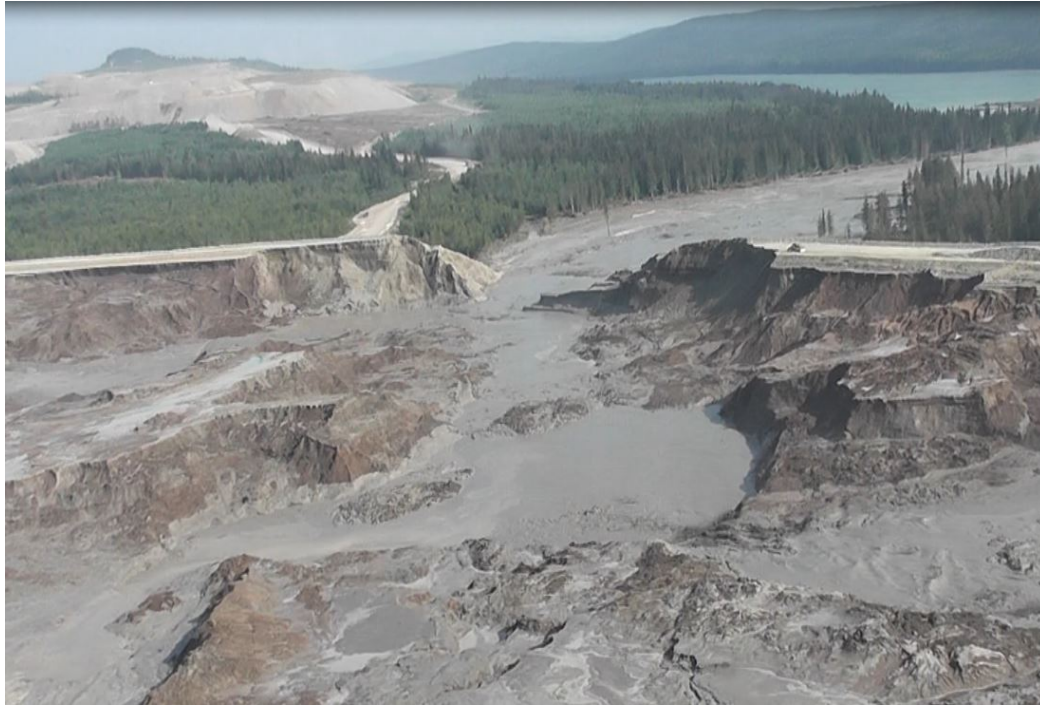
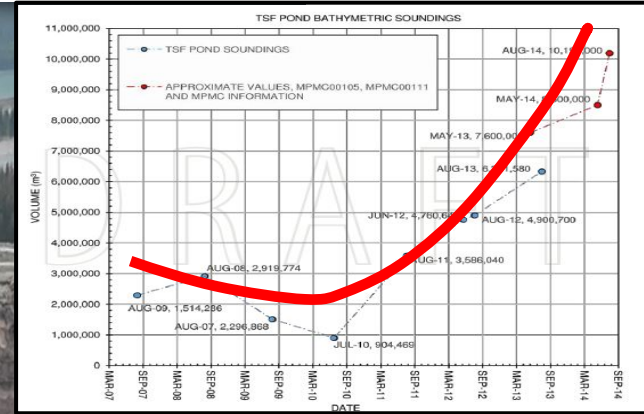
- Most of the tailings were released by erosion from the large volume of water available

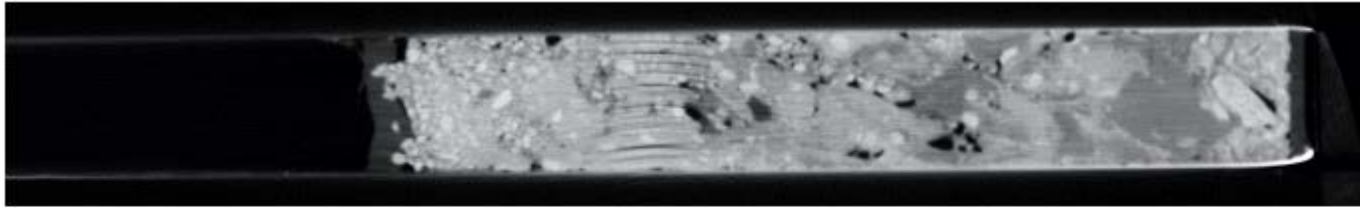
TILL SAMPLE (MR14-104-SA8)
DEPTH: 11.4 TO 12.0 M / EL. 920.3 TO 919.7 M

UPPER GLU SAMPLE (MR14-106E-SA3)
DEPTH: 8.2 TO 8.8 M / EL. 920.5 TO 919.9 M
