Ma On Shan Area 77 Reclamation Failure

CONTENTS OF PRESENTATION

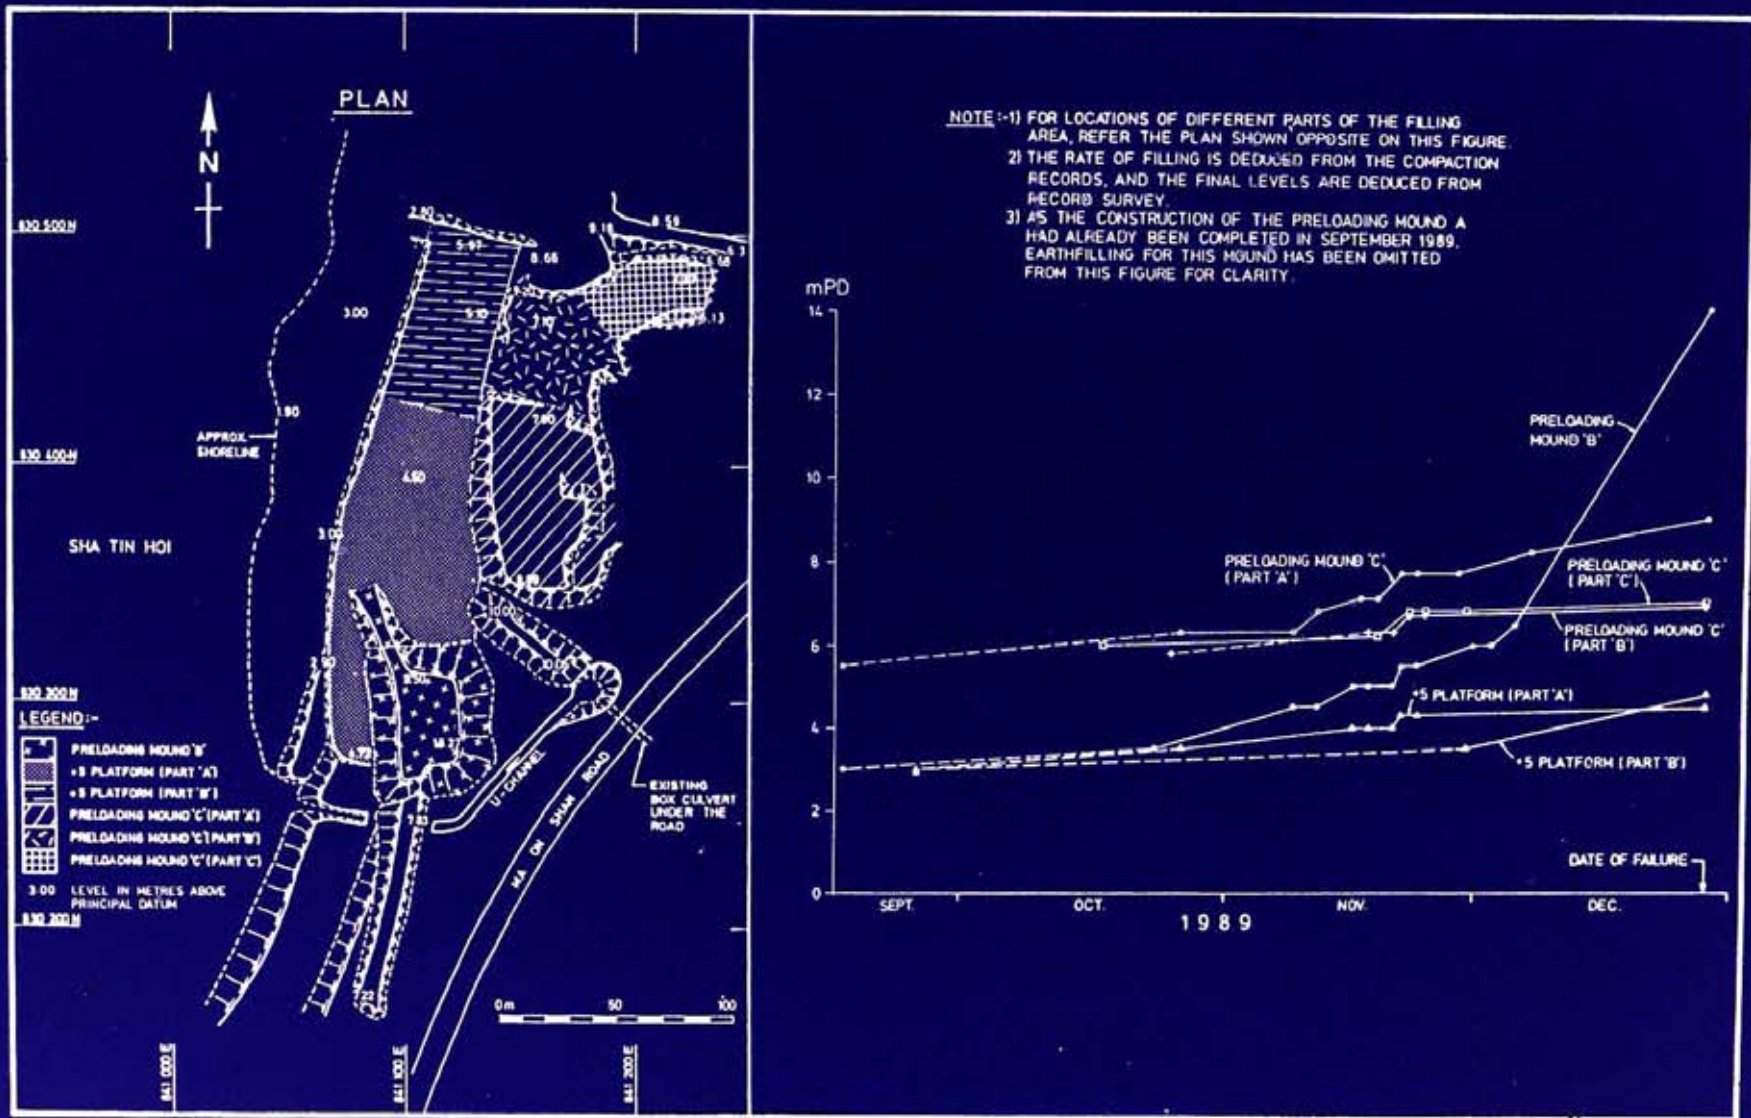
Figure 4 - Progress of Earthfilling for the Three Months Preceding the Failure

- Apparently rapid loading of the area due to earthfilling at the Preloading Mound B is the major factor contributing to the failure.
- The minimum FOS calculated was close to unity and the critical failure surface coincided approx. with the backscarp of the failure and the heaving at its toe.
- There were large variations in the thickness of the marine clay and there was evidence that the seabed might have been disturbed in the earlier reclamation processes. These disturbances, though difficult to quantify, might have contributed to the failure.
- No definite failure surfaces could be picked up in the detailed inspection of the clay samples.
