Blasting related failures

K F Man

Mines Division, CEDD

3 March 2007

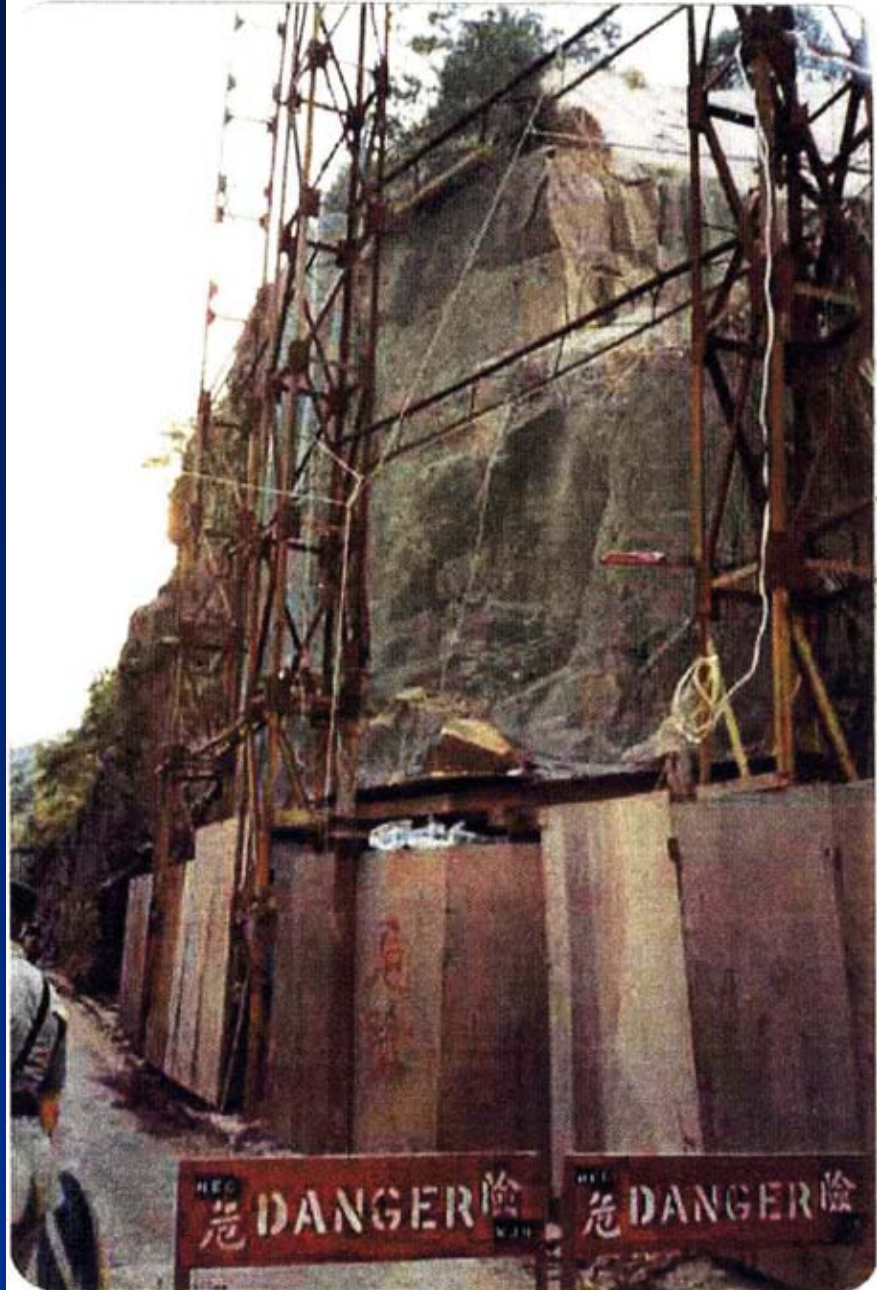
Slope before failure

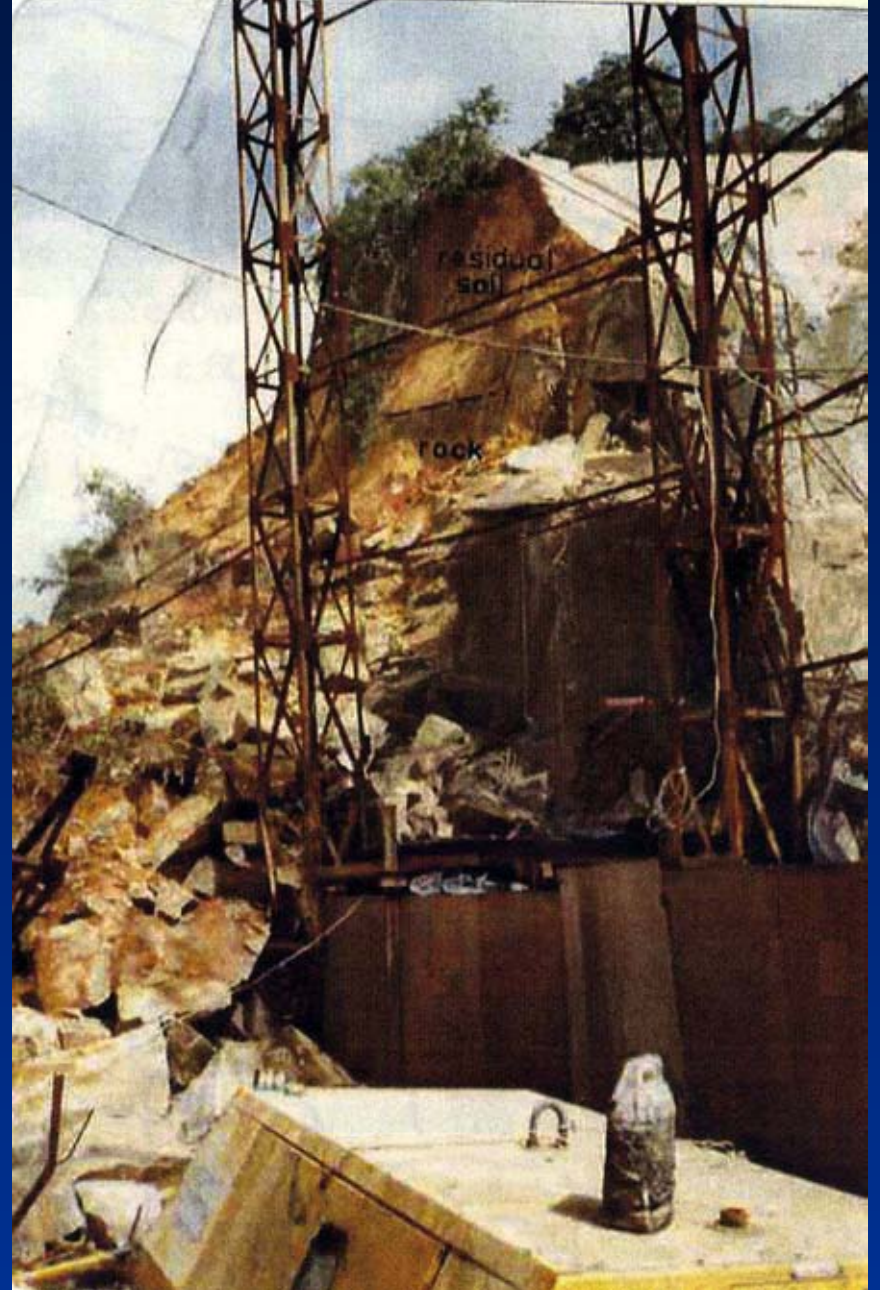
Slope after failure

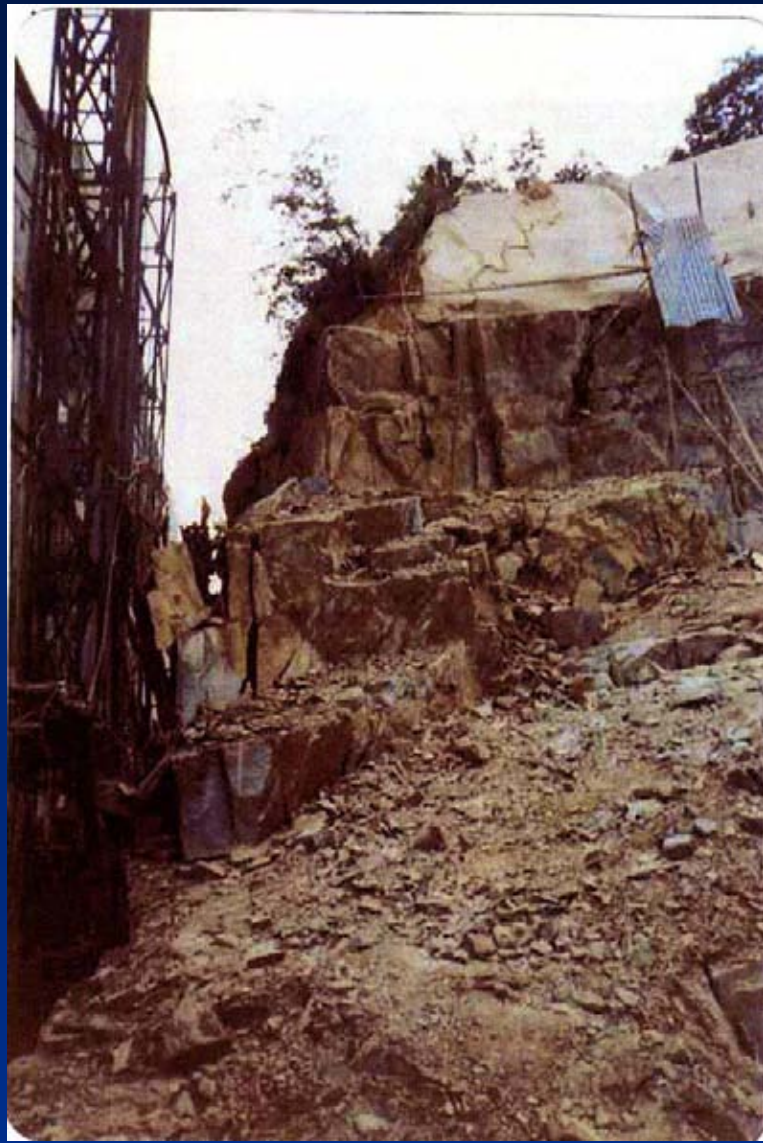
Eastern part of slope after failure

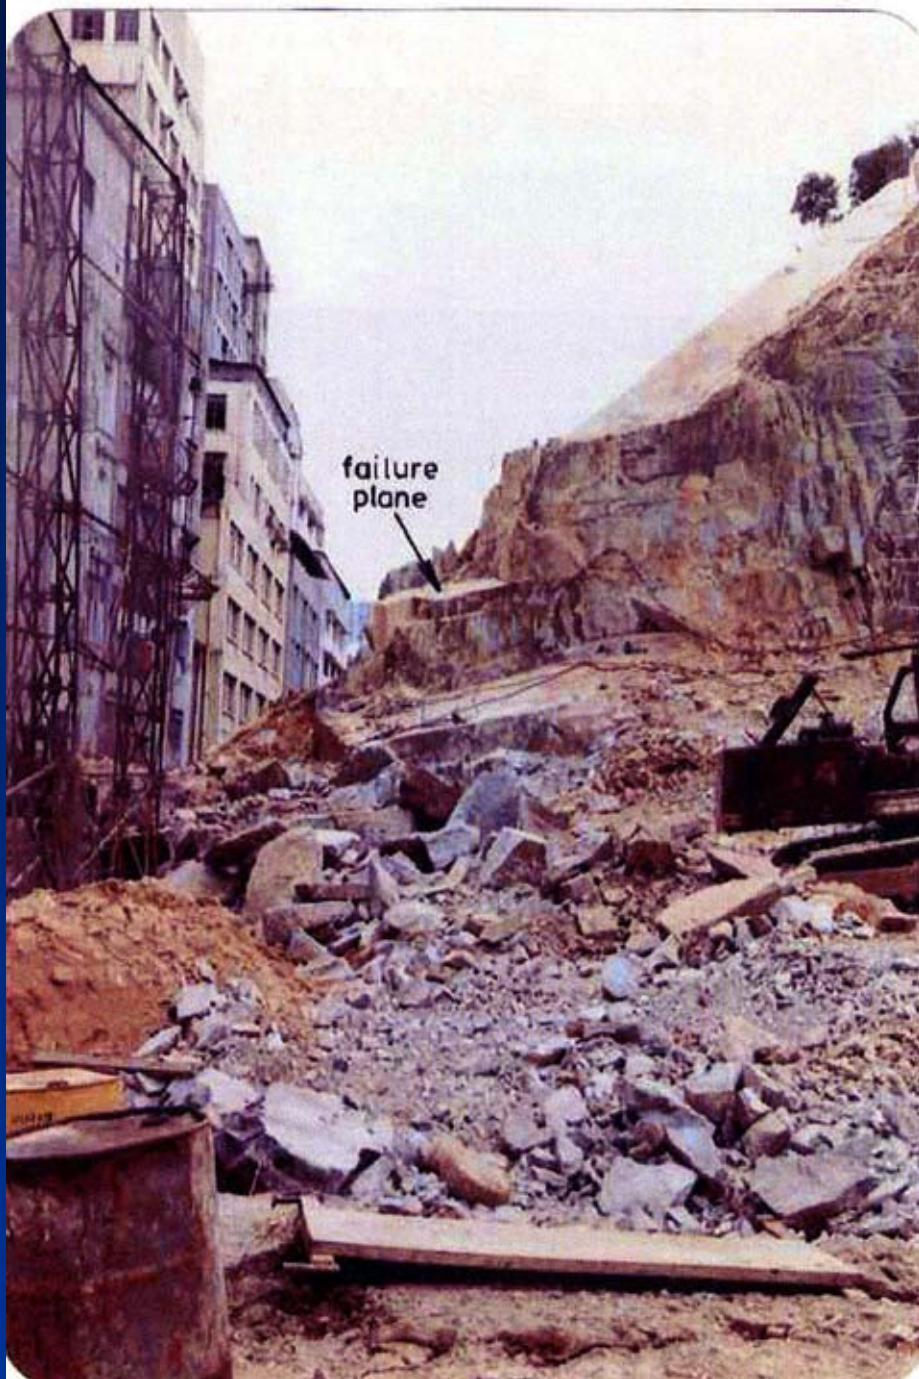
Eastern flank of slope following removal of debris

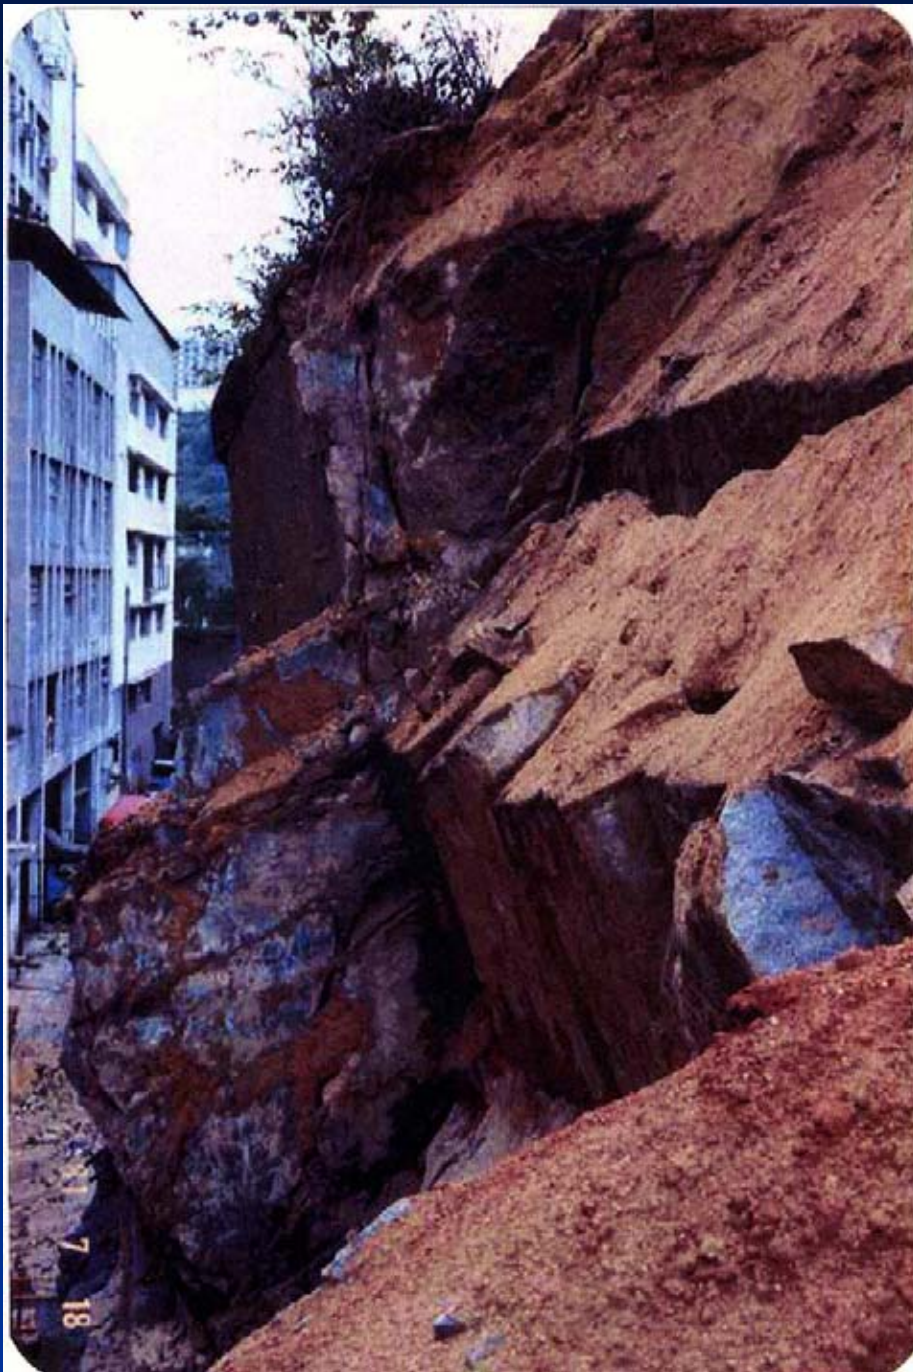
Shattered rock to the west of the main failure scar

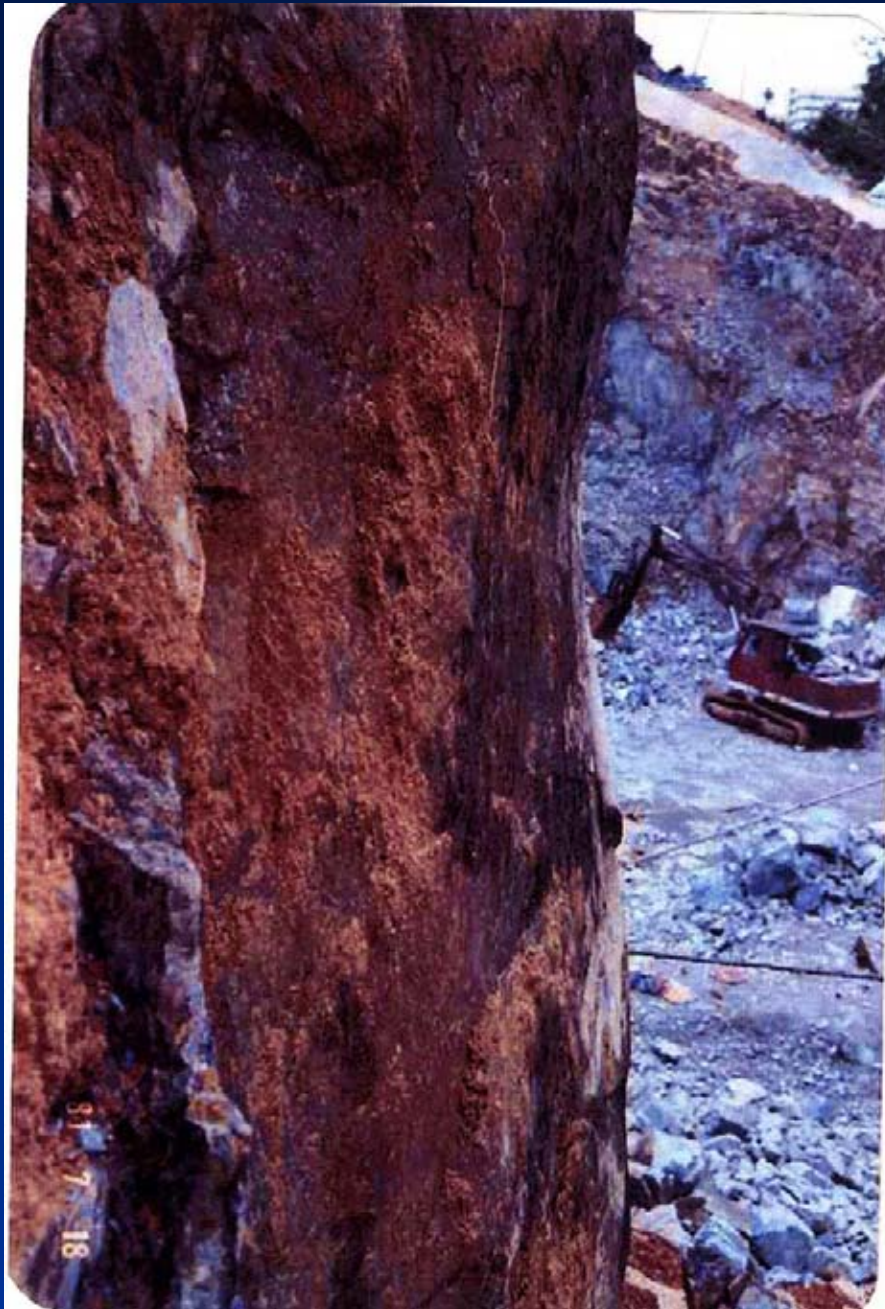
**Release joint from which
block moved in eastern part
of failure**

- Low shear strength and adverse discontinuities
- Ground water pressure (heavy rainstorm before failure)
- Blasting – ppv of up to 17.5mm/s at slip location due to blasting on 4.7.1981

- Initiated by blasting or water pressures or by movement in the upper soil slope or a combination of these factors

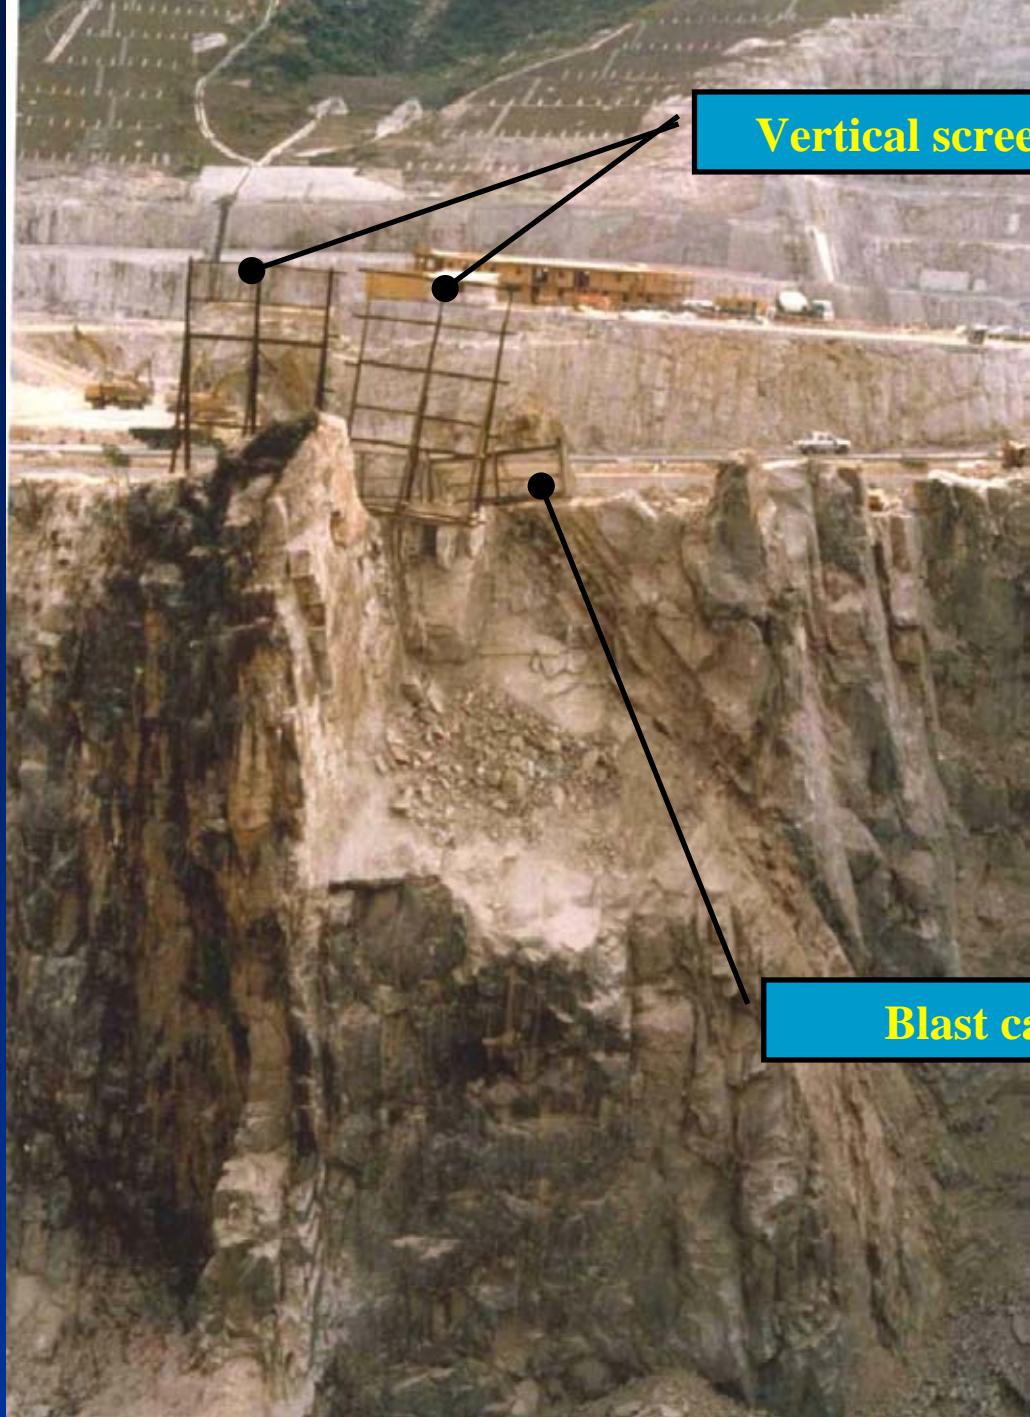
Blasting induced failure on 28.2.1991 causing injuries and damage to properties

Failure debris at slope toe

Vertical screen
fallen from crest

Damaged
temporary fence

Damaged temporary structure
(container offices)

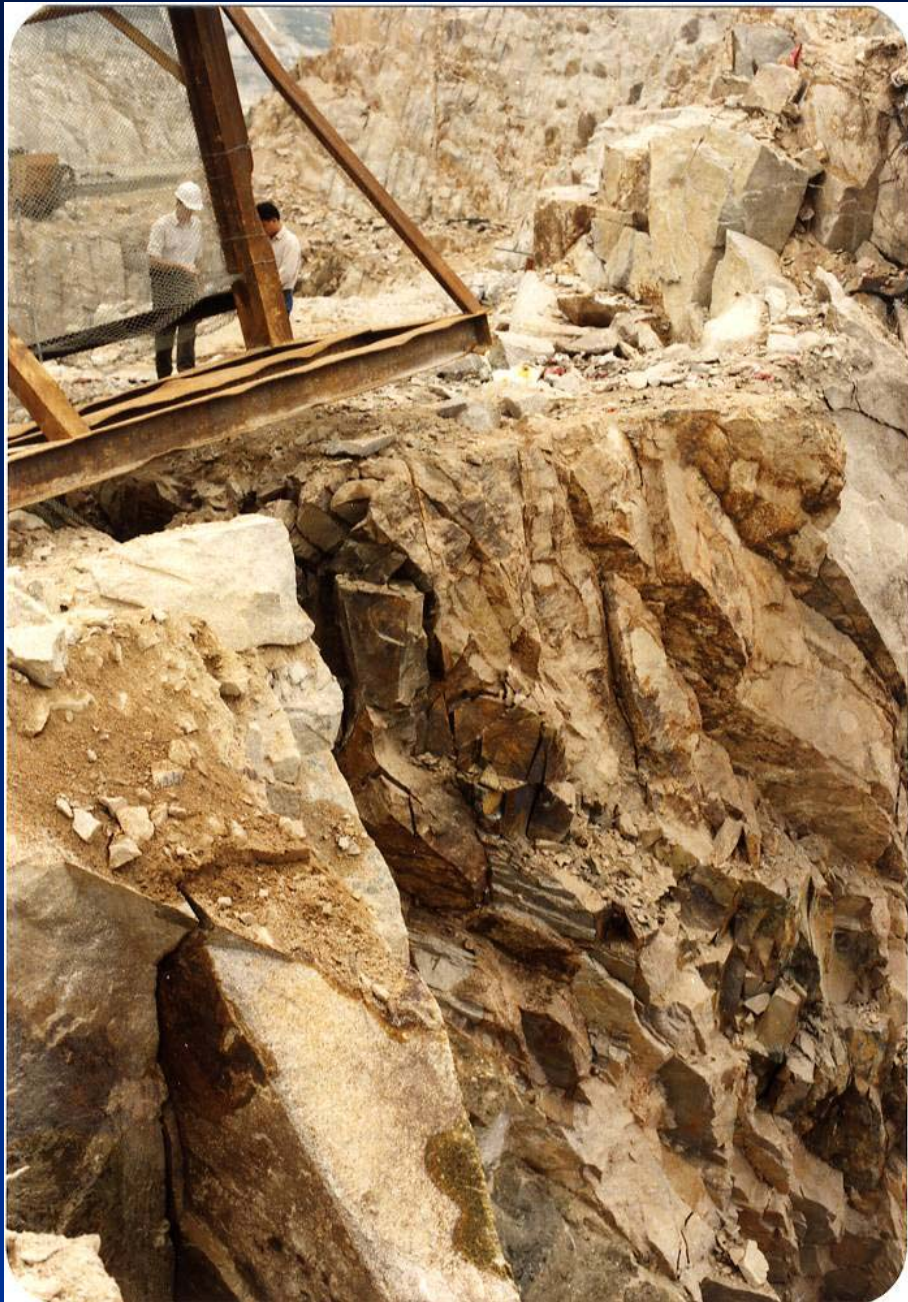
**Western release surface
with the shear zone and
basalt dyke**

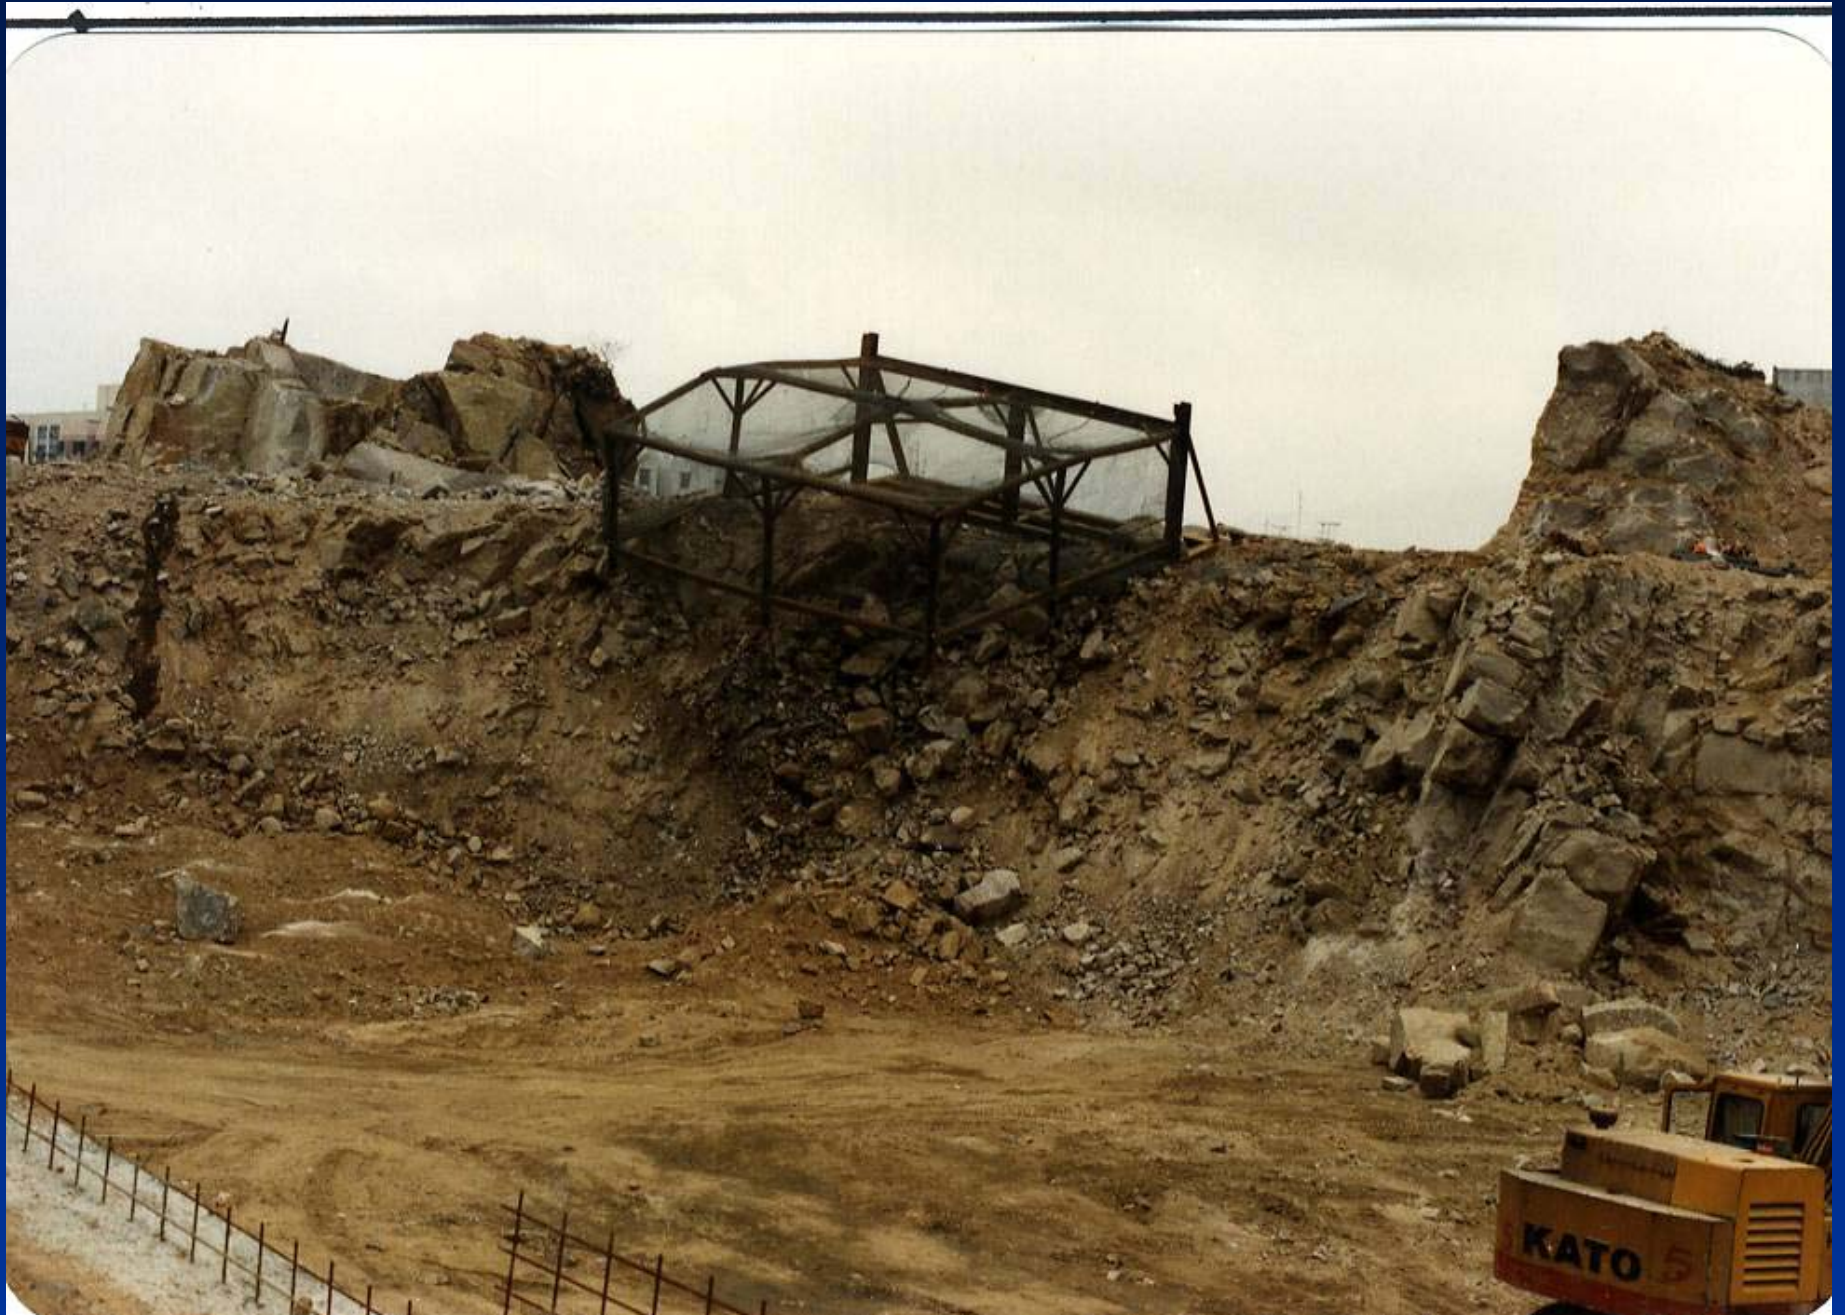
Loosening and shattering of rock at crest

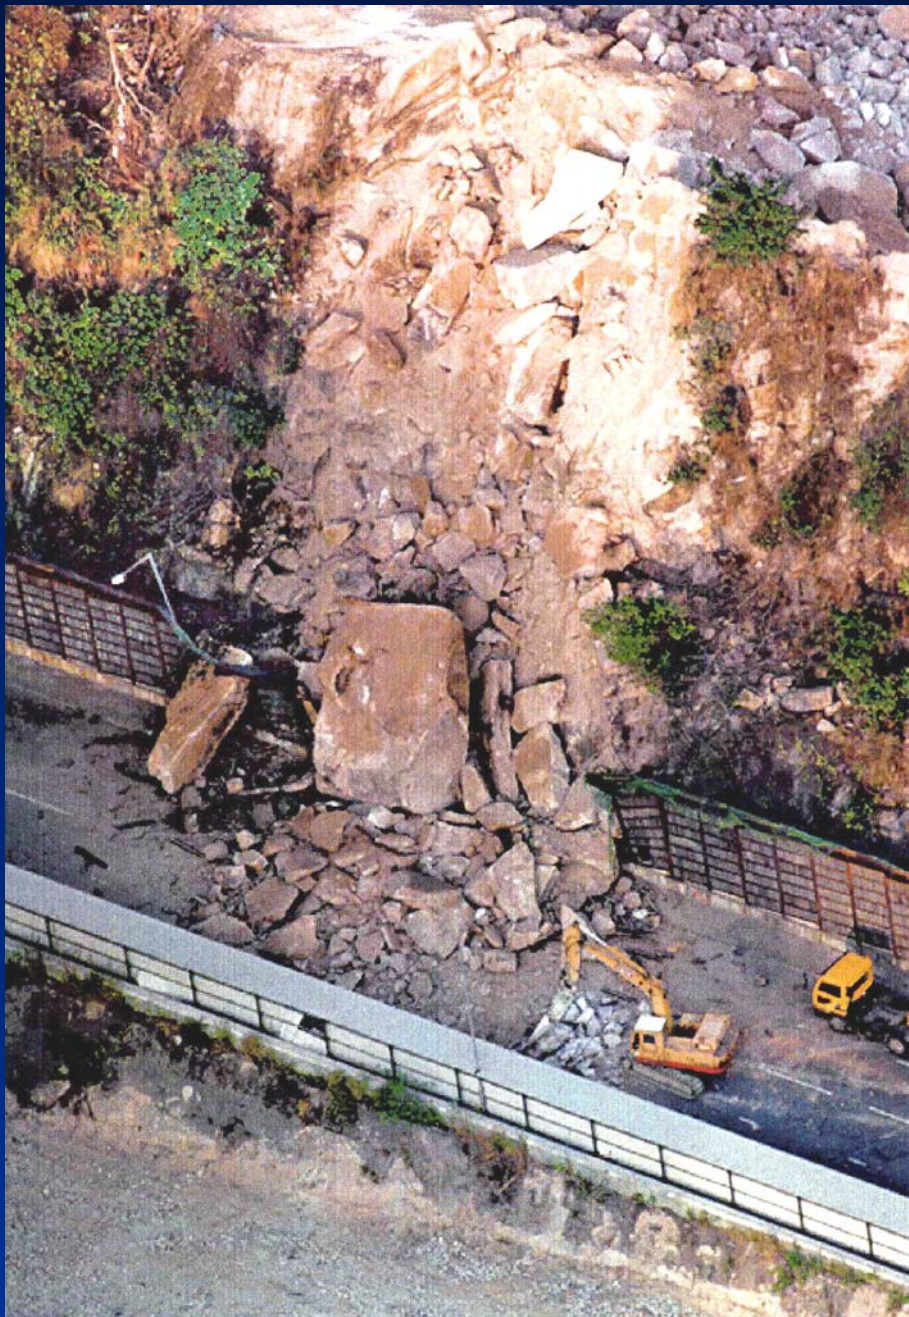
Sau Mau Ping Road slope failure on 4.12.1997

25m high rock slope about 60 deg.

1,000 cu.m. of material collapsed towards Sau Mau Ping Road

Largest rock block of 150 cu.m.

7.1 m high temporary protective fence damaged

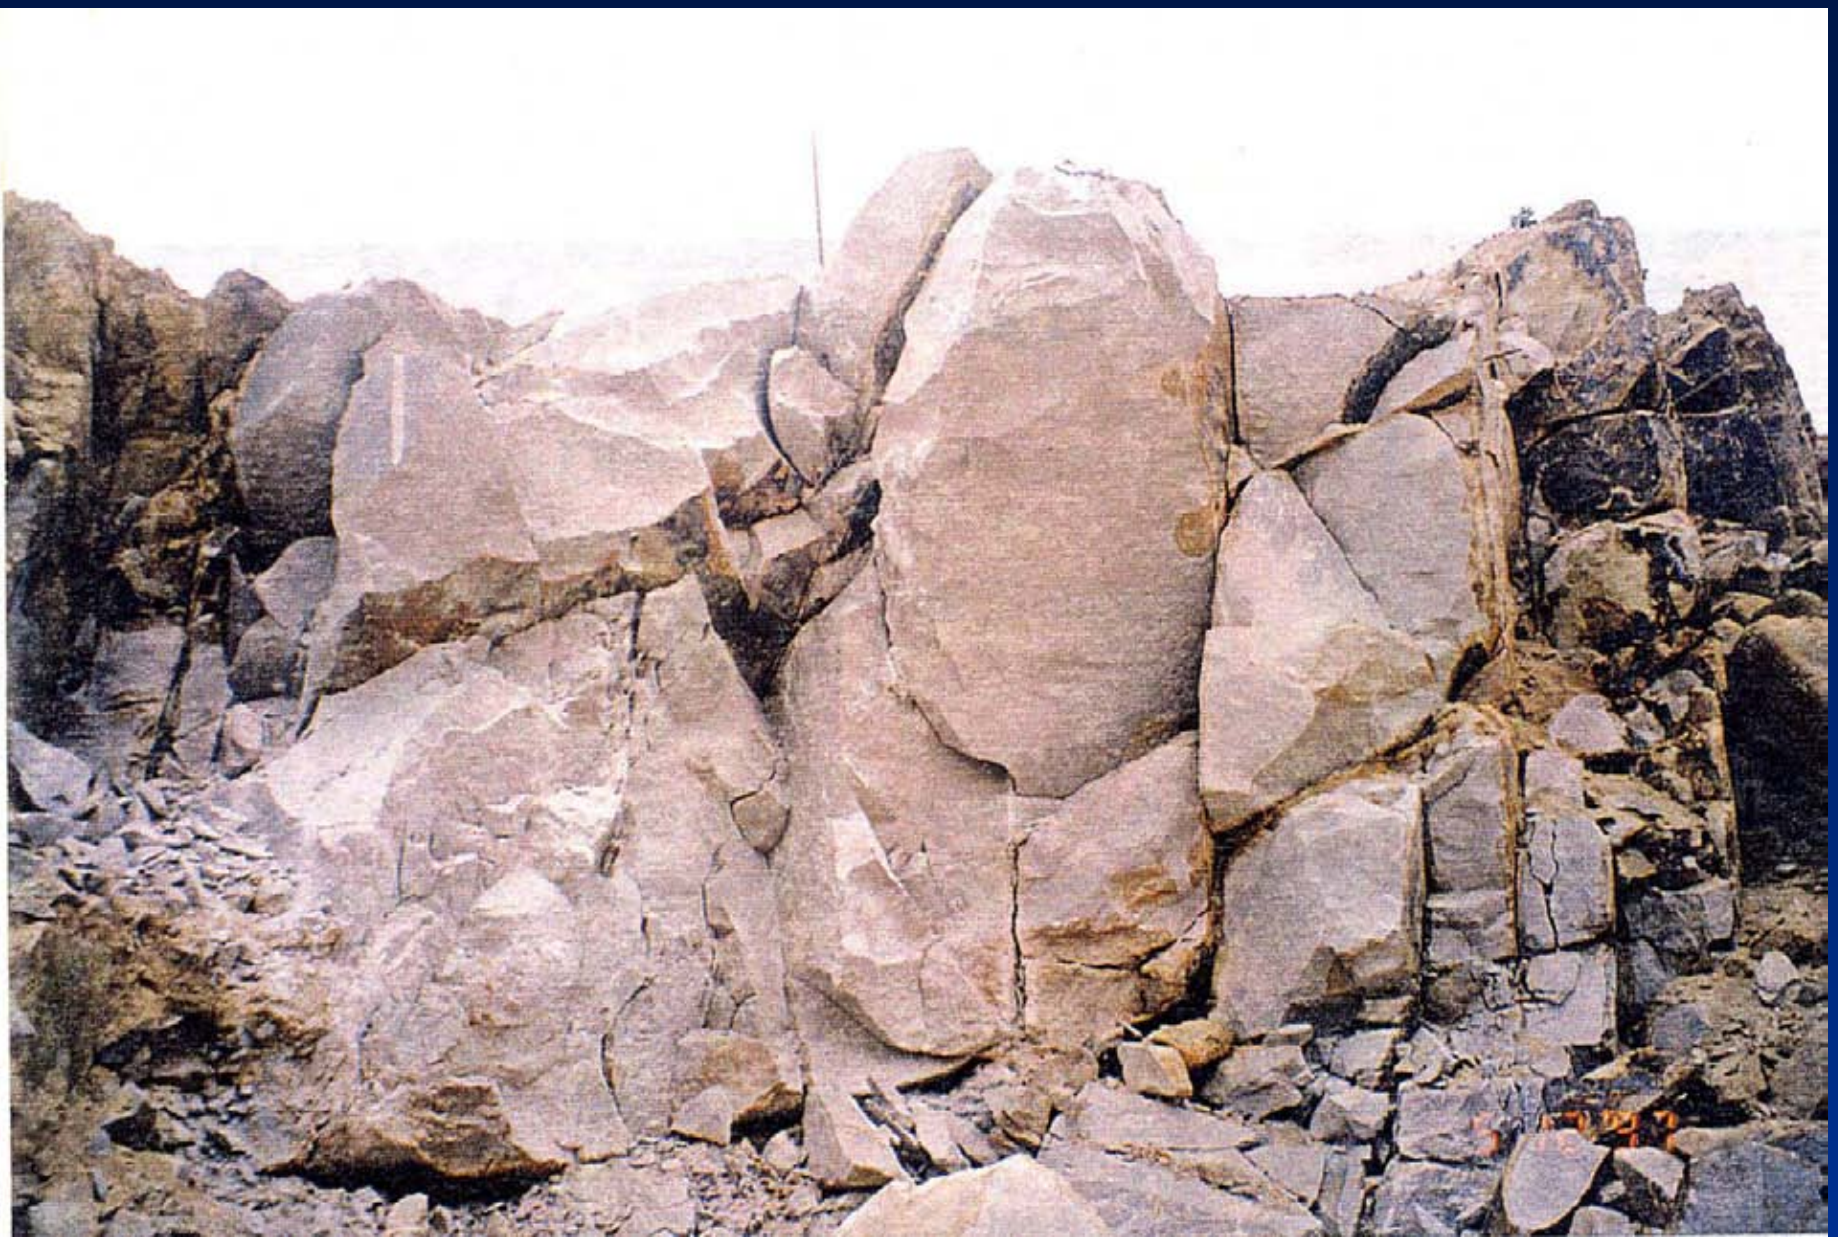
Blast damages observed in the vicinity of the failure site

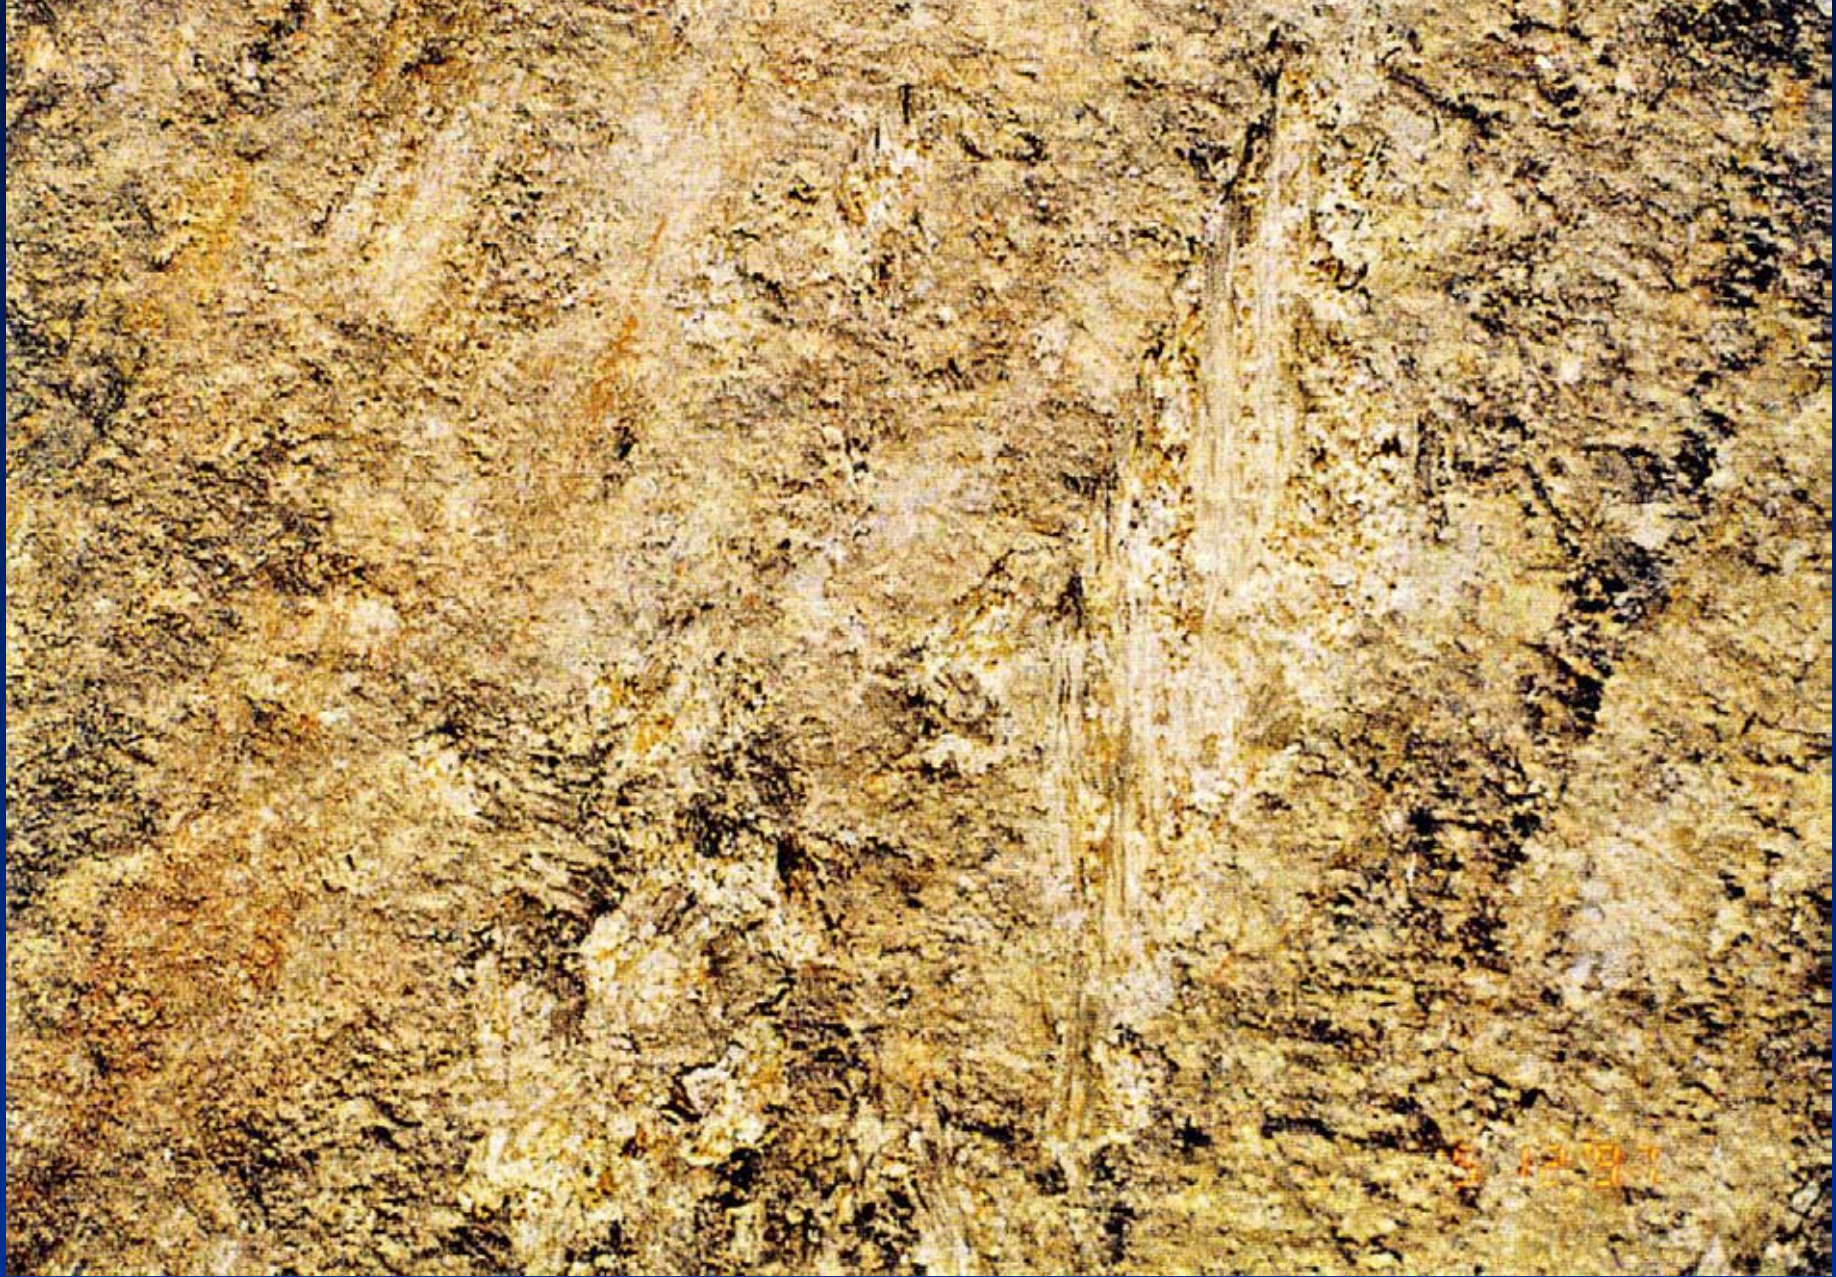
Slickensiding observed on the sub-vertical face of the largest block of rock

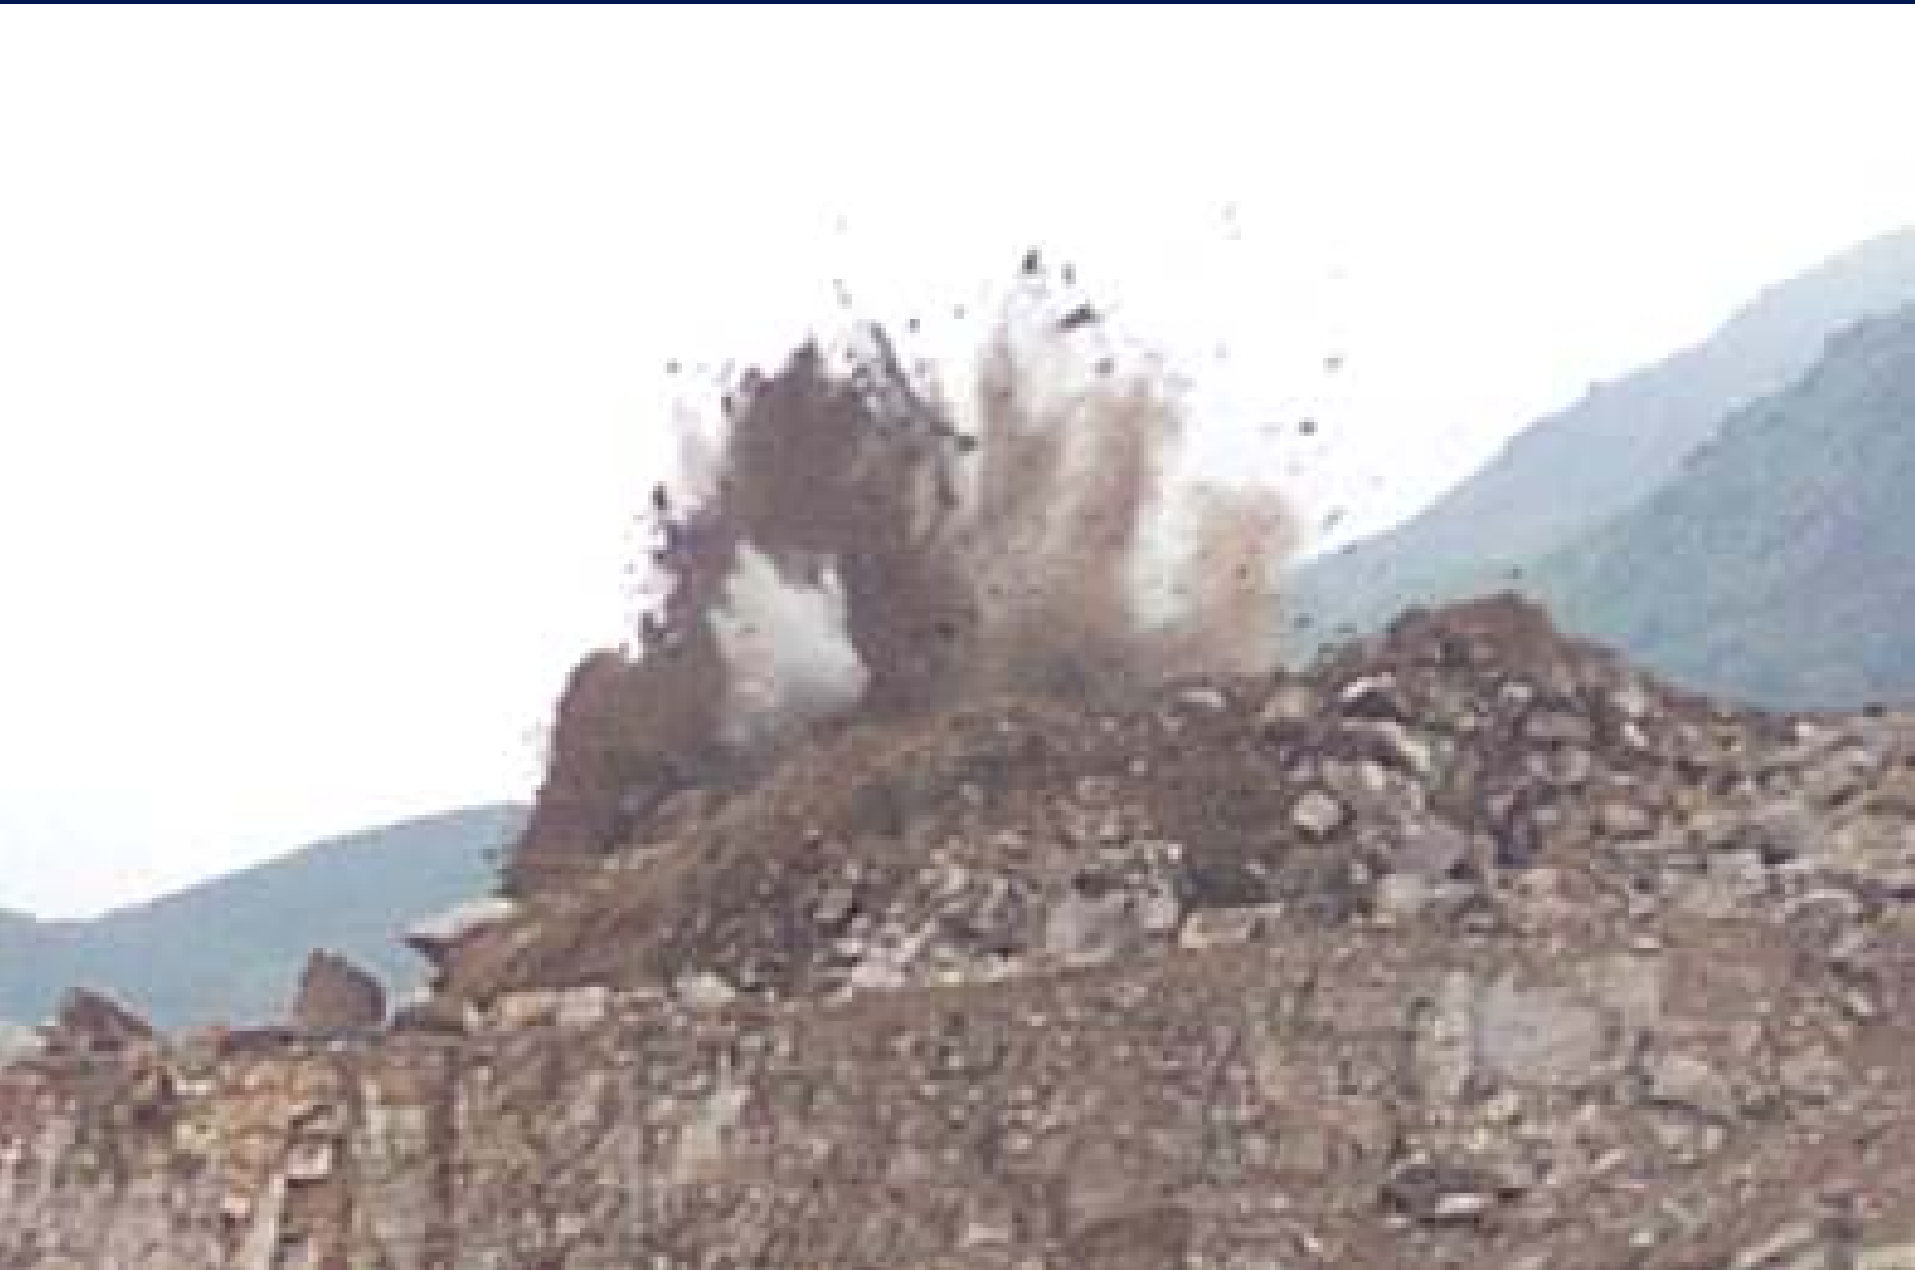
Site formation project flyrock incident 6 June 2003
