Tunnel Failures Hong Kong Case Histories

HKIE Seminar – 3 March 2007

Lorne Woodrow
Mainland East Division
Geotechnical Engineering Office
Civil Engineering and Development Department

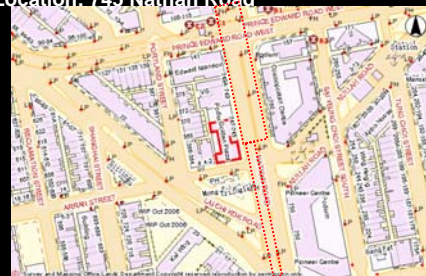
- **Location: 745 Nathan Road**

- **Background**
 - A running tunnel (5m dia, 22 metres bgl) being constructed from a station tunnel (with larger diameter), ground above strengthened
- **The failure**
 - Soil (300m³) flowed into the tunnel, opening a crown hole below Nathan Road

- **Possible causes of failure**
 - Gap existed between the ground treatment above the station tunnel and that above the running tunnel allowing the soil to flow into the tunnel
 - Unexpected ground conditions
 - Inadequate interface arrangement between contracts?
- **Consequences**
 - 100 people evacuated from three buildings
 - Nathan Road closed
 - Major disruption to traffic

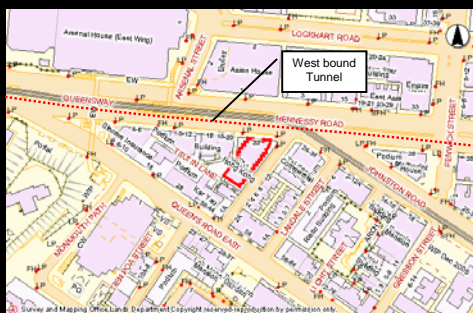
MTR Island Line, 22 Hennessy Road, 1 Jan 1983

- **Background**
 - Westbound tunnel (5.7m dia, 26 m bgl) formed by the drill and blast method
- **The Failure**
 - Water-bearing "fill" flowed into the tunnel, opening a hole at the road above

- **Possible causes of failure**
 - Misinterpretation of the ground condition
 - Blasting went too far, resulting in the tunnel penetrating the rock into soft ground
- **Consequences**
 - Cracks found in the granite masonry of the outside wall of a building at 22 Hennessy Road
 - At least 21 timber piles beneath an adjacent building of 22 Hennessy Road exposed
 - More than 150 people in 18-22 Hennessy Road evacuated
 - The building at 18-20 Hennessy Road reopened 3 hours after the incident and the building at 22 Hennessy Road 6 days later

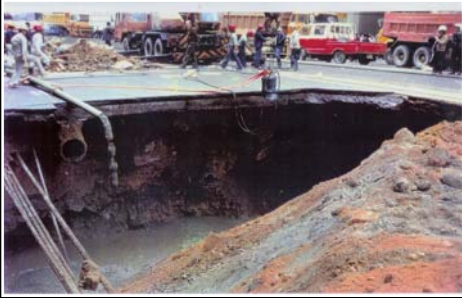
- 1500m³ of material flowed into the tunnel creating a void 100m² by 30m deep beneath the road surface

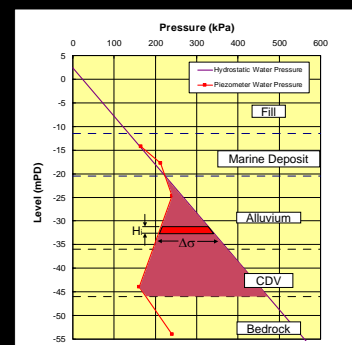
HATS Stage I Project – Tunnel C

Significant ground settlement
