**Sea wall/reclamation failures Part 2**  
**Junk Bay (Tseung Kwan O) Controlled Tip Failure**

By  
**Ir Dr J Premchitt**

**GEO Advisory Report No. ADR 17/84 –  
Investigation of A Failure at Junk Bay  
Controlled Tip**

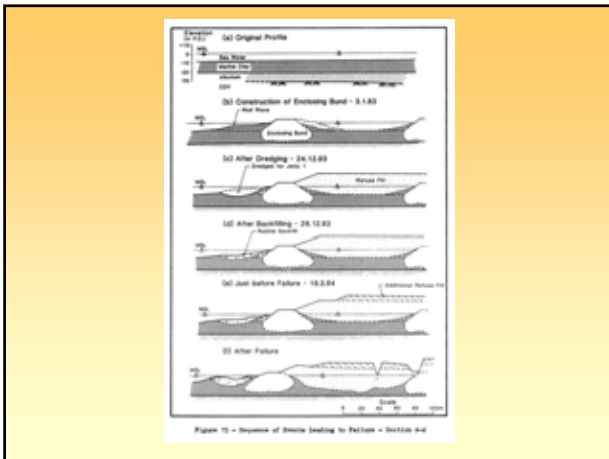
Figure 15 - Sequence of Events leading to Failure - Section A-A

- 3.1.83 enclosing bund built.
- 24.12.83 dredging for Jetty 1 done, refuse filling to about +16mPD.
- 28.12.83 backfill of dredged area completed, refuse fill at about +16mPD.
- 18.3.84 large failure occurred when refuse fill reached a level of +22mPD ... 81 days after backfilling of dredged area.

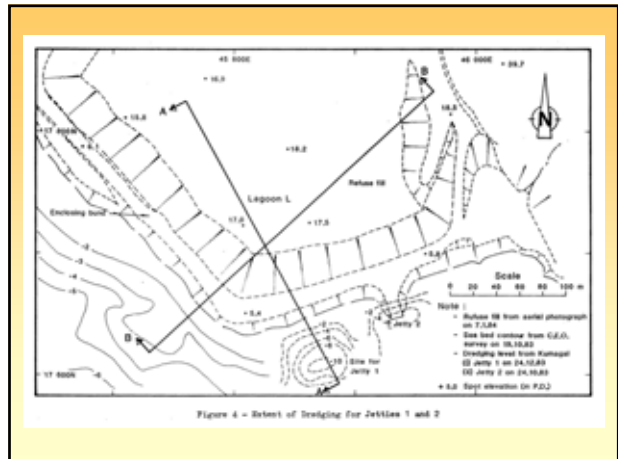
Figure 4 - Extent of Dredging for Jetties 1 and 2

- The bunds did not make full contact with underlying alluvium, hence there is potential for failure through entrapped mud under the bund.
- Localised failures had occurred before on this controlled tip.
- Seabed dredging for Jetty 1 lowered the factor of safety to marginal value locally and caused some small local movements but no failure.
- Main factor is the continuing refuse filling, imposed increasing load on the bunds until the large failure occurred.

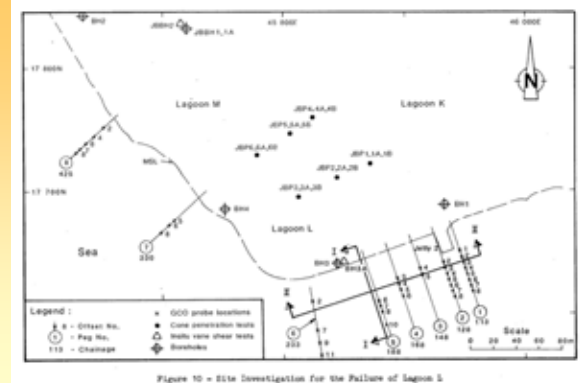
Figure 10 = Site Investigation for the Failure of Lagoon L

- 2 boreholes were drilled near centre of a lagoon with samples of marine mud taken and some field vane tests in the mud.
- 18 locations were investigated by Dynamic Penetration Testing using a 65 kg hammer to find variability and thickness of the waste fill, and met refusal at about 10 to 12 m on average.
- 4 boreholes were drilled through the bunds to determine nature of the contact with underlying sediments, samples of soft layer were taken when found.
