CPD Course on  
Some Old Geotechnical  
Failure Incidents in Hong Kong

**SLOPE FAILURES**

Ir Ken Ho  
Chief Geotechnical Engineer  
Geotechnical Engineering Office  
Civil Engineering and Development Dept

10 MARCH 2007

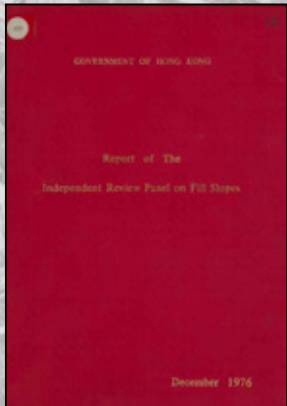
### INDEPENDENT REVIEW PANEL ON FILL SLOPES

- ▣ 4 landslides at Sau Mau Pau Resettlement Estate on 33° fill embankments formed by Government in the 1960s
- ▣ Government engaged an **Independent Review Panel** comprising 6 international geotechnical experts
- ▣ **Conclusion** : Mobile failure was due to **liquefaction of the loose fill with inadequate compaction (end-tipping)**

- ▣ The method of construction (**End-tipping**) for fill slopes was commonly adopted and widely accepted throughout the early 1960s
- ▣ **Independent Review Panel recommended** :
  - ▣ establishment of a **geotechnical control organization** within the Government
  - ▣ recompaction of the **top 3 m of loose fill slopes** as a prescriptive treatment to retrofit the substandard works
  - ▣ .....
- ▣ The then Governor accepted the recommendations. The **Geotechnical Control Office** was set up in Engineering Development Department (EDD) and the **Geotechnical Control Branch** established in B00 in July 1977

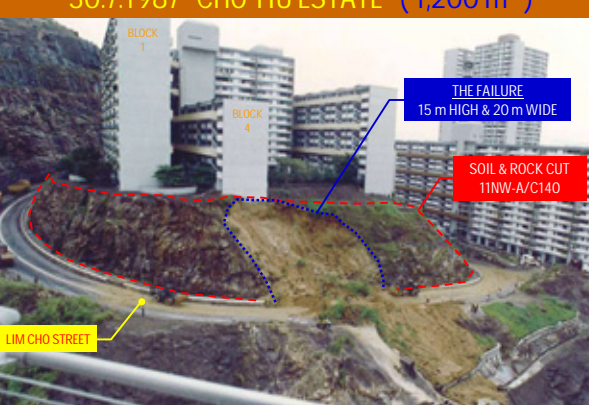
### 30.7.1987 CHO YIU ESTATE (1,200 m<sup>3</sup>)

**THE FAILURE**  
15 m HIGH & 20 m WIDE

**SOIL & ROCK CUT**  
11NW-A/C140

LIM CHO STREET

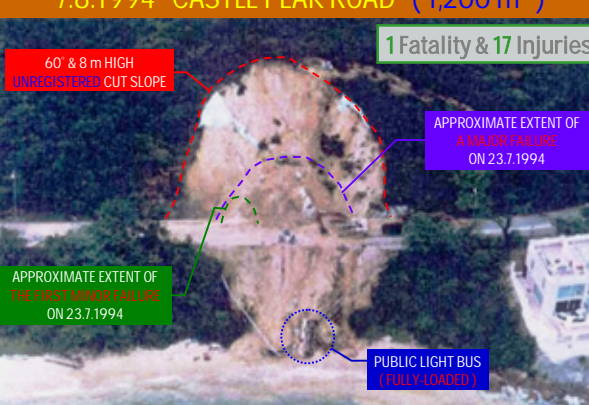
### 7.8.1994 CASTLE PEAK ROAD (1,200 m<sup>3</sup>)

60° & 8 m HIGH UNREGISTERED CUT SLOPE

APPROXIMATE EXTENT OF MAJOR FAILURE ON 23.7.1994

APPROXIMATE EXTENT OF THE FIRST MINOR FAILURE ON 23.7.1994

PUBLIC LIGHT BUS (PLB) (MORNING)

TWO FAILURES OCCURRED ON THIS UNREGISTERED SLOPE ON 23.7.1994

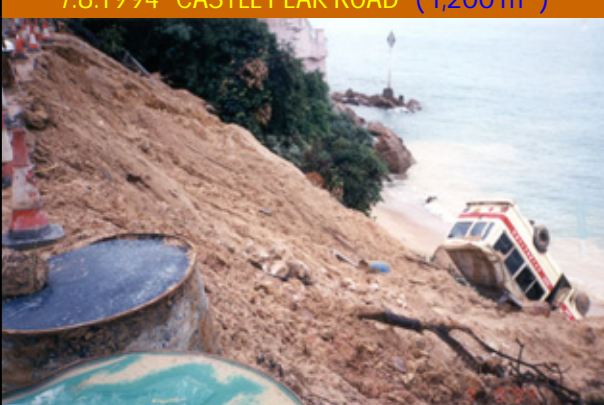
### 7.8.1994 CASTLE PEAK ROAD (1,200 m<sup>3</sup>)

THE FULLY-LOADED PUBLIC LIGHT BUS WAS PUSHED DOWN THE EMBANKMENT ONTO THE BEACH

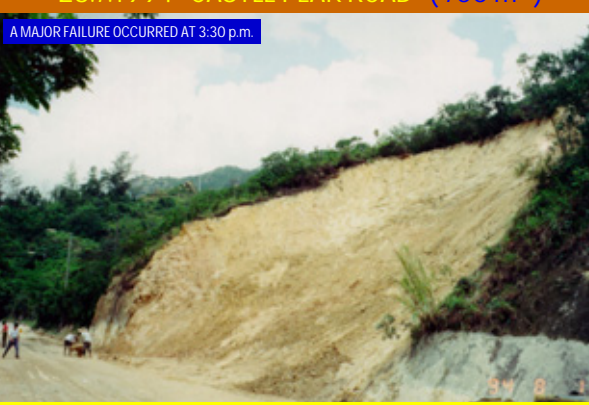
### 23.7.1994 CASTLE PEAK ROAD (700 m<sup>3</sup>)

A MAJOR FAILURE OCCURRED AT 3:30 p.m.

A MINOR FAILURE (20 m<sup>3</sup>) OCCURRED IN THE MORNING OF 23.7.1994

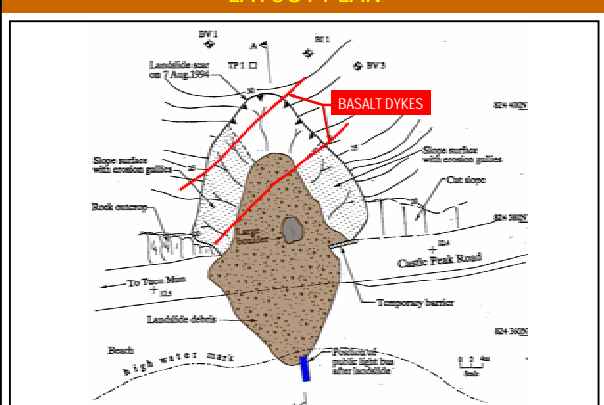
### LAYOUT PLAN

BASALT DYKES
