# Review of Past Failures of Trench Excavations

Ir Y S Au-Yeung

## The GEO Study

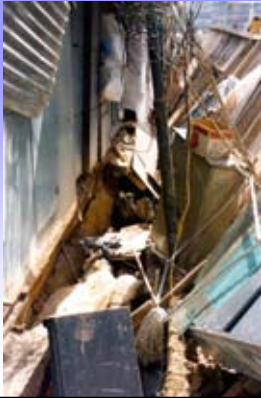
### Sheetpile Failure at Yun Ping Road

10m long pavement subsided

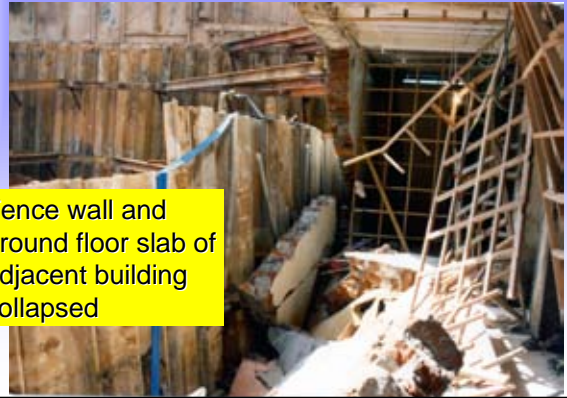
### Sheetpile Failure at Yun Ping Road

Fence wall and ground floor slab of adjacent building collapsed

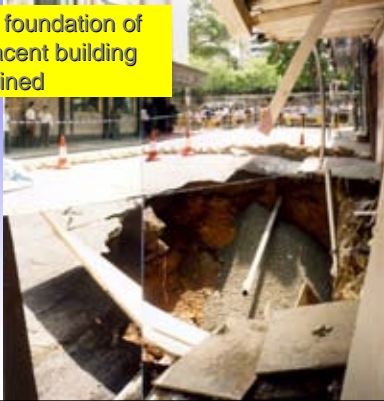
### Ground Subsidence at Mau Lam Street

Footing foundation of the adjacent building undermined

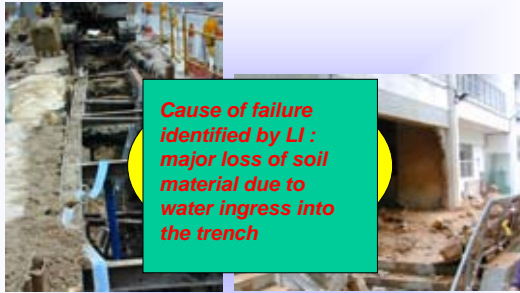
Kennedy Road near HK Park (August 2000)

**Cause of failure identified by LI : major loss of soil material due to water ingress into the trench**

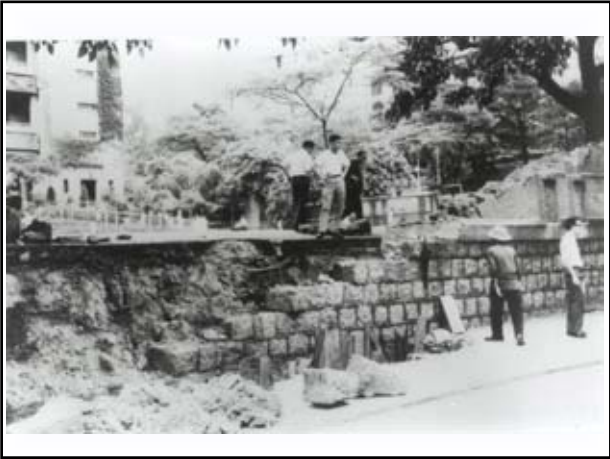
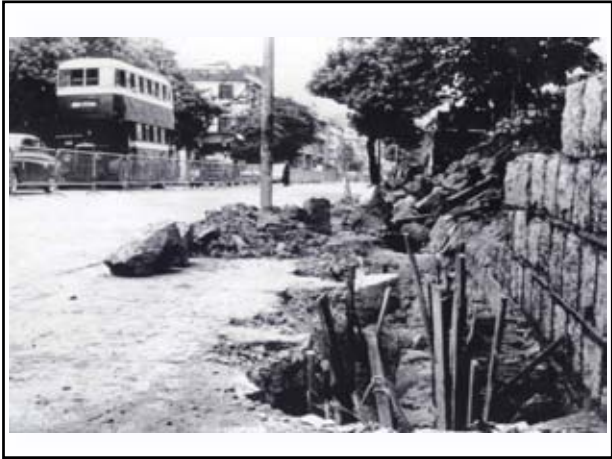
**6 killed, 16 injured** **8.6.1966**

Brick and plaster fence wall

Blocks falling

**Cause of failure identified by Professor Lumb :**  
**" the collapse of the wall was due to the excavation at the foot of the wall.....Failure might not have been occurred if there had been no trench excavated ....."**
