PROPERTY INSPECTION REPORT FORM

Eric Cook <i>Name of Client</i>	05/24/2024 <i>Date of Inspection</i>
4603 Charles Ave., Austin, TX 78746 <i>Address of Inspected Property</i>	
Richard H Craycroft <i>Name of Inspector</i>	5069 <i>TREC License #</i>
<i>Name of Sponsor (if applicable)</i>	<i>TREC License #</i>

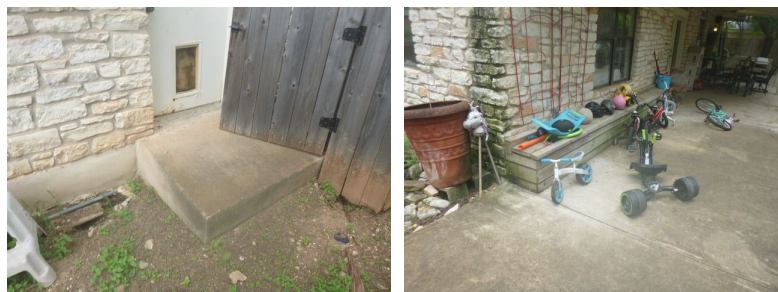
Portions of the foundation are obscured from view. Covered expansion joints, high soil lines, or obscured areas may hide evidence of, or promote termite infestation. Preventative "spot" treatment may be recommended by a Termite Inspector.

Spalling observed along brick ledge and/or at corners of foundation beam. Cracks of this type are the result of friction between exterior cladding and foundation as a result of differential thermal expansion and contraction rates of dissimilar materials and does not represent a loss of structural integrity and are cosmetic in nature unless otherwise noted. Cracks should be monitored and perform repairs in the future as necessary.

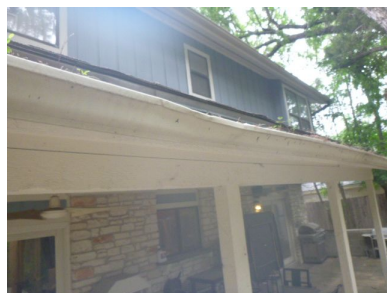
Gutter are damaged in a number of locations.

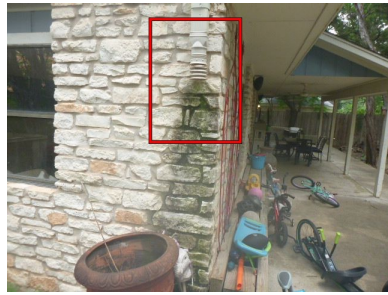
There is erosion occurring at the foundation perimeter. Improper drainage patterns will have a deleterious effect on the long term performance of the foundation.

Extend down spouts 3 feet from foundation perimeter or install splash blocks.

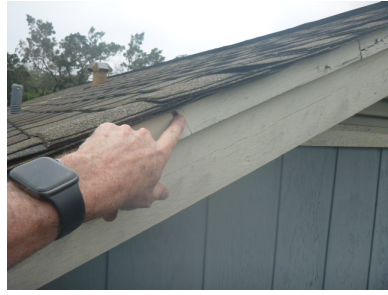
Drip and rake edge flashing is not present where currently required. [IRC R905.2.8.5]

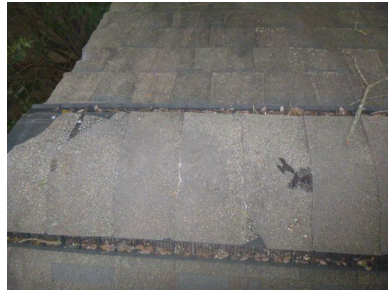
A number of areas have damaged and missing shingles from tree abrasion.

Remove all of the debris from the roof seasonally or as necessary. Build up of debris in valleys, behind chimneys, etc. can lead to water penetration of the roof assembly.

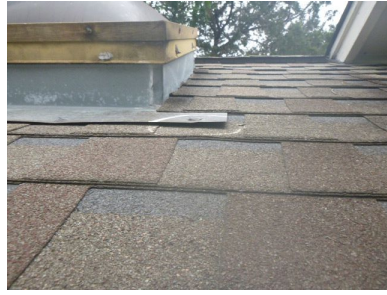
Skylight covers are aged and UV damaged and have become opaque.

Secure all lifting flashings flush to the roof surface.

A qualified roofer is recommended to provide estimates and perform all necessary repairs.

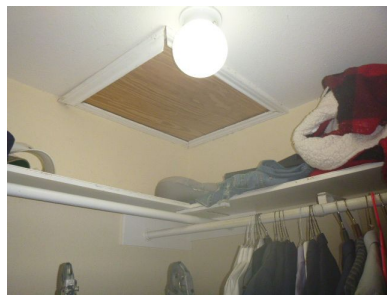
The attic lacks proper provisions for access. The attic access shall be no less than 30" x 22" when in a ceiling or wall. The attic access shall be in a hallway or other *readily accessible* location. Unobstructed headroom clearance above the access shall be a minimum 30". [IRC R807.1]

The attic hatch lacks weather stripping and insulation resulting in unnecessary heat transfer into and out of conditioned air spaces.

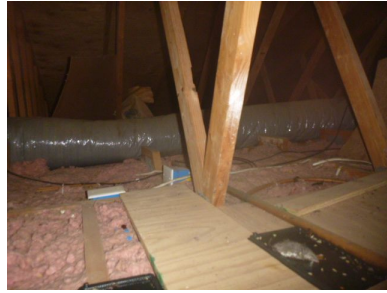
Insulation is minimal by current requirements. Energy efficiency of structure can be greatly increased with additional insulation coverage. Current energy codes require a minimum R-38 insulation value (roughly equivalent to 14-16" of loose fill insulation).

The attic storage decking is undersized and loose. The plywood is too thin and not rated for the spans of the ceiling joists. Use and traverse with caution. 3/4" material is required. Replacement is recommended.

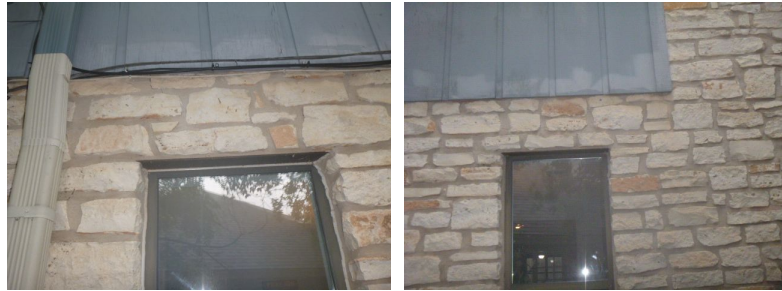
Weep holes are missing at the bases of the exterior masonry wall assemblies at various locations. Weep holes are required at intervals of 33" for proper drainage and to allow a path for dispersal of accumulated moisture from bulk water intrusion or water vapor condensation inside of the wall assemblies. [IRC R703.7.6]

Weep holes are missing over the window and/or door lintels.

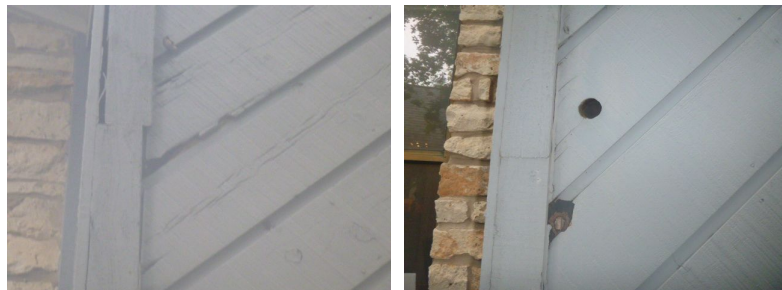
There is water damage to various areas of the siding, trim and fascia.

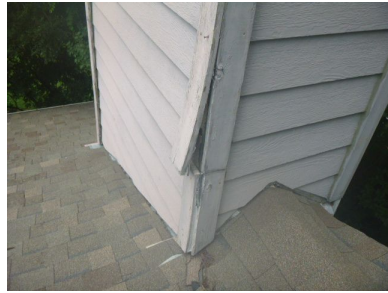
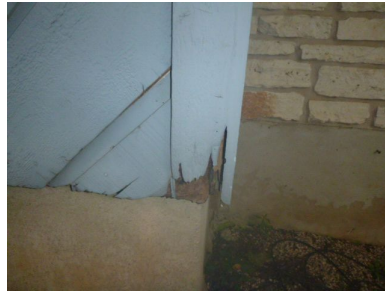
Siding and trim on the chimney is water damaged, has large open gaps, holes, loose trim, and damaged Weather Resistant Barriers (WRB).

-Repair to prevent water and vermin infiltration.

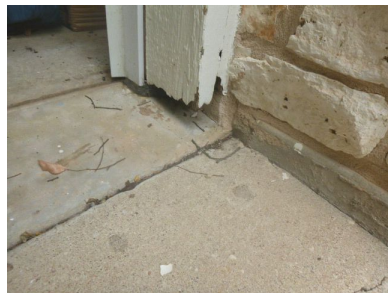
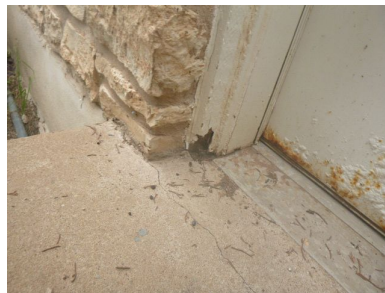
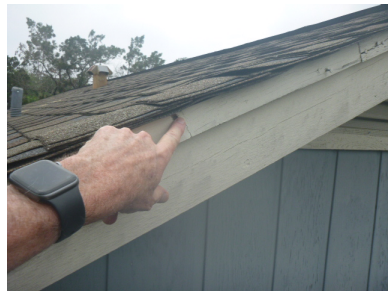
Hardboard siding present. This type of siding is composed of wood fiber, waxes, resins and glues. It is not a water proof material. Edges and rear of panels are not primed or sealed and therefore are susceptible to water damage. It is essential that all surfaces be properly sealed and painted in order to extend lifespan. Regular maintenance will help extend life of product.

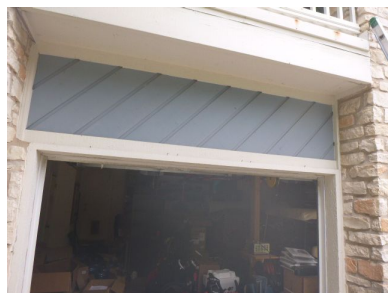
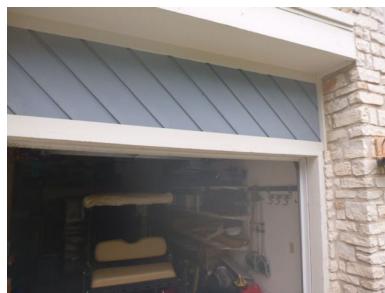
Exterior wood trim is water damaged.

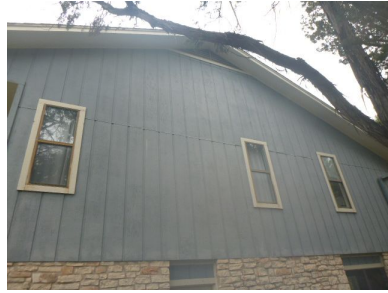
Head flashing is not present above the projecting exterior wall trim at the windows and doors as required. Head flashing is required to prevent bulk water penetration of the exterior wall assemblies at these vulnerable areas and to protect the trim from exposure and water damage. [IRC R703.4(4)]

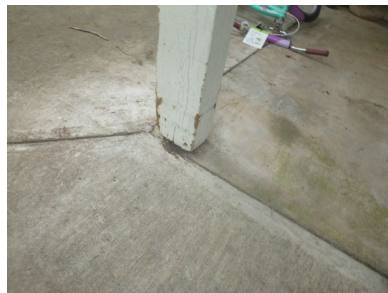
The right side rear porch post is water damaged and is no longer anchored to the patio.
-This could create a safety hazard and compromise the patio roof structure.

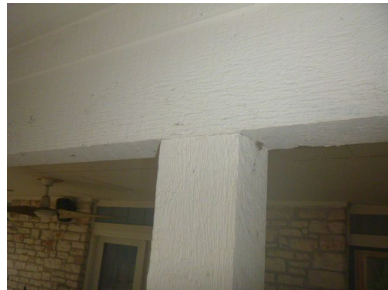
Patio posts are butt jointed and toe nailed.
-Some of the joints are loose.
-Add structural straps and bolts.

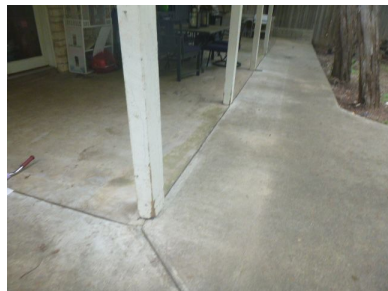
The rear porch posts lack offsets from the concrete patio to prevent water damage.
-The post in the foreground is the loose one.

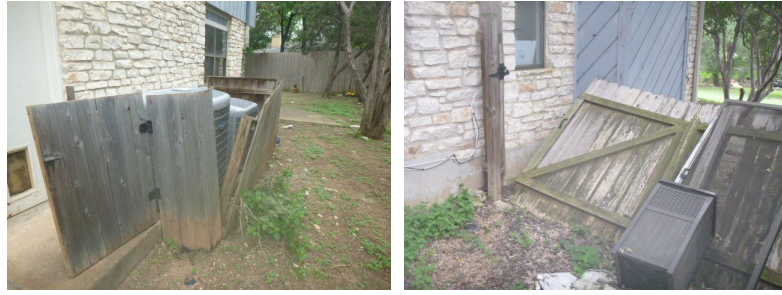
Right and left side fences are in failure stage.

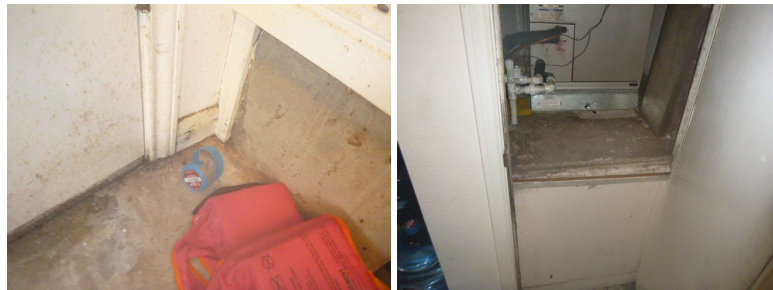
There is excessive moisture and biologic growth at the HVAC enclosures in the garage and upper hallway.
-Some biologic growth can be harmful.
-A qualified technician is recommended for sample collection and lab analysis to determine the type of biologic growth present.

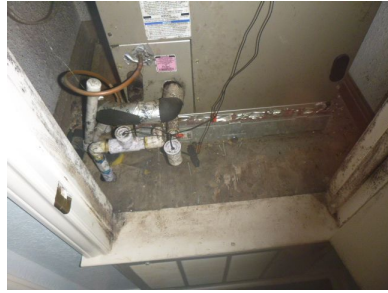
Wall trim and enclosure platforms at the HVAC enclosures are water damaged.

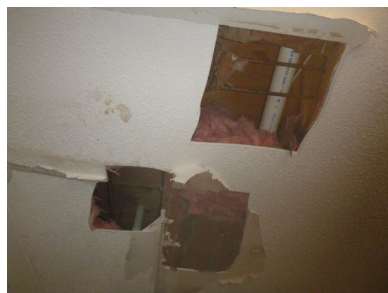
Leakage has caused water damage to the garage ceiling.

- The sub floor insulation needs to be replaced.
- Drywall must be repaired to restore the required fire rating of the garage ceiling assembly.
- Occupied spaces above the garage must have an intact fire separation between the garage and the conditioned spaces.

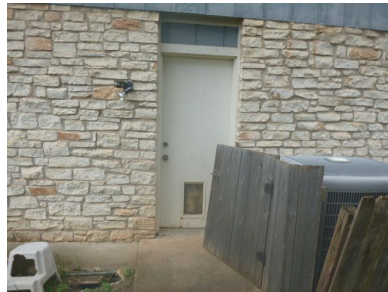
The exterior door off the garage is subject to water damage due to the close proximity of the adjacent deck or patio slab from back splashing and exposure. Storm doors are very effective at protecting exposed exterior doors from damage. Water damage was noted to the door and adjacent areas.

-Note: This door was blocked by stored items in the garage and could not be fully inspected.

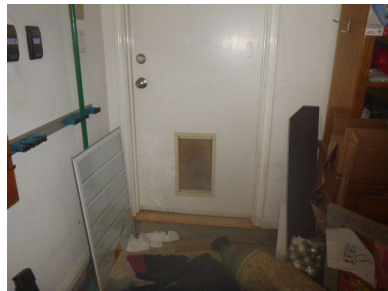
Interior garage door is not fire rated for location installed due to a pet door. Interior garage doors are required to be 1 3/8" solid core/metal [IRC R302.5.1].

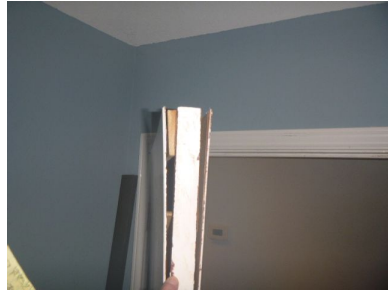
The master bedroom door is damaged.
-The door skins are loose.
-Replace.

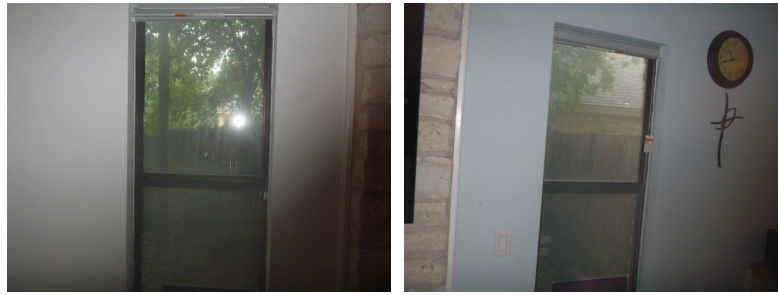
Various windows were observed to have moisture or staining between double panes. This is the result of failure of the seals between double panes allowing moisture to enter space and causes "fogging" to windows.

- Living room
- Upper rear right bedroom
- Den
- Possibly others that were inaccessible due to belongings.

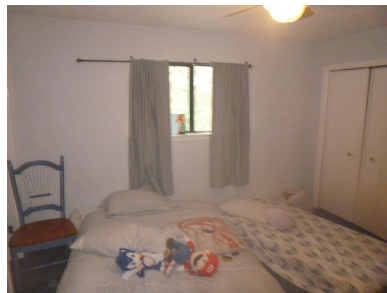
Bedroom window sills measure at a height in excess of 44" above the floor.

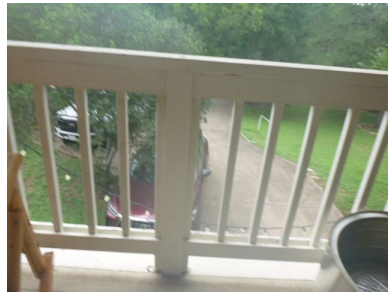
Stair and guard rail spacing will allow passage of a 4" sphere. This is considered a safety hazard. [IRC R312.3]

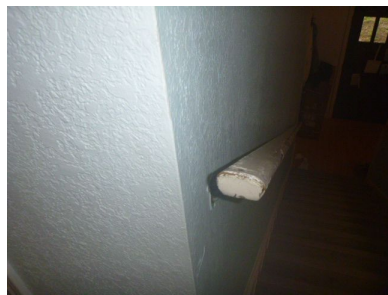
Hand rails terminate improperly. Hand rails are required to turn back at the adjacent wall plane to avoid loose clothing or articles to snag and become a tripping hazard. [IRC R311.7.7.2]
-The stairway hand railing is loose at the midpoint.

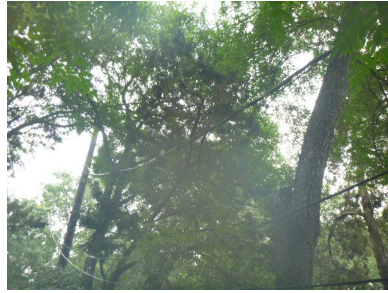
The Service Drop is in direct contact with trees and subject to damage and power interruption

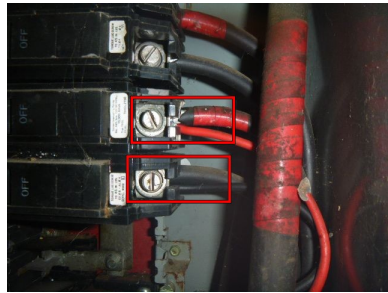
Double tapped breaker present. Manufacturer specifically forbids attachment of more than one branch circuit wire to each breaker.

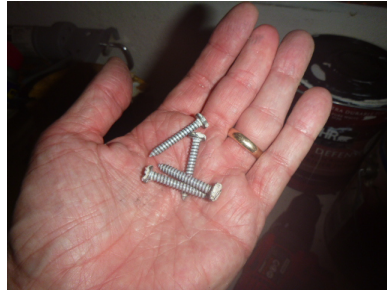
The panel dead front cover is attached with pointed sheet metal screw(s).
-Screws are in dangerously close proximity to conductor(s) inside the panel
-Damage to the conductor insulation will result in an electrical fault that could be potentially very hazardous.
-Replace the substandard screws with blunt tipped screws supplied by the manufacturer of the panel.
-Safety/Fire Hazard.

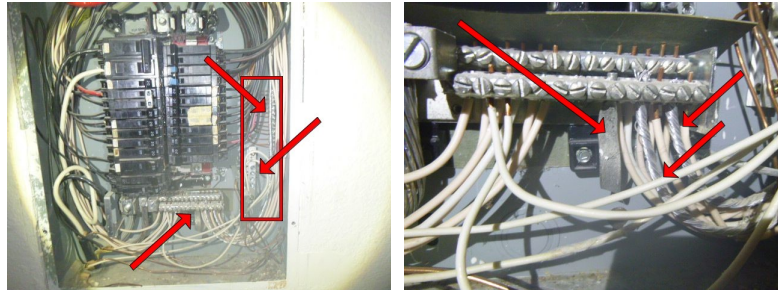
The Grounded (bare copper wires) and Grounding (white/neutrals) are bonded at the Sub Panel. This is never allowed at Sub Panels as it creates a false, or circular ground path. Grounded and Grounding conductors are to be bonded ONLY at the Service Disconnect Panel. [NEC 480.40] Safety Hazard.
-The bonding strap must be removed from the Neutral Buss Bar.
-Ground Wires are attached to the Neutral Buss Bar.
-The Ground strap causes a bond connection between the Neutral Buss Bar and the Grounding Buss Bars.
-Safety Hazard.

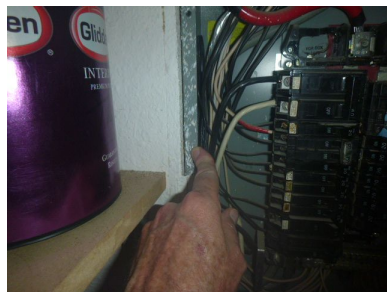
Drywall gaps around the panel are greater than the allowed 1/8". [NEC 312.4]
-Seal the gaps.

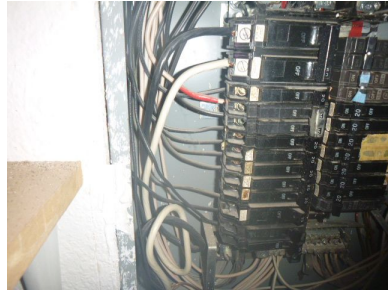
Breaker(s) have a "white" wire utilized as a "hot" conductor on one leg of the circuit without being designated as such. For example, this white wire should have a piece of red tape wrapped around it to designate it as a "hot" conductor versus a "neutral" conductor. [NEC 210.5]

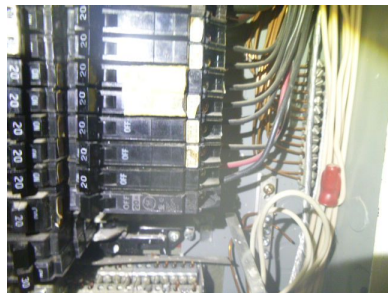
The multi wire circuit(s) lack required trip ties. [NEC 210.4].

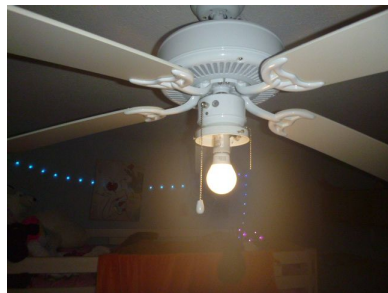
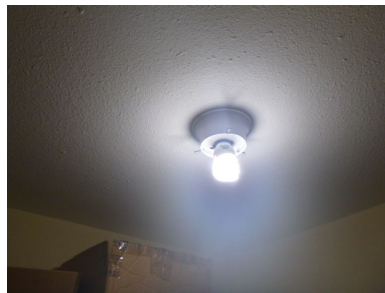
Install protective cages or globes on all exposed attic and closet lights to prevent physical damage. -Several fixtures have missing covers, cages, and globes.

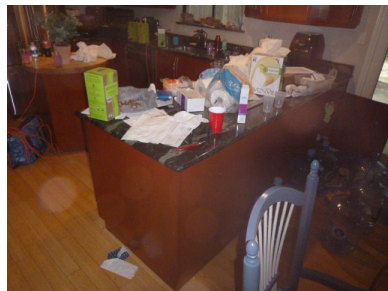
The kitchen peninsula lacks receptacles.

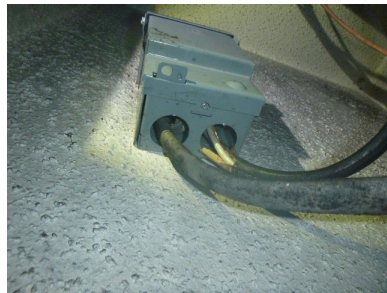
Wire clamps are missing at the wiring entrances to the upper level HVAC air handler disconnect. This may allow damage to the conductor insulation which could result in an electrical fault and become a shock/fire hazard. Missing cable clamps and bushings are considered to be a latent fire and safety hazard. [NEC 300.4(B)(1)]

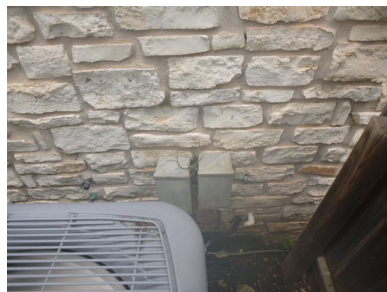
The HVAC disconnect(s) lack required clearance(s) for access. [NEC 110.26(A)]

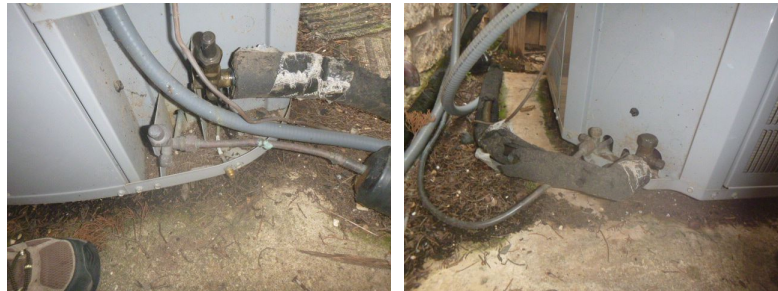
The refrigerant lines are not adequately protected from damage. Protective sleeves are required to prevent abrasion damage, UV exposure, and potential leakage. [IRC N1103.1.1] [R403.4.1]

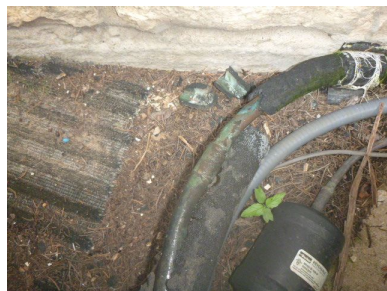
There are insulation voids on the refrigerant line. These will cause a loss of system efficiency, and when indoors or in attics, will cause sweating and possible water damage.

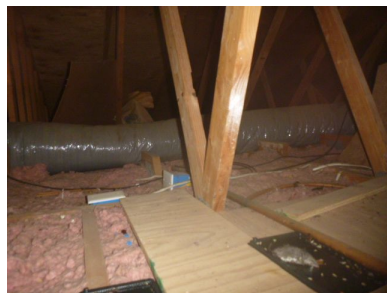
Grey flexible ducting observed. Ducting of this type is known to have a higher than normal failure rate due to the lack of resistance to UV radiation in attics. Some ducts were observed to have degraded vapor barriers which is a sign of failure. Recommend budgeting for replacement.

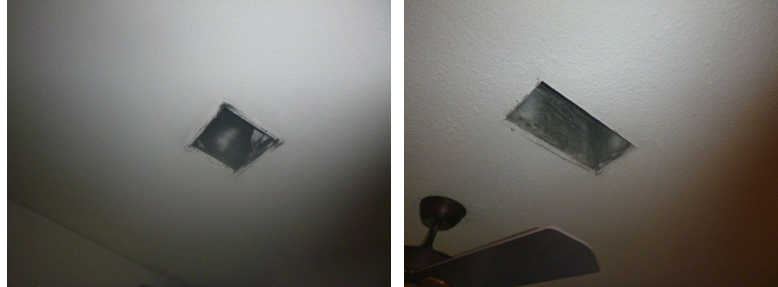
Ceiling registers are missing in a number of locations.

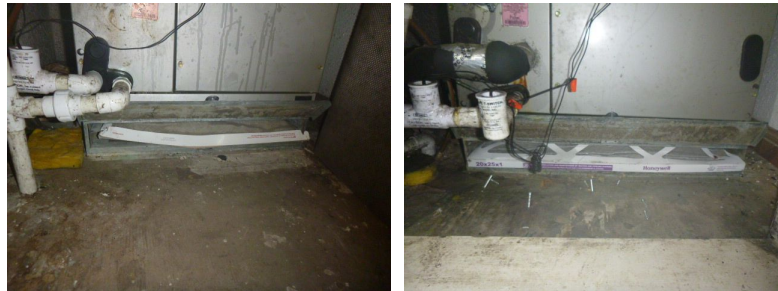
The air filters are dirty, damaged, and past due for change out.

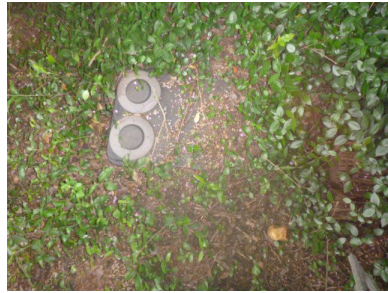
There is no home owner's cut off valve. System cut off is at city side of the water meter.
-A meter box key and city shut off Tee Handle will be required to turn the water to the structure off.
-These are recommended tools for home owners.

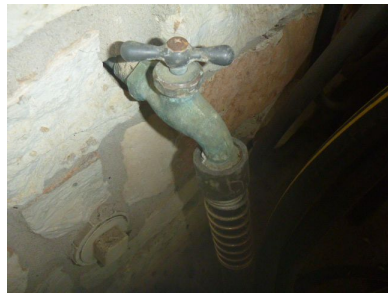
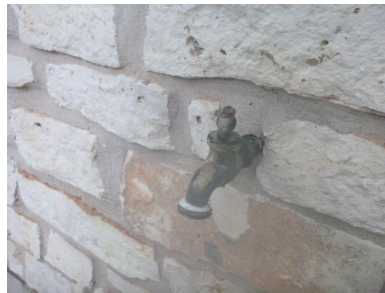
Back flow prevention is missing at exterior hose bibbs. Protective sleeves and collars are not present or damaged at exterior hose bibb masonry veneer penetrations. The hose bibbs drip when operating.

Fully insulate all exposed exterior plumbing to help prevent freeze damage.

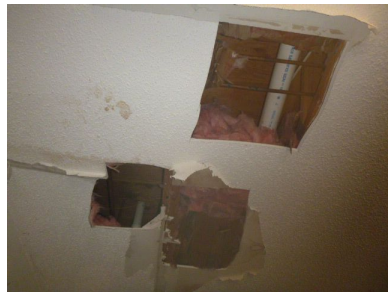
Plumbing in the garage ceiling is exposed and subject to freeze damage in extreme weather conditions.

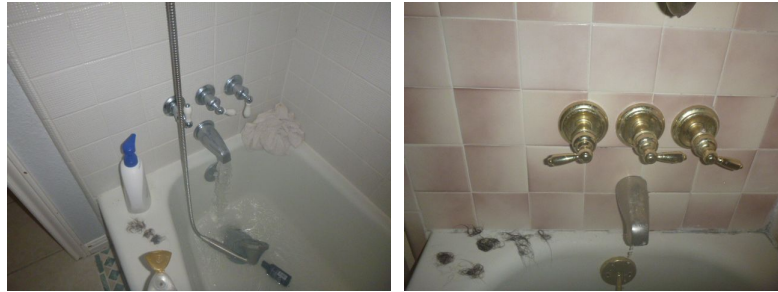
The bathtub hot water valves do not have an identifiable temperature limiting device as currently required by local and National Building Codes.

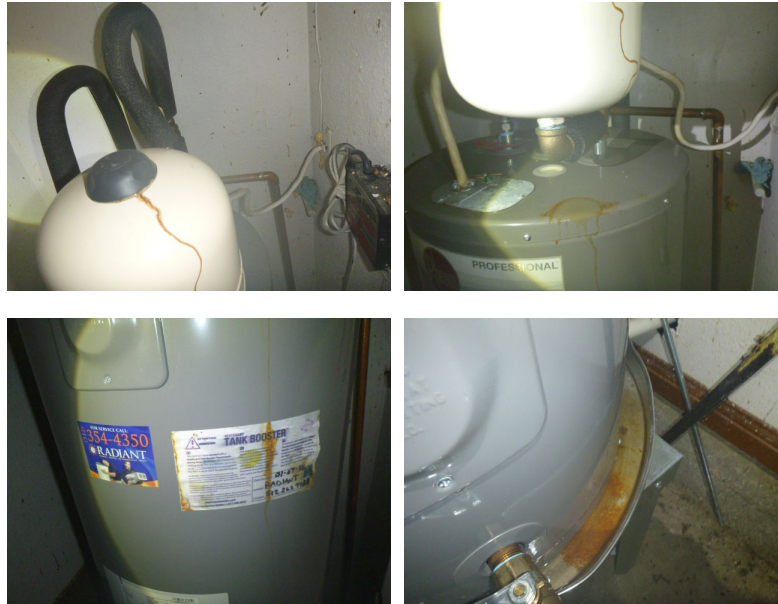
The expansion tank is corroded and actively leaking down the unit and into the drip pan.
 -The drip pan has standing water and corroded.
 -Repair ASAP.

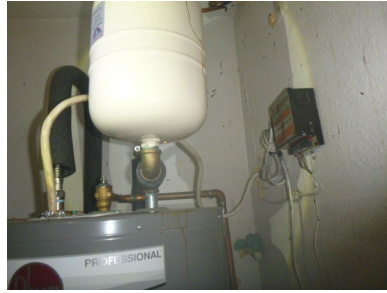
The water heater lacks a required electrical disconnect. [NEC 422.30]

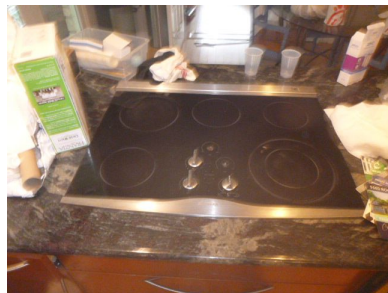
The glass cook top has a fracture in the glass surface.
 -Knobs are missing and damaged.
 -Burner controls are damaged and inoperative.
 -Several burners are inoperative.
 -The cook top is beyond repair and should be considered for replacement.

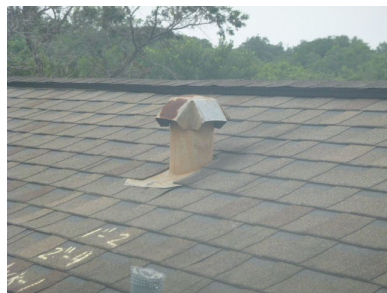
The dryer vent terminates above the roof at a non dampered vent cap.
