WOOD DESTROYING PESTS AND ORGANISMS INSPECTION REPORT

Building No. 2372	Street BRANDON MILES WAY	City BRENTWOOD	Zip 94513	Date Of Inspection 2/19/24	Number Of Pages 8
----------------------	-----------------------------	-------------------	--------------	-------------------------------	----------------------

General Description: TWO STORY FRAME, ATTACHED GARAGE, SINGLE FAMILY RESIDENCE	Inspection Tag Posted: IN THE GARAGE
	Other Tags Posted: NONE CURRENT

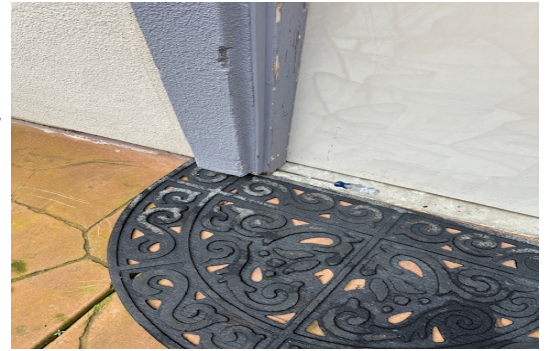
1A

FUNGUS OR DRY ROT

FINDING: THERE IS FUNGUS DAMAGE TO THE BOTTOM OF THE SIDE GARAGE DOOR CASING AND JAM.
RECOMMENDATION: TRIM UP THE WOOD MEMBERS TO ELIMINATE CONTACT WITH THE CONCRETE AND THE MINOR AMOUNT OF DAMAGE ALONG THE BOTTOM. FILL THE VOID WITH STEEL WOOL OR MORTAR.

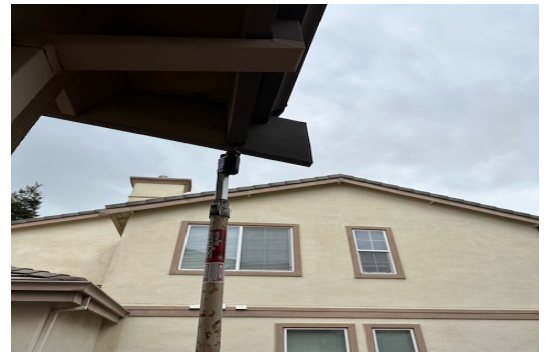
FUNGUS OR DRY ROT

FINDING: THERE IS FUNGUS DAMAGE TO THE FASCIA BOARD WHERE IT TOUCHES THE GABLE END RAFTER AT THE BACK AREA MARKED AS ITEM 1B ON THE DIAGRAM. DAMAGE EXTENDS INTO THE ROOF PLYWOOD SHEATHING AT THIS AREA.

RECOMMENDATION: REMOVE ROOF TILES AS NEEDED TO EXPOSE THE EXTENT OF THE DAMAGE. REPAIR/REPLACE DAMAGED SECTIONS OF ROOF SHEATHING, GABLE END RAFTER, AND FASCIA BOARD. PRIME PAINT AFFECTED AREAS. REATTACH ROOF COVERING.
NOTE: A ROOFER SHOULD BE CONTACTED TO EVALUATE SERVICEABILITY OF THE ROOF COVERING AS THIS IS BEYOND THE SCOPE OF OUR LICENSE.
ADDITIONAL NOTE: CAUTION WILL BE TAKEN NOT TO BREAK TILES. HOWEVER, BECAUSE THESE ARE OF CERAMIC MATERIAL; IF TILES ARE BROKEN DURING THE COURSE OF THESE REPAIRS, A SUPPLEMENTAL REPORT WOULD BE ISSUED WITH ADDITIONAL REPAIR ESTIMATES.

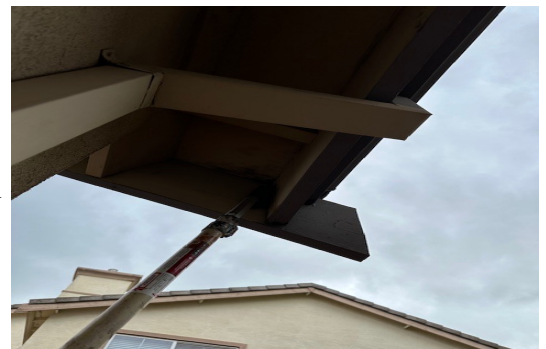
1C

FUNGUS OR DRY ROT

FINDING: THE DAMAGE DESCRIBED AT ITEM 1B IS BEING CAUSED BECAUSE THE END CAP OF THE GUTTER IS LEAKING AND THE GUTTERS APPEAR TO BE FULL OF DEBRIS.
RECOMMENDATION: WE RECOMMEND CLEANING AND SEALING ON A ONE TIME BASIS THE END CAP OF THE GUTTER AT THIS LOCATION. OWNERS ARE THEN ADVISED TO CONTACT THE PROPER TRADES PERSON TO CLEAN THE GUTTERS. SEE ITEM 2A.

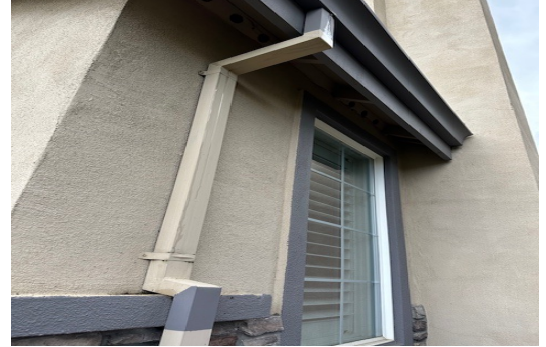
2A

CONTACT THE
PROPER TRADES
PERSON

FINDING: THE RIGHT SIDE FRONT CORNER DOWN SPOUT IS CLOGGED AND IS LEAKING AT THE TOP AND AT THE SEAM CAUSING MOSS GROWTH TO THE STUCCO AND STUCCO STONE VENEER. MOSS IS NOT A WOOD DESTROYING PEST. HOWEVER, DOES INDICATE EXCESSIVE MOISTURE.
RECOMMENDATION: WE RECOMMEND OWNERS CONSULT THE PROPER TRADES PERSON TO CLEAN AND SEAL THE GUTTERS AND DOWN SPOUTS TO CONTROL MOISTURE INTRUSION.
