# A Buyer's Choice Home Inspections

## PROPERTY INSPECTION REPORT

34 Hanna Dr, Bowmanville, ON, L1C 5M4

Date of Inspection: 4/29/2025 Time: 1:30 PM  
Order ID: 1621

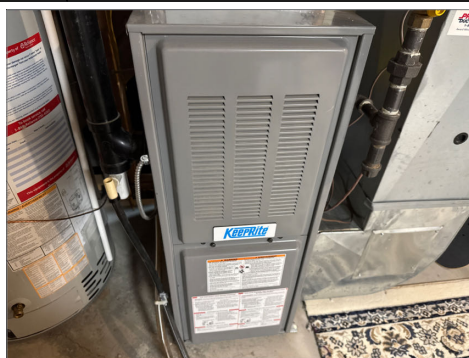
Page 19 Item: 2	Condition	• Further evaluation required - The unit started and operated during the inspection. However, due to the age of the unit it is recommended that the unit be evaluated by a qualified professional for operation and viability.
-----------------	-----------	--

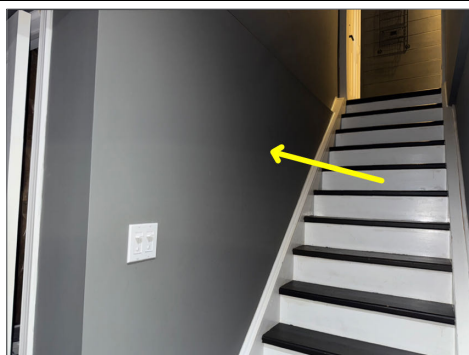
Page 31 Item: 8	Railing	• Repair - Missing handrail observed. This may have been removed to transfer furniture in and out of the basement. Recommend evaluation and addition of a handrail by a qualified professional.
-----------------	---------	---

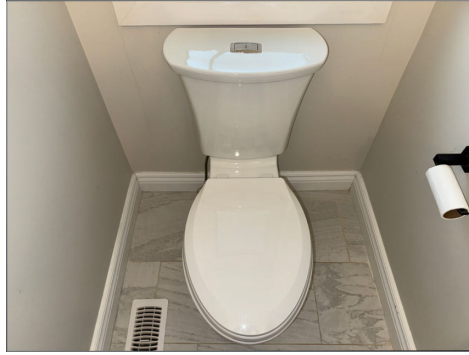
Page 40 Item: 13	Toilets	• Repair - Toilet loose and may need re-anchoring, this may lead to leaking and deterioration of the floor structure, as well as potential for mould growth. Recommend evaluation by a qualified professional.
------------------	---------	--

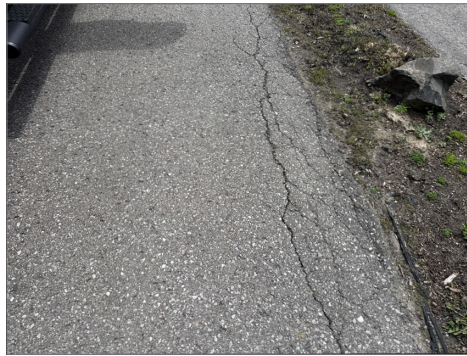
- Repair - Deterioration and cracking noted on surface, recommend sealing to avoid further deterioration of the driveway surface. Replacement of the driveway will eventually be required.

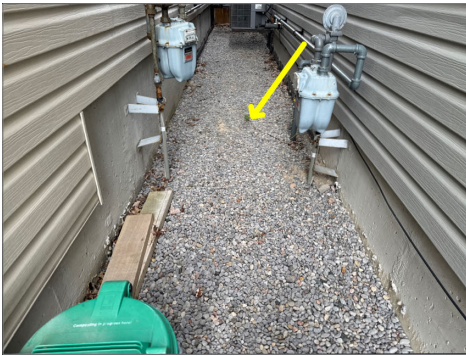
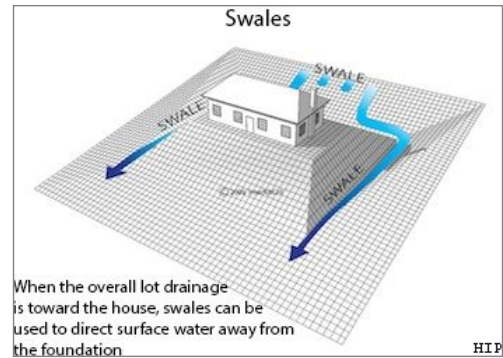
- Repair - Swale does not have adequate depth or slope for proper drainage. Recommend evaluation by a qualified professional.

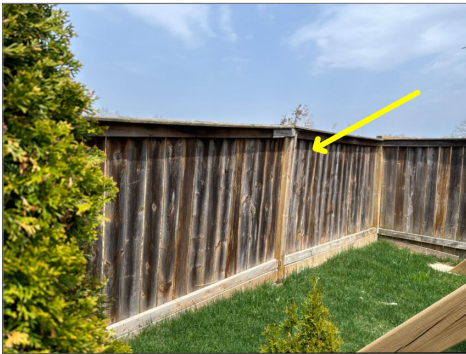
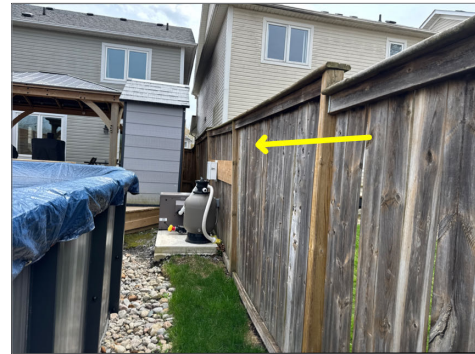
- Repair - Fence is damaged and leaning in some areas. This does not affect the house but the client is advised to consider repair. Recommend evaluation by a qualified professional.

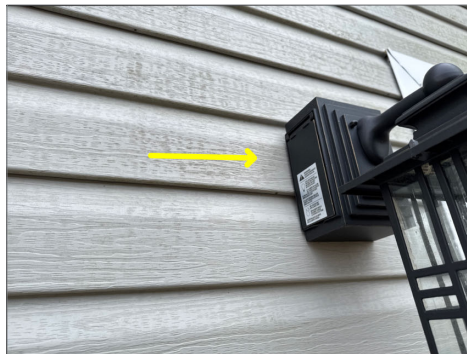
- Maintenance - Deteriorated or missing caulking or sealant noted on siding. Suggest sealing/caulking around all electrical fixtures, penetrations in siding, and joints between different siding materials, as part of routine maintenance to ensure watertightness and prevent further deterioration.

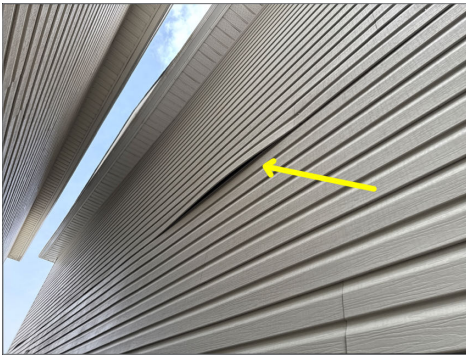
- Repair - The siding is noted as loose or improperly fastened, creating a potential pest and water infiltration point. Recommend evaluation by a qualified professional.
- Repair - Siding damage or wood rot noted, this is a potential water and pest infiltration point. Recommend evaluation by a qualified professional.

Loose siding

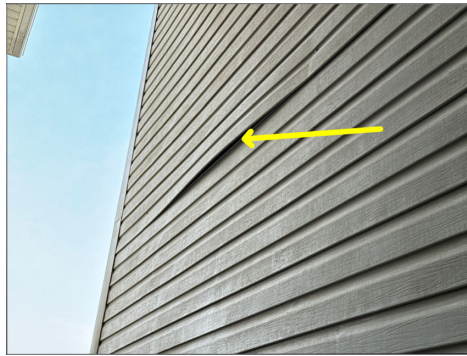
Loose siding

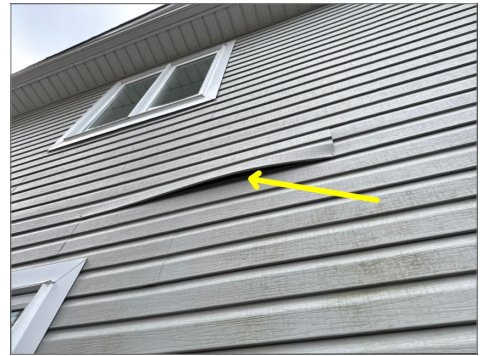
Loose siding

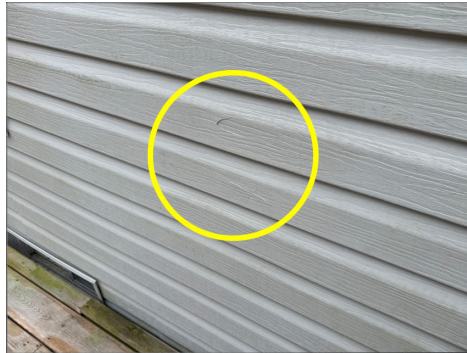
Siding damage

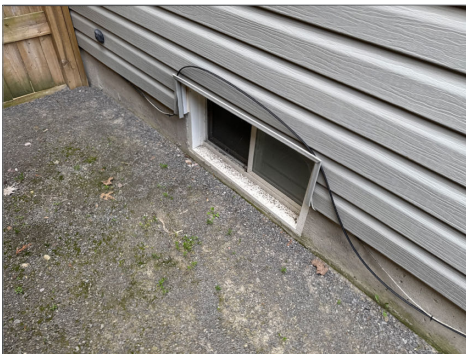
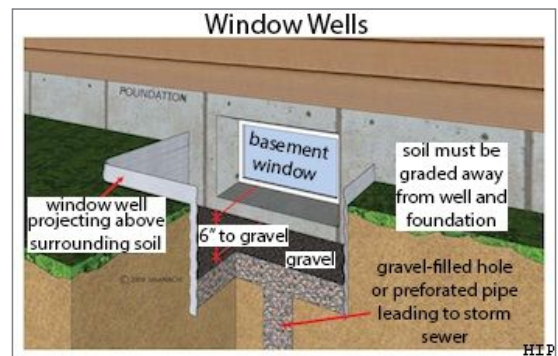
- **Repair -** Window is too close too grade. The window has to be a minimum 6" above grade. It is recommended that some earth is removed if the grading allows or a window well installed. Recommend evaluation by a qualified professional.

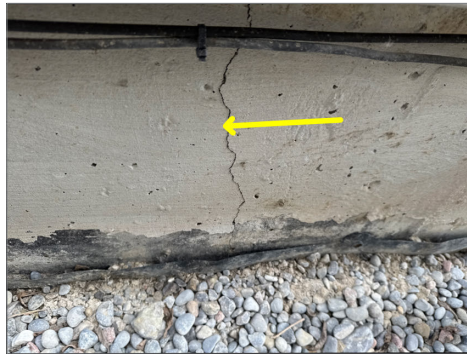
- Poured Foundation
- Monitor - Crack noted on the side of the house due to regular settlement and/or the curing process of concrete. It is recommended that the crack is monitored and sealed if the width exceeds 1/4", to prevent moisture penetration. Recommend evaluation by a qualified professional when needed.
- Inspection limitation - Finished basement limits the inspection of the structural components.
- Inspection limitation - The comments reflect only the visible parts of the structural components.

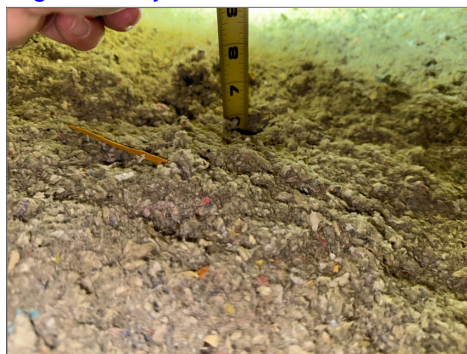
- **Improve - Insulation level in the attic is typical for homes this age. The buyer should consider adding insulation as per current standards, to improve the insulating efficiency. Recommend evaluation by a qualified professional.**

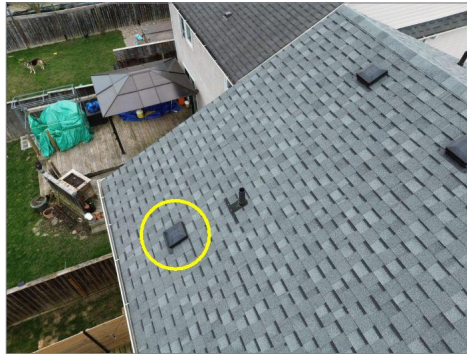
- **Improve - Roof vents noted as installed as bathroom vents. These style vents may not allow for proper venting of the warm moist bathroom air and may cause moisture issues with in the structure around the vent. Recommend evaluation by a qualified professional.**

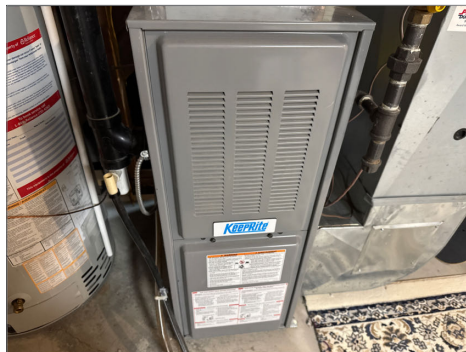
- Further evaluation required - The unit started and operated during the inspection. However, due to the age of the unit it is recommended that the unit be evaluated by a qualified professional for operation and viability.

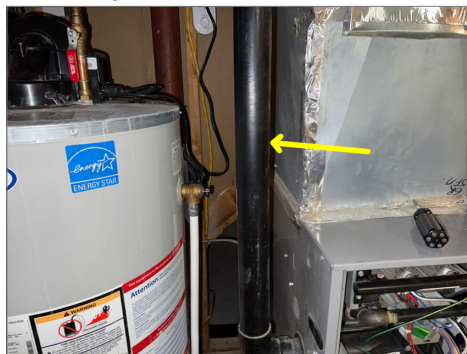
- Information - The black ABS piping on the furnace is no longer allowed for venting of natural gas appliances and will need to be upgraded at the time the furnace is replaced with a newer unit.

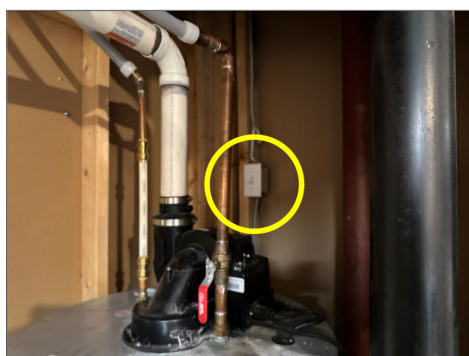
- Emergency shut off switch is present.
- **Repair - The emergency shut off switch is should be installed before the furnace. Recommend evaluation by a qualified professional.**

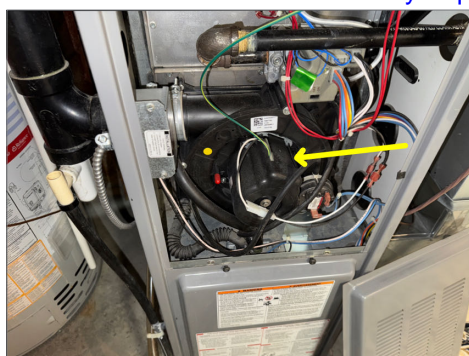
- **Repair - Excessive Vibration of the fan noted. Recommend evaluation by a qualified professional.**

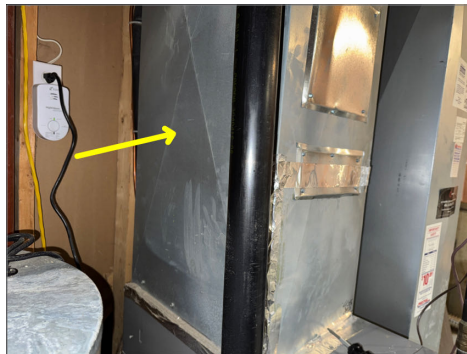
- Improve - No humidifier installed. A level of humidity between 45% and 55% is required in a house. It is recommended that the humidity of the house is monitored in the next heating season and a humidifier installed if required.

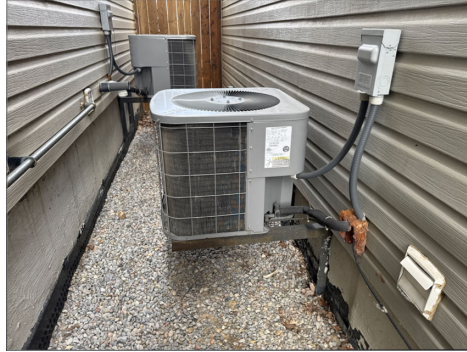
- Further evaluation required - The unit started and operated during the inspection. However, due to the age of the unit it is recommended that the unit be evaluated by a qualified professional for operation and viability.

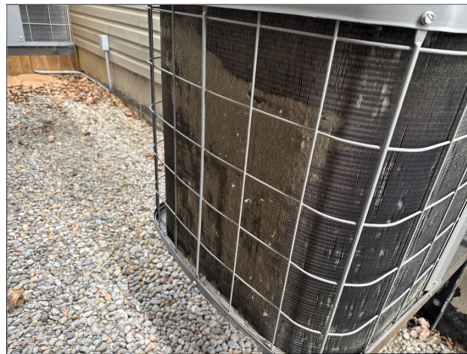
- Pad mounted unit
- Maintenance - Exterior unit cooling fins are noted as plugged or clogged. This may affect the operation of the air conditioner. Recommend evaluation by a qualified professional.

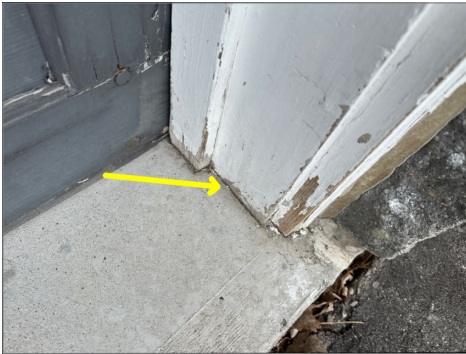
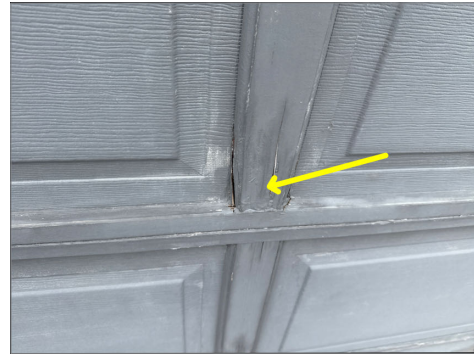
- **Maintenance** - Garage door frames noted with rot and damage from moisture. Deteriorated or missing caulking at the base of door frames should be replaced. Recommend evaluation by a qualified professional.
- **Repair** - Door panels are noted as damaged and repair or replacement is required. Recommend evaluation by a qualified professional.
- **Maintenance tip** - Garage door operation and lifespan are greatly increased by regular maintenance including: greasing of the rollers, adjustment of the rollers, painting and caulking of the exterior and frame.

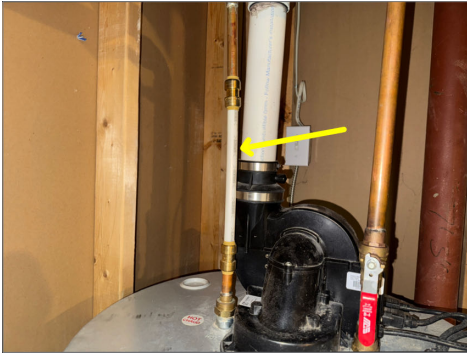
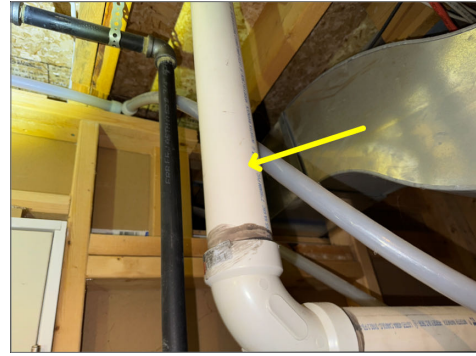
- Improve - Due to the proximity of the plastic pipe to the hot exhaust, it is recommended to provide pipe insulation for protection. Recommend for improvements.

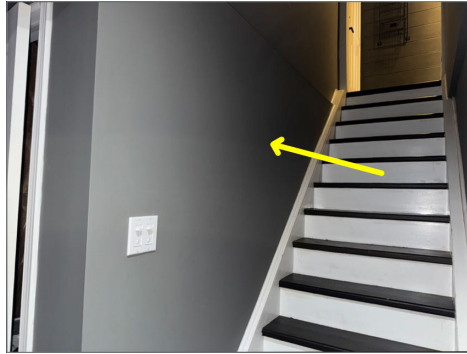
- [Repair - Missing handrail observed. This may have been removed to transfer furniture in and out of the basement. Recommend evaluation and addition of a handrail by a qualified professional.](#)

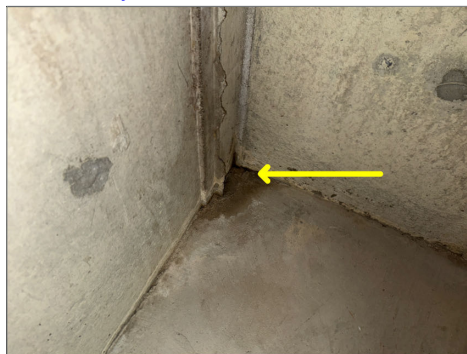
- **Monitor - Minor moisture stains noted in the utility room. Recommend monitoring and repairs as necessary.**

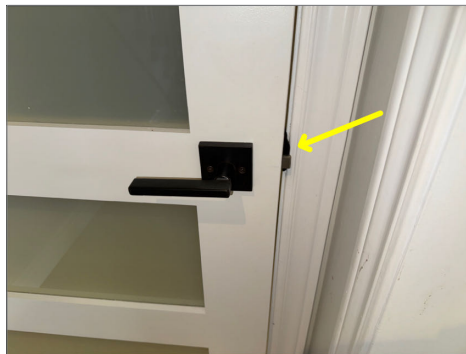
- Wood frame door with glass
- **Repair - The door is not latching. Recommend repair of the defective hardware.**

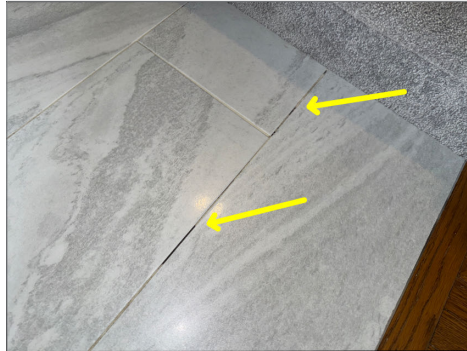
- Repair - Cracking noted in ceramic tiles grouting. This is an indication of inadequate subfloor installation. Recommend evaluation by a qualified professional.
- Inspection limitation - Furniture and personal items , limit the full inspection of the floors.

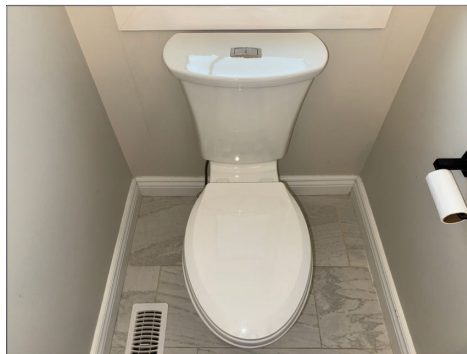
- Repair - Toilet loose and may need re-anchoring, this may lead to leaking and deterioration of the floor structure, as well as potential for mould growth. Recommend evaluation by a qualified professional.

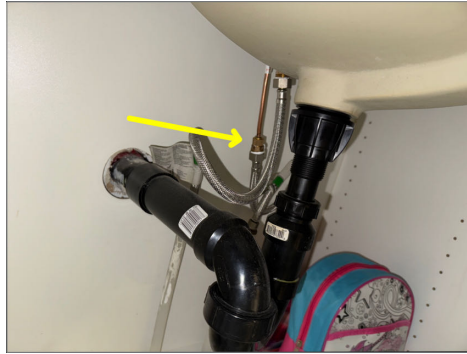
- **Repair** - The hot & cold water supplies are reversed. This is not a functional problem but to someone who is not familiar with this condition unexpected hot water could scald them. Recommend evaluation by a qualified professional.
- **Improve** - No shut off valves noted under the sink for isolation of the faucet. Recommend evaluation by a qualified professional.

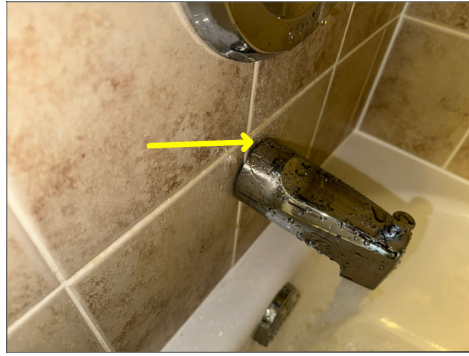
- Maintenance - It is recommended that the caulking around the faucets and/or bathtub is redone, to prevent moisture penetration.

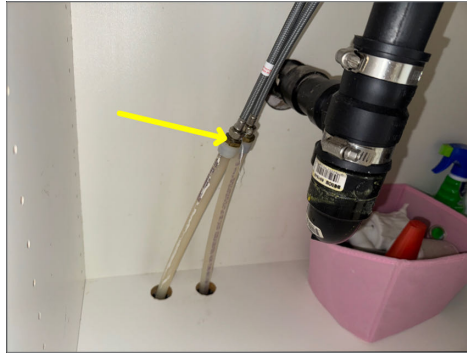
- Improve - No shut off valves noted under the sink for isolation of the faucet. Recommend evaluation by a qualified professional.

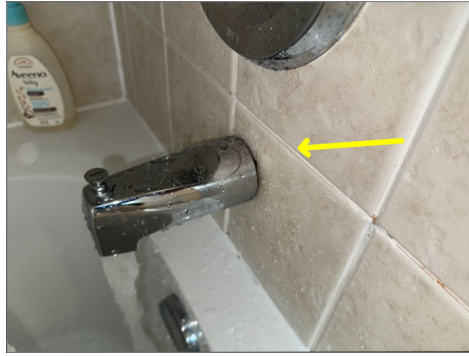
- Maintenance - It is recommended that the caulking around the faucets and/or bathtub is redone, to prevent moisture penetration.
