Technical Service Information

4L80-E

CASE COOLER LINE FITTINGS

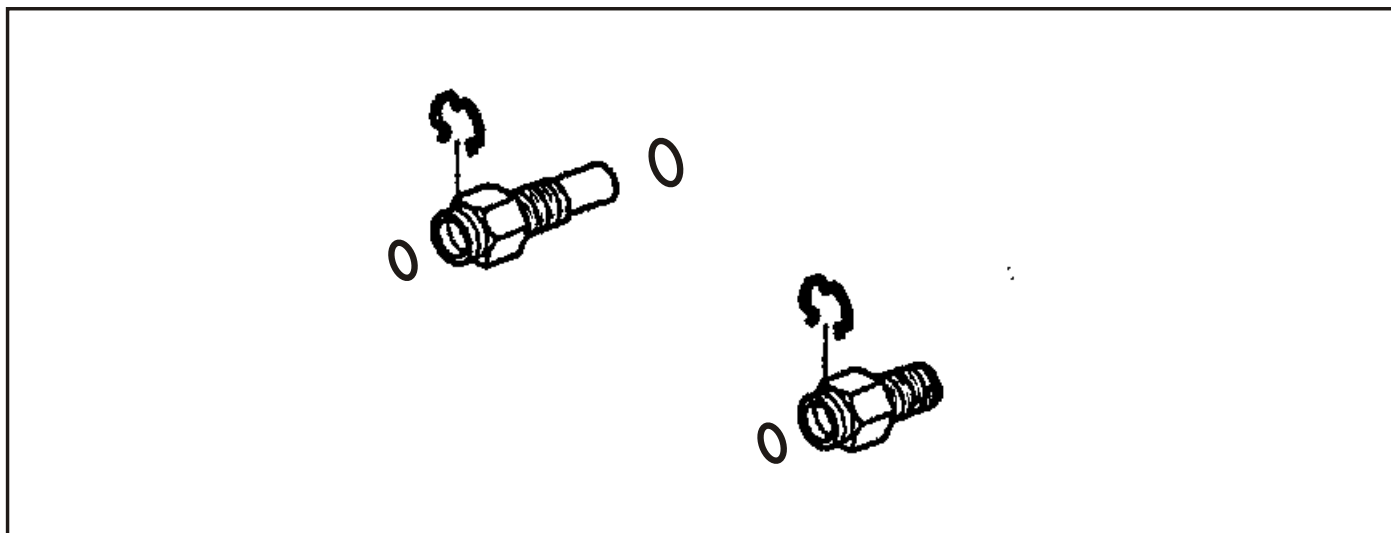
Figure 1

CORRECTION: 1997 and later center lube transmissions had the oil cooler return line relocated to direct oil returning to the transmission from the cooler directly into the center support at the middle area of the case instead of returning to the pump as in the 1996 and earlier units. This change also made a redesign of the case fittings necessary. The profile of the rear fitting was changed to make it longer so that the inner end will fit into a seal in the center support. At the same time, the front fitting as well as the rear fitting, was modified for quick connect / disconnect in place of the earlier flared line / threaded type. (See figure 1)

Retaining clip only - 24205103
Front fitting with clip - 24205102
Rear fitting with clip - 24207013
